Industry Bulletin 151

Tie-downs and connections in timber framed walls

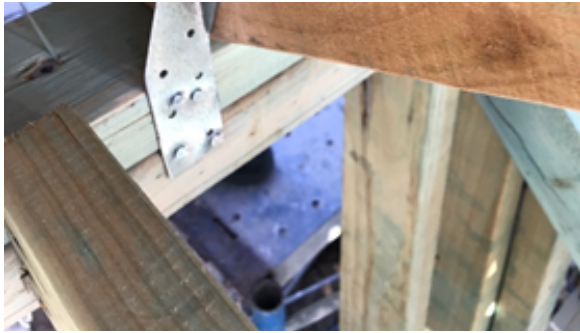
- connector nails - where hand driven fixings (connector nails) are specified in manufacturer's requirements, they should not be replaced by machine driven nails of lesser capacity;
- number of fixings (nails or screws) – unless otherwise specified fixings in the manufacturer's requirements must be installed;
- fixing spacings - nails must be appropriately spaced i.e. if too close together can cause punch through; and
- connectors - metal connectors must be correctly orientated i.e. vertical rather than horizontal.

Figure 1, inappropriate number of machine driven nails used with insufficient spacings to existing holes.

If the manufacturer's installation instructions regarding metal connectors are being relied upon to meet applicable building standards, any deviation from these may cause a weak point in the chain of tie-down which could lead to a building failure.

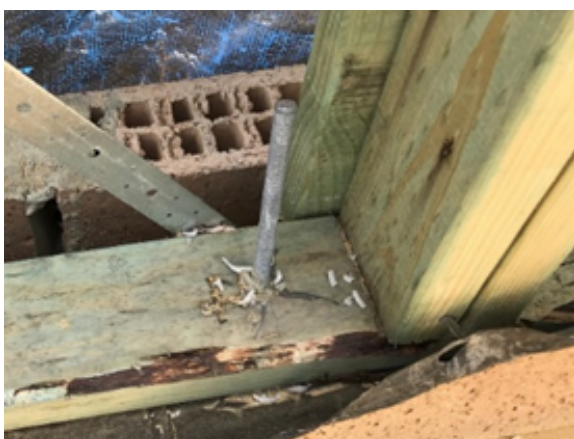
Anchors that are not installed correctly will likely result in connections with a reduced capacity.

Figure 2 above. No nut or washer installed to holding down bolt as required by approved engineering plans.

- anchor spacings - ensure they are installed to the engineers' requirements
- anchor size - ensure the correct sized anchors are supplied and installed
- washers - ensure the appropriate size washers are supplied and installed
