COMPLIANCE REPORT

Investigation into gypsum plasterboard ceiling collapses

An investigation into the fixing of gypsum
plasterboard ceiling sheeting to timber
framing in residential homes
in Western Australia

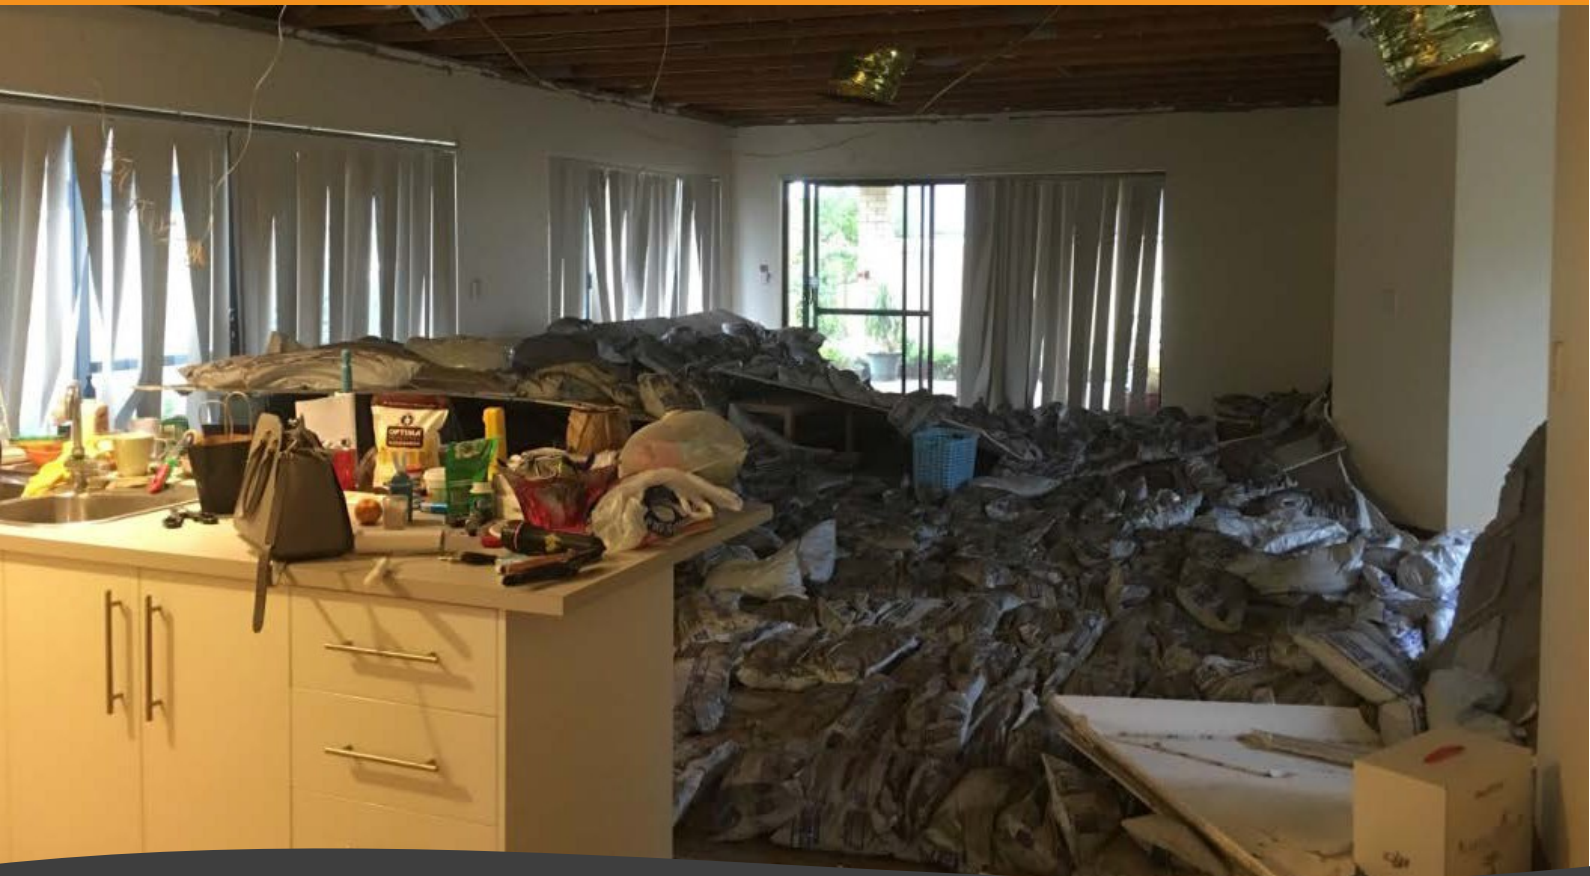
Cover image: Photograph by the Building Commission of a ceiling collapse assessed during this investigation.

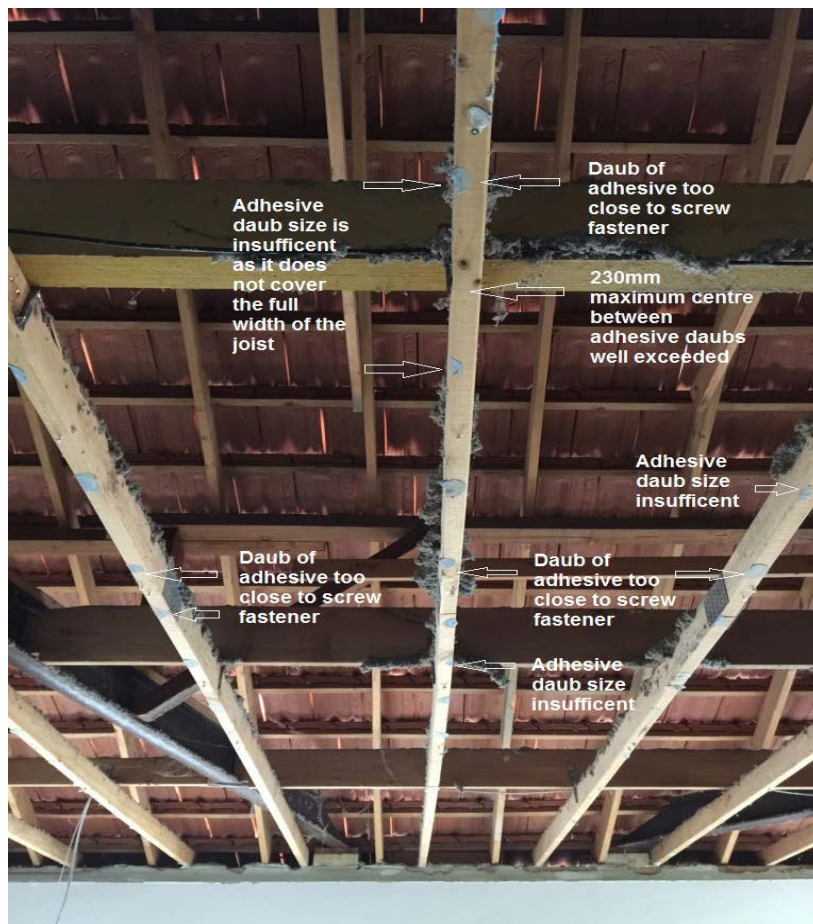
The positioning and amount of adhesive applied to the timber ceiling joists is critical to ensuring the stability of the ceiling sheeting and this element was found to be the most problematic.

- adhesive daubs were spaced too far apart;
- adhesive daubs were insufficient in size; and
- adhesive daubs were placed too close to a mechanical fastener.

The poor application of adhesive can be seen in Image 1. This example of deficient and misplaced adhesive was common at all sites visited and also observed in photographs provided from home owners of homes not inspected by the Building Commission.

Image 1. Example of incorrect positioning and insufficient quantity of adhesive from a failed ceiling installation

1. In all ceiling failures viewed by the Building Commission it was evident that insufficient adhesive had been applied. AS/NZS 2589 specifies a daub size of 25mm by 15mm high be applied to the framing member. The adhesive daub should fully spread across the framing member and be easily seen on both sides of the joist member after installation of the plasterboard sheeting.

2. Adhesive daubs were positioned inside the minimum 200mm separation spacing from fasteners and board edges. The distance between adhesive daubs exceeded the 230mm maximum centres. Fasteners also coincided with an adhesive daub which is contrary to manufacturers' recommendations.
