Perth Children's Hospital audit

BUILDING COMMISSION AUDIT REPORT

PERTH CHILDREN'S HOSPITAL

An audit of contractor and product performance in the construction of the new Perth Children's Hospital

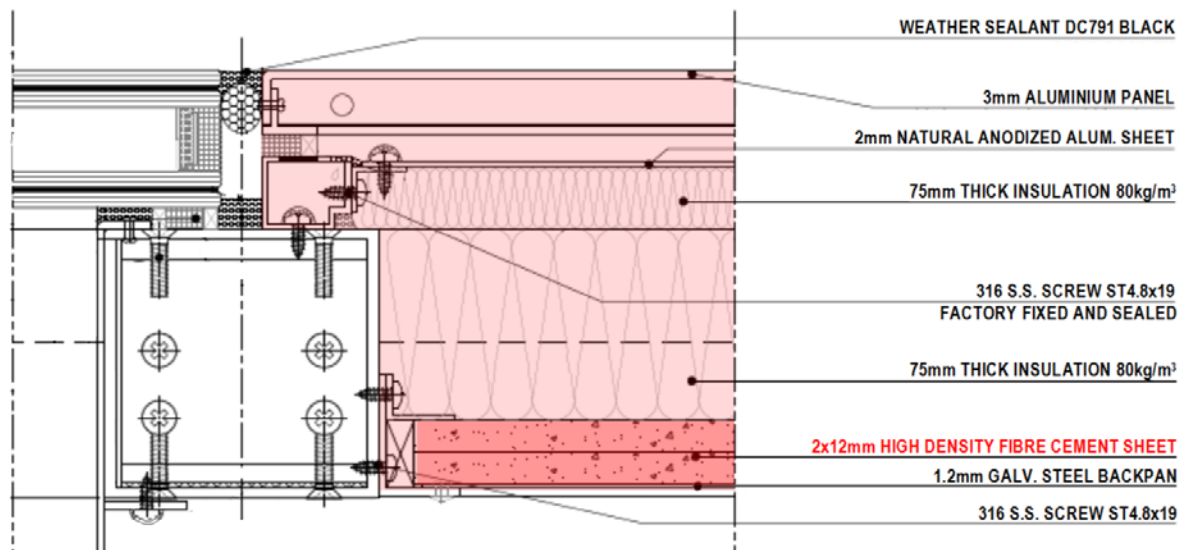
Figure 1: Sectional diagram of unitised roof panel, shaded in red, showing location of asbestos-containing fibre cement sheeting

The URPs are a type of sandwich panel. Two layers of fibre cement sheeting sit beneath a core of synthetic mineral fibre insulating batts (see Figure 1). This fibre cement sheeting was found to contain asbestos.

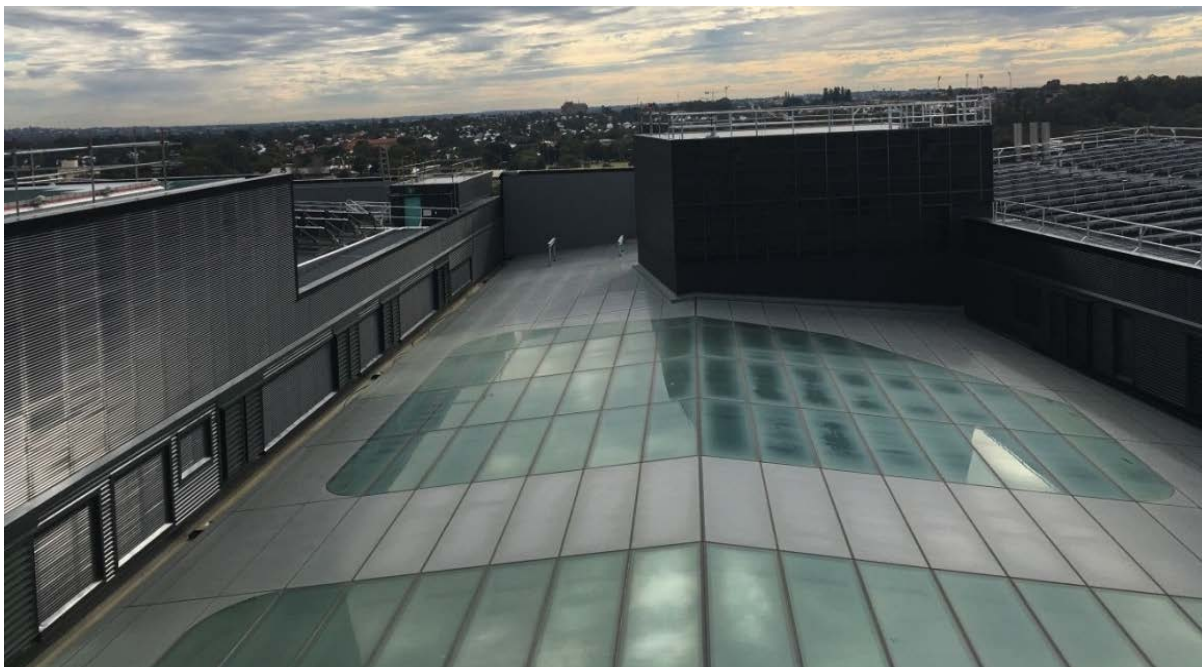
Photograph 1: Unitised roof panels installed at Perth Children's Hospital

Fibre cement panels in 132 of the 189 atrium roof panels were found to contain asbestos. The remaining 57 panels contained a non-asbestos plasterboard material which was also changed to new cement sheeting. The original prototype design used plasterboard for sound dampening.

John Holland’s subcontractors removed and replaced the asbestos-containing, sound-proofing fibre cement sheets using the following process:

- Focus Demolition (Focus) (the licensed asbestos removal contractor) erected filtered, negative-pressure enclosures above individual URPs that were to be deconstructed. The enclosure controlled the asbestos hazard during the rectification work.
- GCS removed the top layer from the URP.
- Focus, in conjunction with Coffey (the ACM consultants) removed the ACM and provided clearance for the URP.
- GCS installed a temporary, weather-proof top layer in accordance with approved documentation.
- Once asbestos test results were clear, the enclosure was moved to the next panel to be deconstructed. There were four enclosures working at the same time.
- GCS replaced the fibre cement board and insulation and re-installed the top aluminium panel.

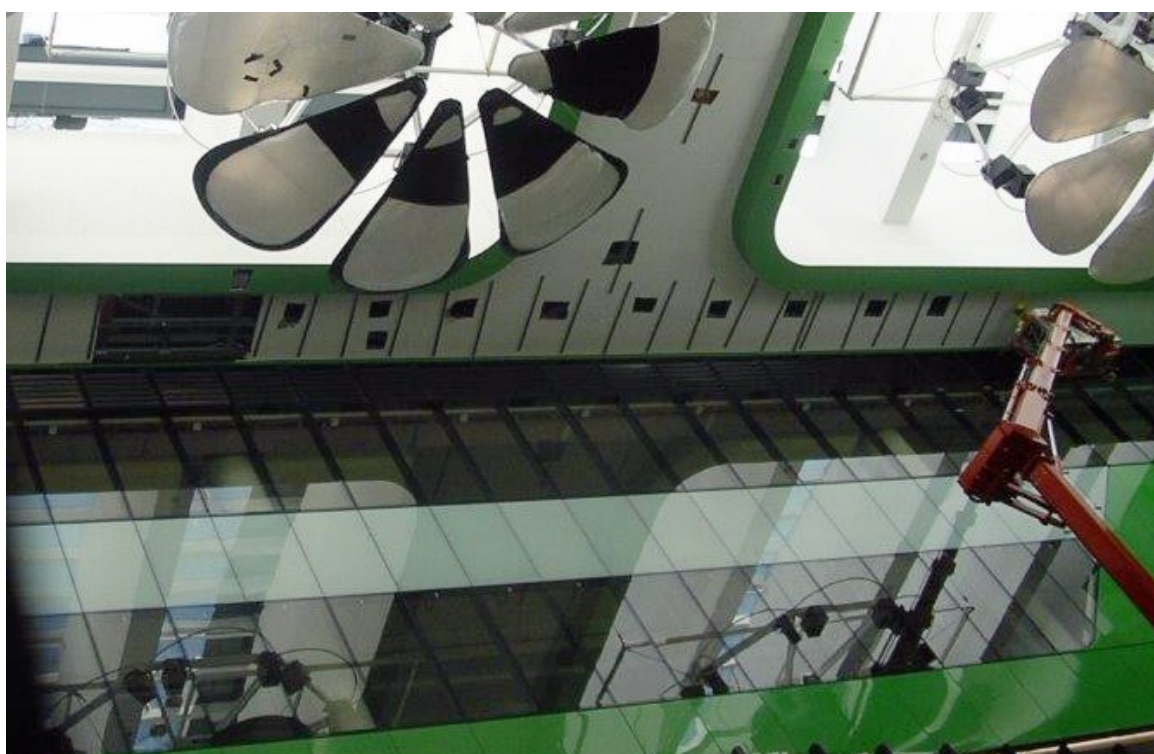
Photograph 3: Atrium ceiling collapse – initial works

According to Strategic Projects, on 15 September 2016 just prior to the collapse, John Holland identified evidence of water leaking into the PCH atrium roof. This leak occurred because the weather proofing component was removed to rectify the URPs by John Holland.

This allowed water to seep into the void beneath the URPs and damage the insulation and ceiling panels below. John Holland subsequently added additional, temporary water-proofing to protect the area while subcontractors rectified the panels.

Despite the use of temporary lids and tarpaulins, John Holland advised that following heavy rain on 18 September 2016 water seeped into the ceiling space through the URp remediation works. Areas of the atrium's plasterboard ceiling became water damaged as a consequence.

On the evening of 20 September 2016, work began to rectify the ceiling damage including rapid drying to preserve the integrity of the ceiling. This work involved cutting holes in the ceiling where moisture had been detected by the IAQS thermographic images. Plasterboard and insulation were removed and affected areas reinforced with metal battens to prevent adjacent areas from pulling away from fixings during the drying process.

On 14 November 2016, the last of the rectification work to repair the water damage to the atrium ceiling was completed.

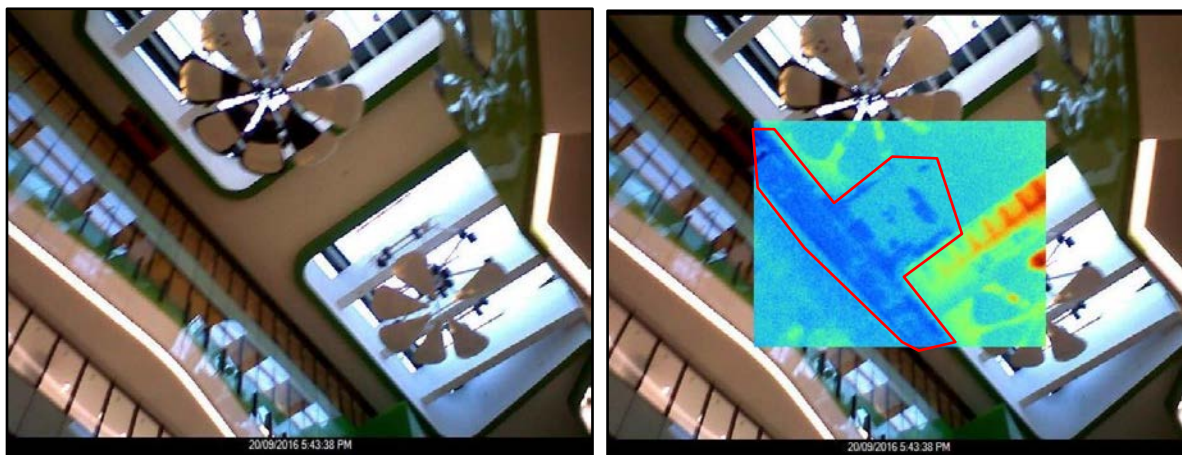
IAQS reinspected the affected area after 10 days of drying using fan-forced, ambient air through the open ceiling space. A small number of isolated areas were still affected by moisture.

Photographs 4 (left) and 5 (right): Photographic and thermographic images of water damage

After each subsequent period of heavy rain the thermographic survey was repeated, to confirm there were no further water leaks.

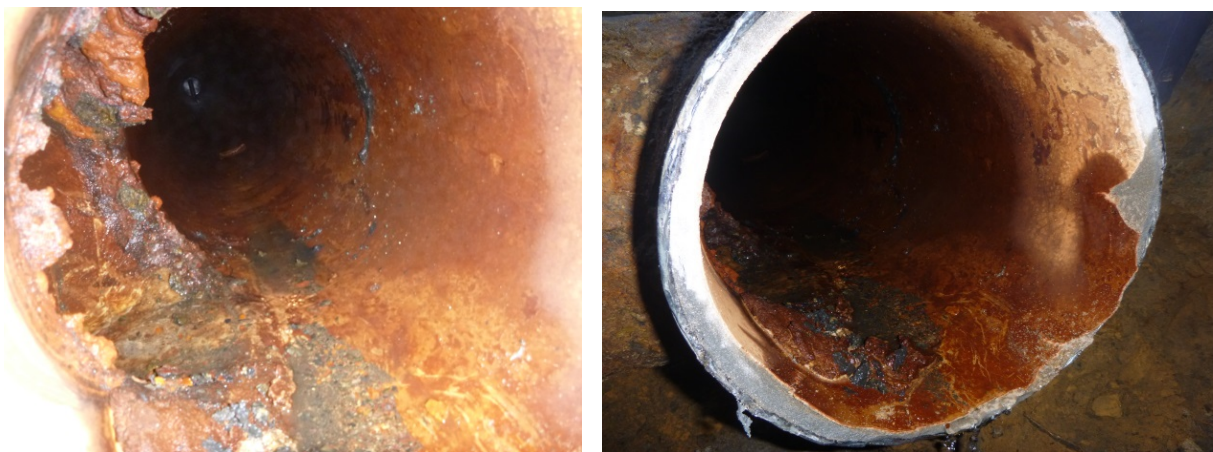
The water and residues from the dead leg were tested by ALS Environmental (ALS) and were found to have accumulated heavy metals, sediment and biofilm. Additionally, ChemCentre tested for lead and also found raised lead levels.

Photographs 7 (left) and 8 (right): Inside the QEII ring main 'dead leg'

To enable future testing of the ring main water at that point, the Building Commission plumbing inspectors recommended the installation of a flushing/testing valve. Only the testing valve was installed.

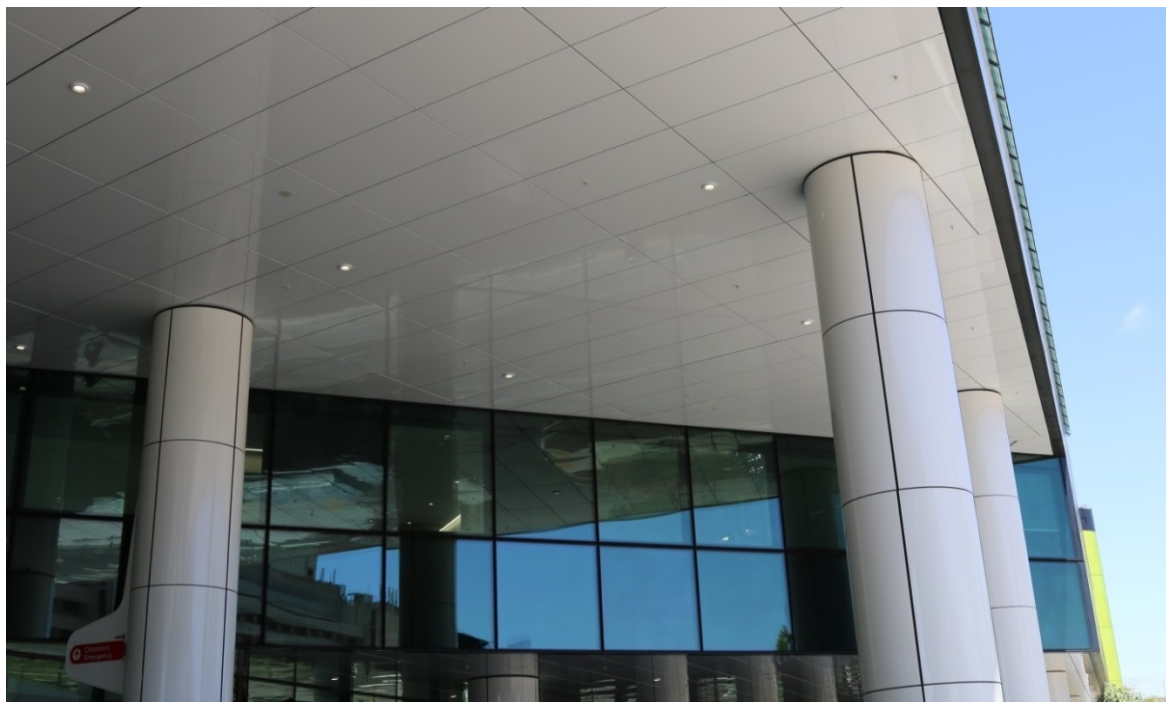
Photograph 9: Alpolic/fr fire resistant panels to external ceiling

The Building Commission was not provided with evidence that Alpolic/fr panels had been tested to Australian Standard AS1530.1 required to demonstrate whether it is or is not combustible. The CodeMark certificate of compliance with performance requirements CP2 and CP4 is evidence that the Alpolic/fr panels do not constitute an undue risk of fire spread. As a result the Building Commission is satisfied that the use of Alpolic/fr meets the deemed-to-satisfy requirements.

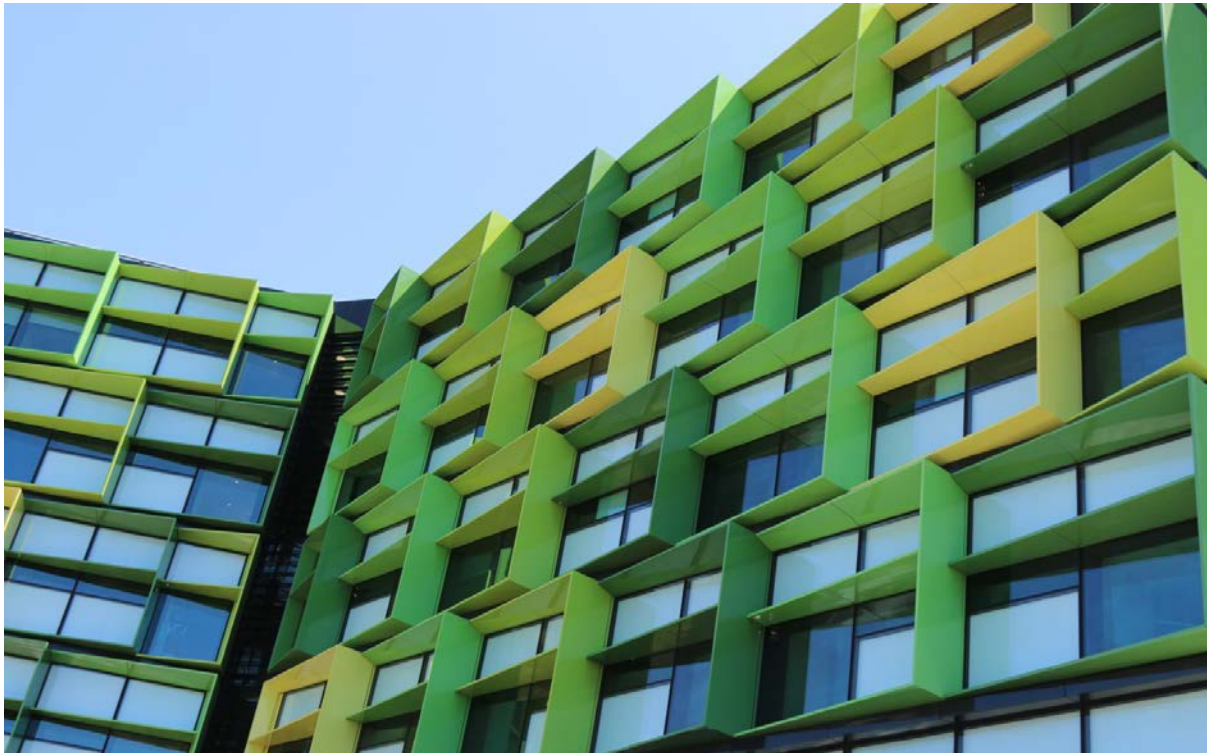
Photograph 11: Haidabond panels used as sunshades at PCH

Building Commission sought further specialised advice on whether the Haidabond panels present a risk to occupants of the PCH.

The Building Commission engaged RED Fire Engineers who engaged the CSIRO Infrastructure Technologies testing laboratory in Melbourne to test Haidabond samples provided by Yuanda (Australia). CSIRO tested the panels' mineral content to establish the properties of the product. The CSIRO report concluded that the Haidabond core contained 60 per cent non-combustible mineral fibre.

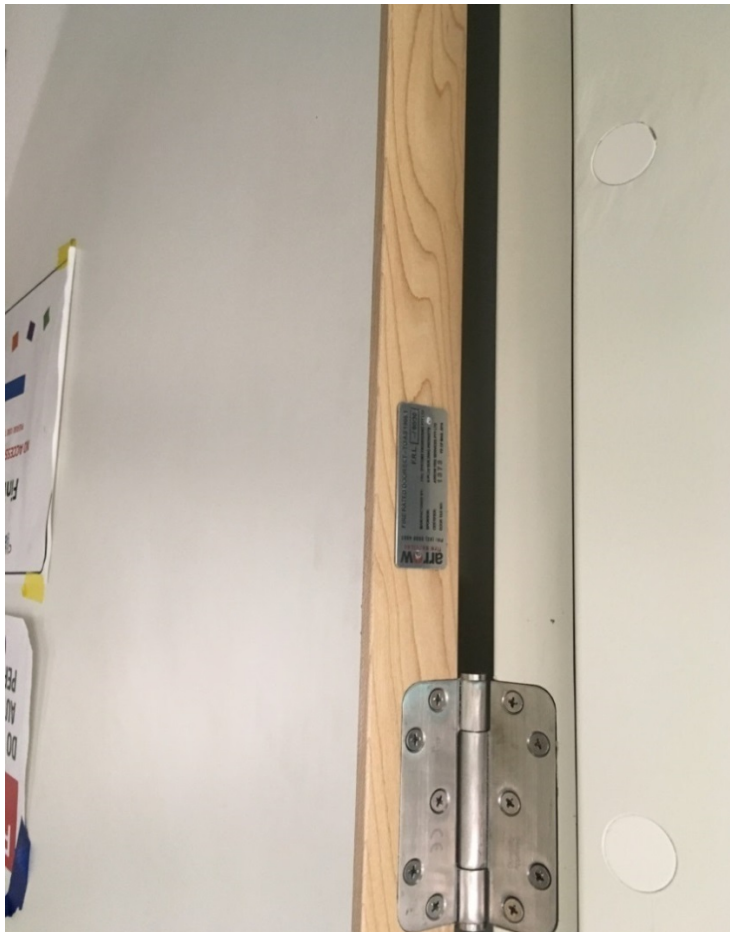
Photograph 12: Fire rated doorset

John Holland met with the CSIRO regarding the compliance of the fire doorsets. The CSIRO advised that Australian Standard AS1905.1 permitted variations, subject to certification of compliance by a Registered Testing Authority such as CSIRO. CSIRO concluded that the fire doorsets would be able to achieve the required FRL subject to 10 detailed technical recommendations.

Weekly reports from Strategic Projects provide regular updates on how the non-compliant doorsets were rectified. From October 2015 Strategic Projects noted concerns raised by JMG about the certification of fire doorsets and the quality and compatibility of doors and door frames.
