General Inspection (Investigation) Report Five

Investigation into re-roofing of buildings

April 2021

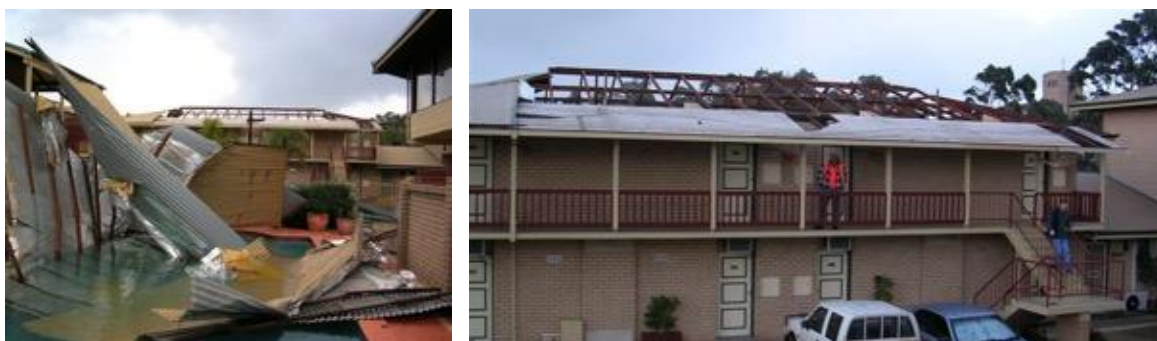
(a) Damage to a two-storey commercial property in 2004. The original tiled roof was replaced with a metal sheeted roof.

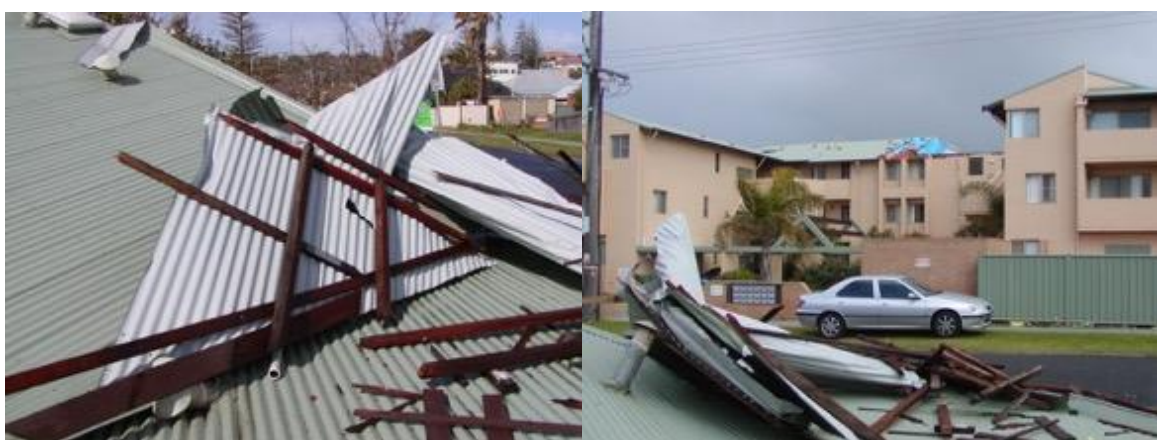
(b) Damage to an apartment building during a storm in 2004. The original tile roof was replaced with metal sheet roof. The roof cladding and part of the roof structure damaged a neighbouring building.

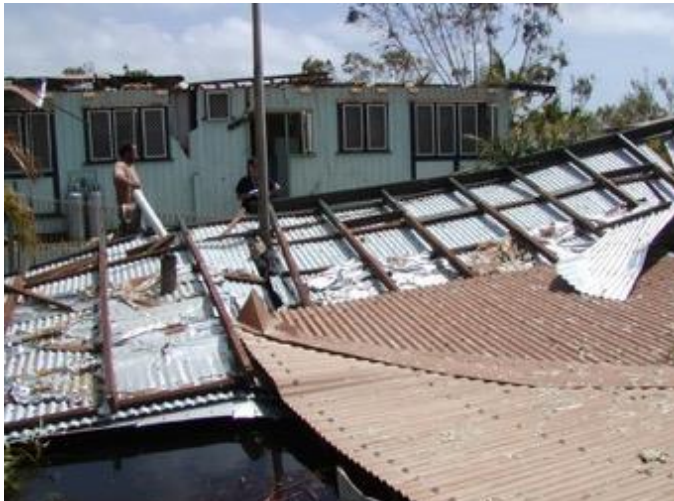
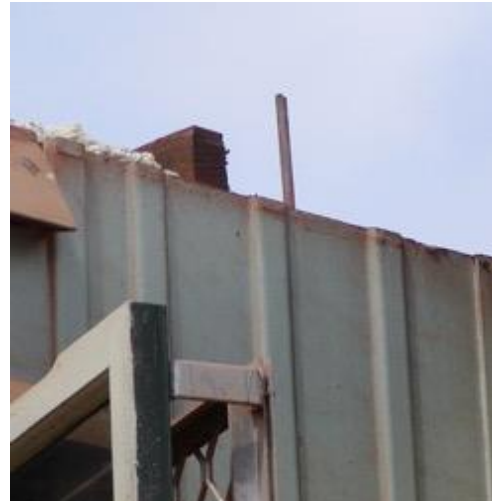
(c) Roofing and roof structure loss during a tropical cyclone in 2007. The original metal sheet roof had been tied-down with over-battens, which were removed, and the tie-down rods were cut when the roof was replaced. No alternative tie-down system was installed.

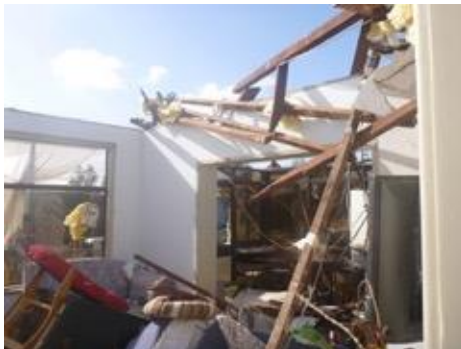
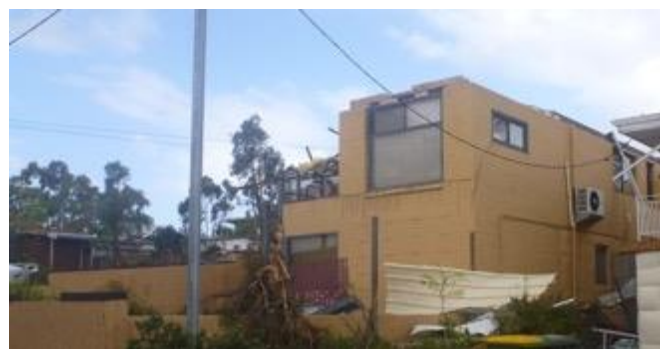
(d) Damage to a two-storey house built in 1964. The original tile roof was replaced with a metal sheet roof in 2002. The roof cladding and roof structure were lost during a storm in 2014.

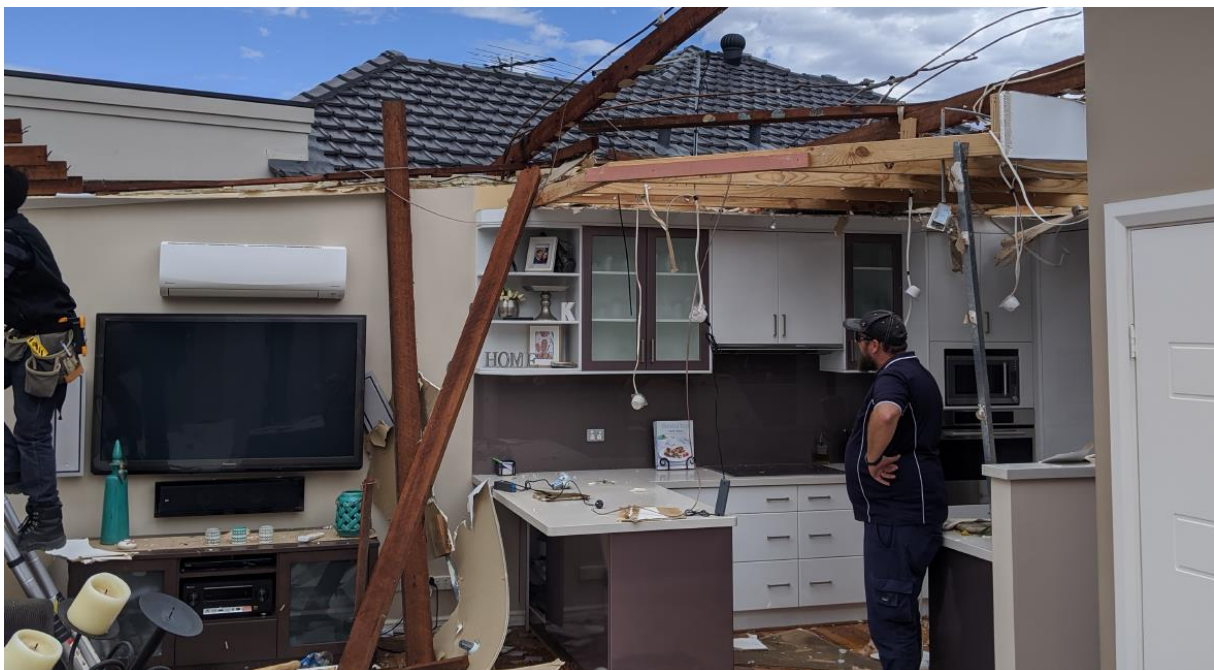
(e) Damage to a two-storey house built in 1979. The original asbestos roof sheeting was replaced with a metal sheet roof in 2004. The roof was lost during a storm in February 2020 with the owners still awaiting completion of repair works prior to moving back into their home at the time of this report

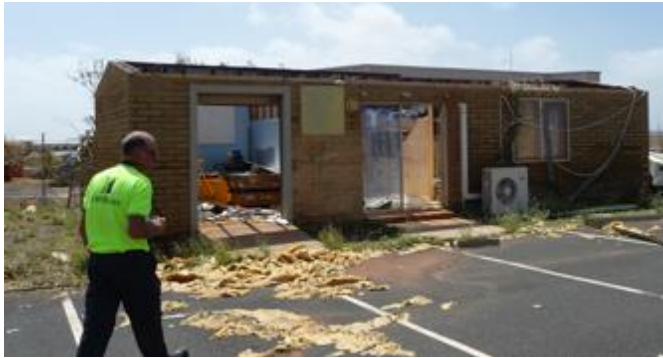
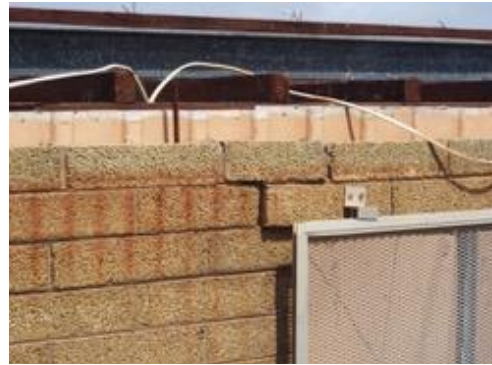
- (f) Damage to an office and storage building built before 2000. The original roof was replaced in 2011, but the corroded tie-downs were not upgraded. The roof cladding and roof structure were damaged during Tropical Cyclone Damien in 2020.

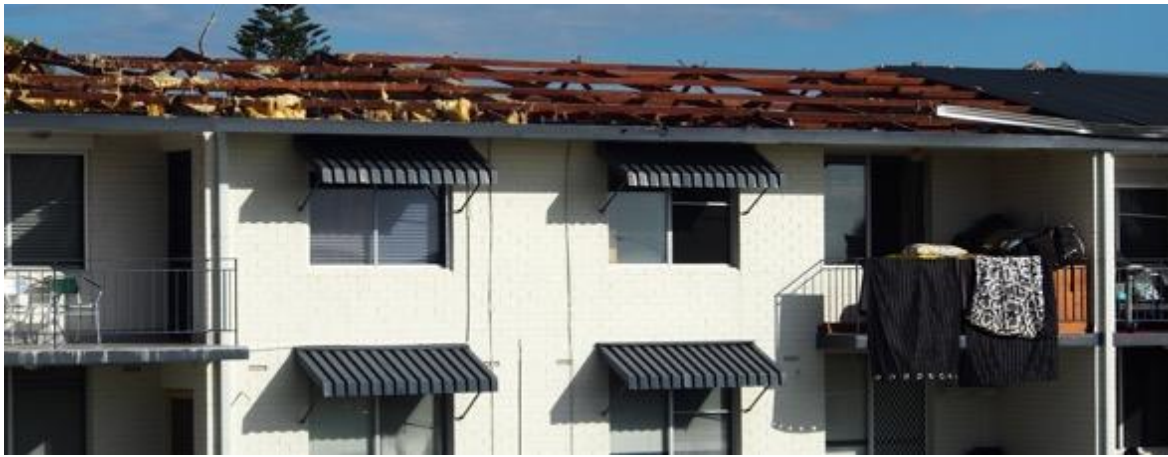
- (g) Damage to an apartment building during a storm in 2018. The original metal sheet cladding had been replaced with a new metal sheet roof, but the hardwood battens had not been replaced and split when the new roofing screws were installed.
