INTERIM REPORT

Perth Children's Hospital asbestos

An interim report on the discovery of asbestos
within imported atrium roof panel products
used in the construction of the new
Perth Children's Hospital

13 September 2016

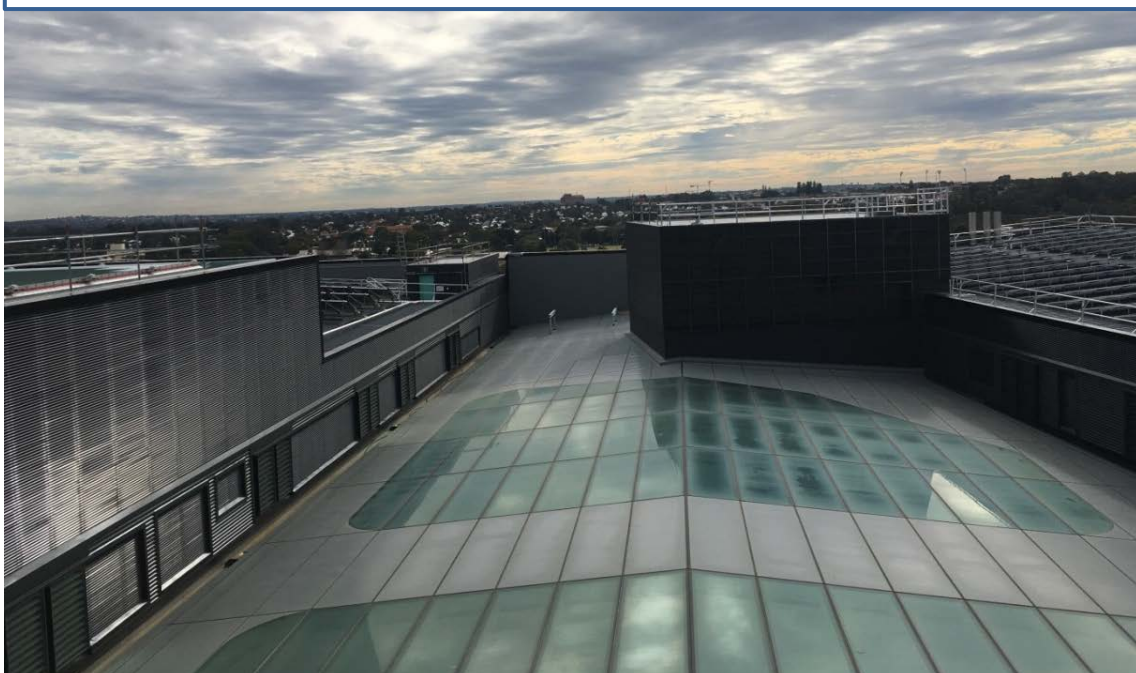
Photograph 1

On Monday 11 July 2016, work was undertaken at the PCH to fit an additional mechanical smoke exhaust fan system into and through the atrium roof section which is constructed with URPs. The URPs were designed as a type of sandwich panel, consisting of a core of SMF insulating batts with two layers of fibre cement sheeting located underneath the batts (see Figure 1). This sheeting was the element that was found to be an ACM. The atrium roof is made up of 174 URPs, restricted to a single area of the hospital roof, located outside of the level seven and level eight link bridges on the north balcony (see Photograph 1).

Unitised roof panels installed at Perth Children's Hospital
