CYCLONE
TESTING
STATION

Shoalwater and Roleystone WA tornadoes
Wind damage to buildings

Geoffrey N Boughton and Debbie J Falck

Report: TR54
August, 2008

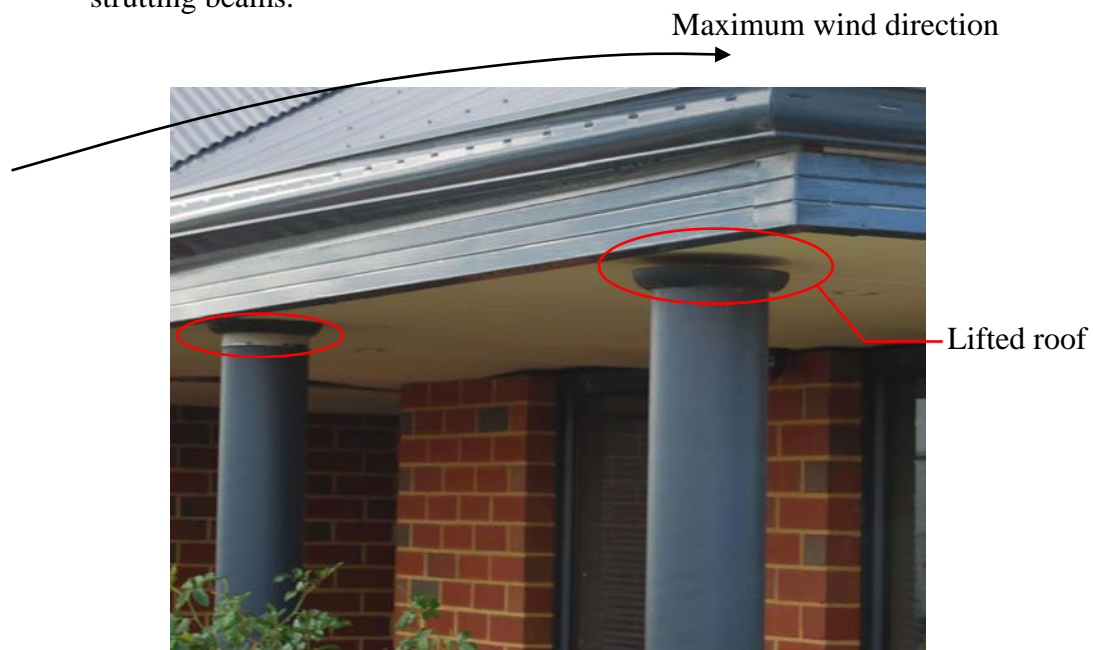
Figure 3.1 External (front) view of sheet roof house

Wind speeds at roof height were estimated at between 110 and 120 km/h or 32 to 34 m/s. This building was less than three years old and had sustained considerable damage including:

- Damage to front door fixings that meant the front door blew in as the strong winds first arrived.
- Loss of part of the roofing near a hip (roofing had battens attached).
- Partial separation of part of the roof structure from the walls including lifting of some bricks to which the top plate had been fastened.
- Partial separation of batten to rafter connections throughout the roof.
- Partial separation of some underpurlins from struts and some struts from strutting beams.

Figure 3.1 shows a general view of the house viewed at 90 degrees to the direction of peak winds. There is no debris damage in this view, but the lifted roof is obvious by the gap over one column and the movement on the other. While the roof has moved, it did not become detached as a whole.

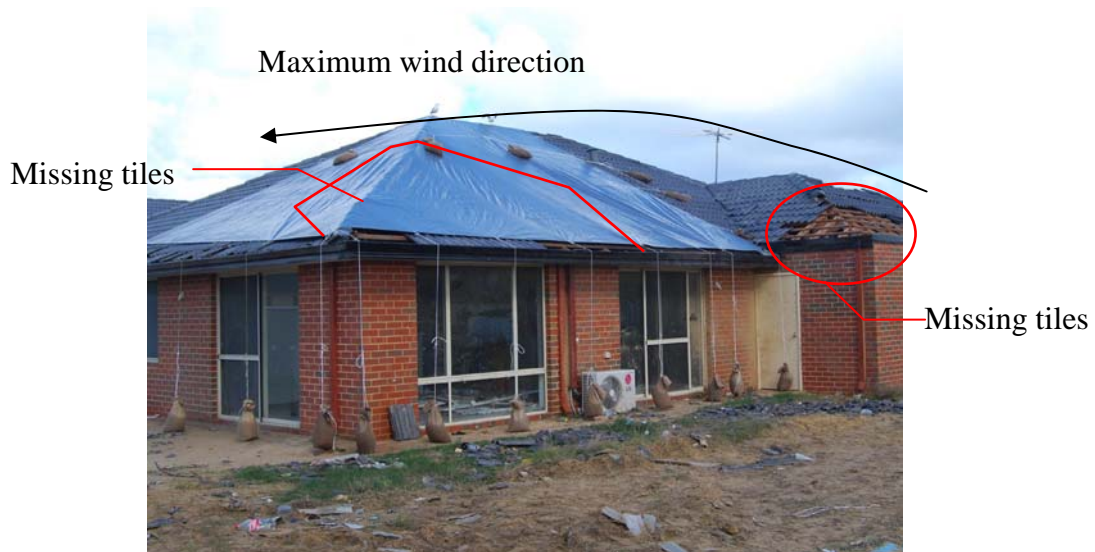
Figure 3.2 Damage to tiled roof due to wind loads

Wind speeds at roof height were estimated at between 110 and 160 km/h or 32 to 43 m/s. This recently completed building was located within 150 m of the one detailed in Section 3.1.1 and with the same relative positioning to the tornado track. This building had sustained damage to the roof including:

- Loss of some tiles near the hips.
- Subsequent collapse of ceiling due to water ingress.

Figure 3.2 shows a general view of the house showing damage to roof tiles near hips.

The tiled roof used for wind speed estimation and illustrated in Figure 3.2 also experienced wind damage to tiles. In all of these cases, relatively small areas of roof were affected by the tile damage. It was only parts of the roof close to the intersections of roof planes (hips and ridges) that were subjected to tile loss. This indicates that at the design load, the highest loaded regions of the roof are close to their capacity.

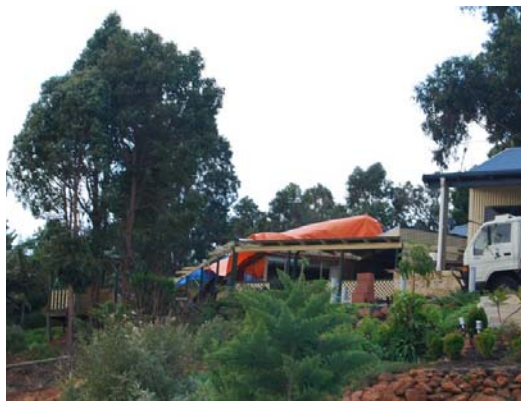
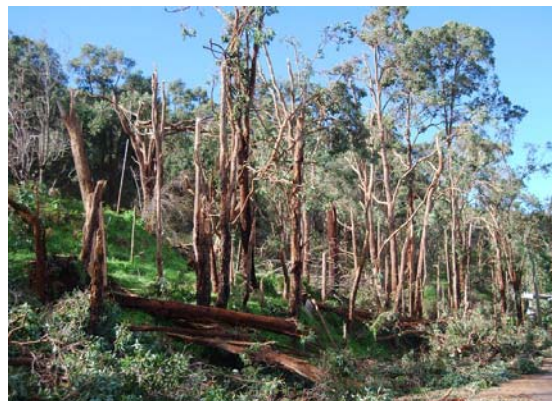
Figure 3.3 Damage to trees in Roleystone tornado

- In the first half of its path, the Roleystone tornado had a lower wind speed than the Shoalwater tornado. Here only branches less than 100 mm were broken and leaves remained on most trees in its path. Some deciduous trees even retained some autumn leaves.
- In the second half of its path, the Roleystone tornado had a higher wind speed than the Shoalwater tornado, but there were no buildings that were in the direct path of the tornado in this half. There were a number of buildings that were close to its path and some of these were damaged. An estimate of the wind speed in the wall of the tornado was 180 to 200 kph as some trees in excess of 400 mm diameter had been broken half way up the trunk.

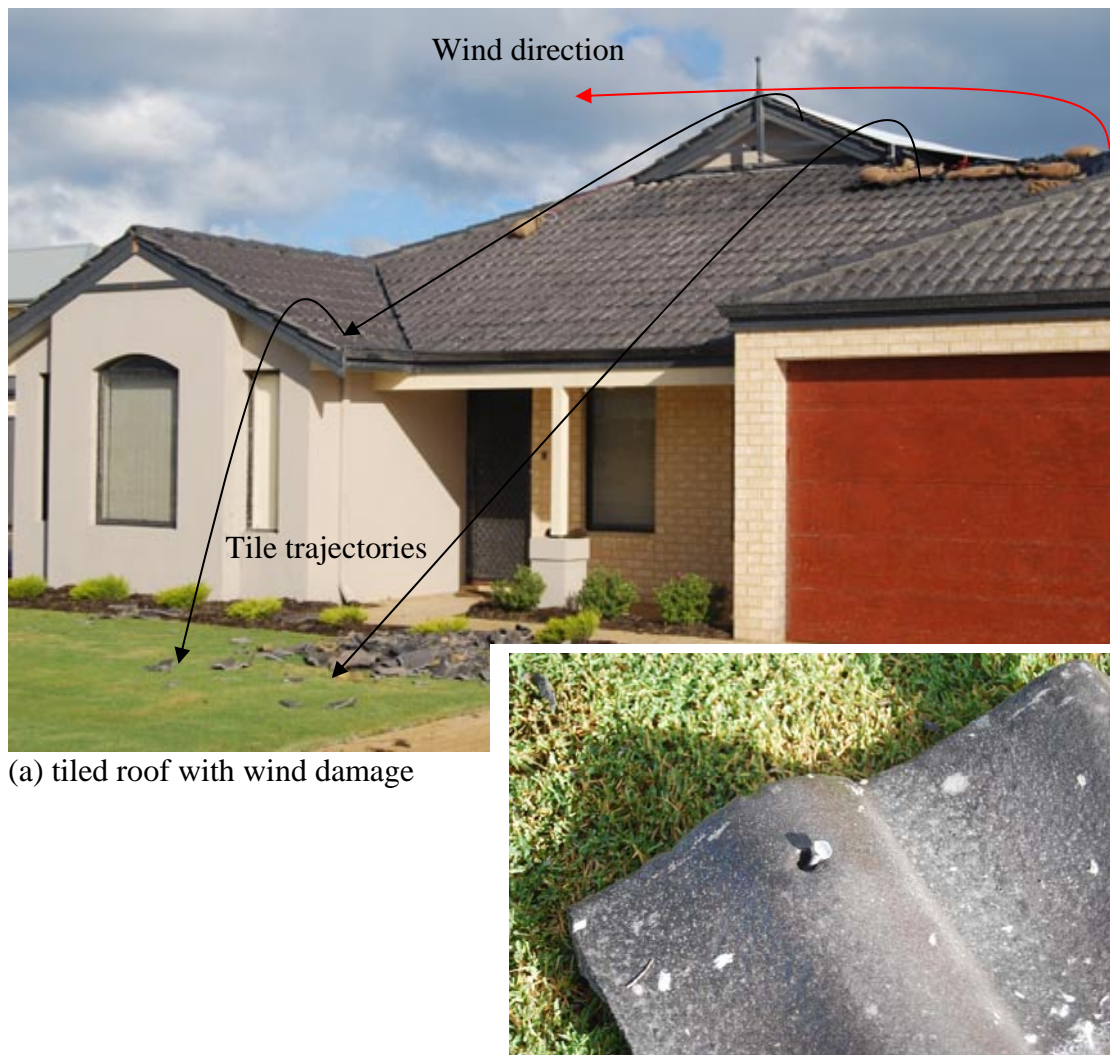
Figure 4.1 Wind damage to tiled roof

Figure 4.1 shows a roof with incidental tile damage in areas of the roof that would have experienced very high suctions under wind actions alone. In the affected area, there was no sign of debris impact and many of the tiles had been removed with little breakage. In some cases, the nail used to anchor the tile was still in place in the tile.

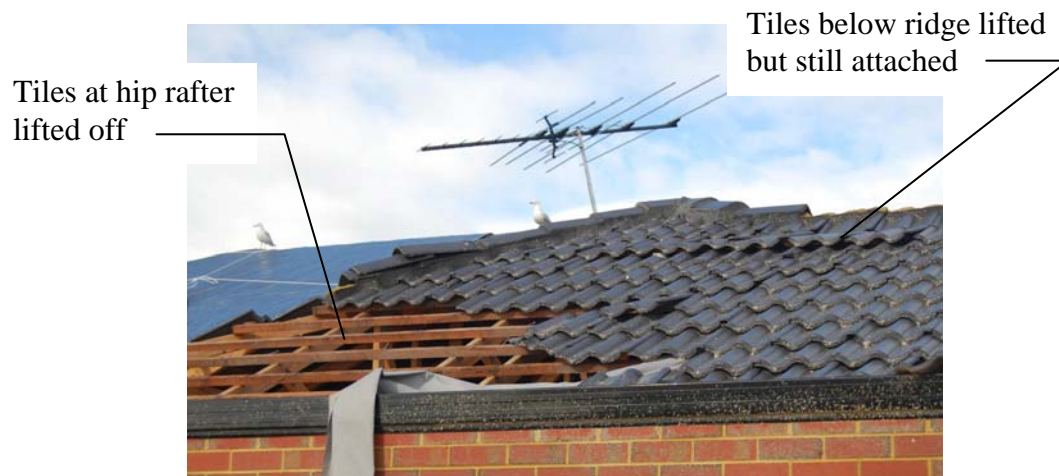
Figure 4.2 tiles in high uplift regions of the roof.

Figure 4.2 shows a roof panel that experienced particularly high suctions, and it can be seen that while the tiles just below the ridge are still intact, they have almost lifted off. The tiles near the hip have been lifted by the wind.

The estimated tornado wind speed was sufficient to lift individual tiles under external suctions. As the estimated tornado wind speed was close to the design wind speed for this location, the design wind speed is also sufficient to lift individual unfastened tiles. In peak suction areas of hip roofs, uplift forces exceed the weight of the tile at gust wind speeds of between 25 and 30 m/s.

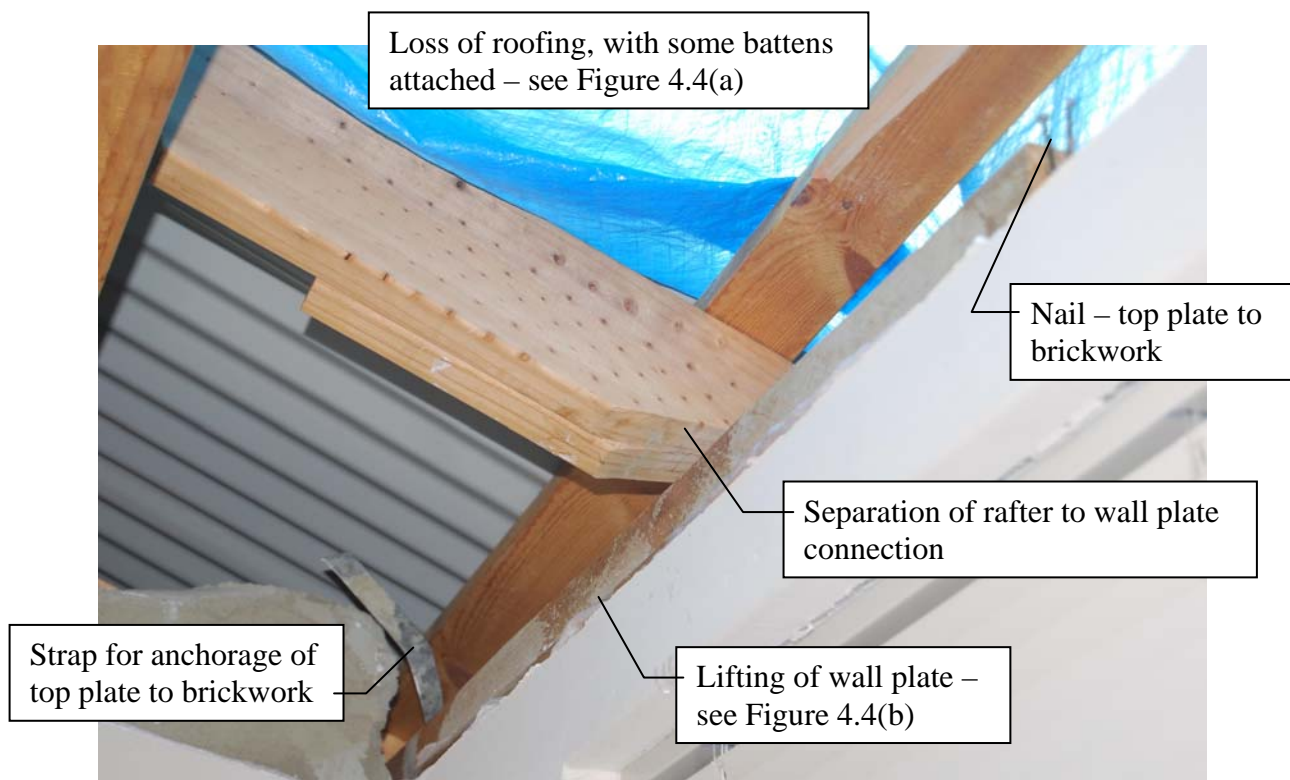
Figure 4.3 Wind uplift damage to sheet roof

Figure 4.3 shows a view of the roof from inside the house. The most obvious problems are that the roof has lifted over the room from which the photo was taken, and the ceiling has collapsed with the subsequent water damage. However, a more detailed investigation inside the roof showed that many of the structural connections in the roof had been significantly compromised and the whole roof structure was very close to a comprehensive failure. Figures 4.4 and 4.5 were taken from inside the roof space in an area in which the roof sheeting was still attached, and where from an external perspective, there were no problems.

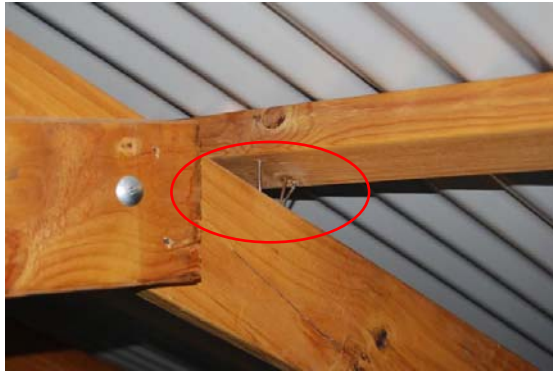
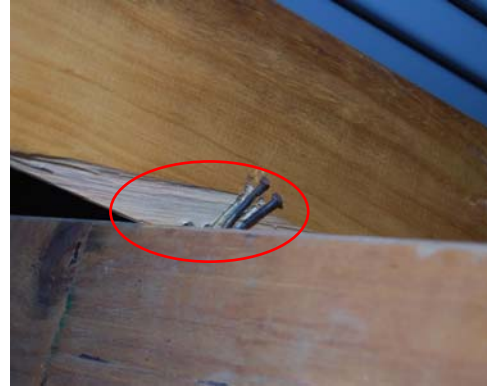
Figure 4.4 Separation of connections in the outer roof structure

Figure 4.4 (a) shows a batten to rafter connection in which three gun driven nails had been used. In other parts of the roof, only two nails were used. However, where the roof had detached, battens and the roof sheeting remained together. The batten to rafter connection was a weakness in the outer roof structure. In some places on this house, rafters had also separated from the wall plates.

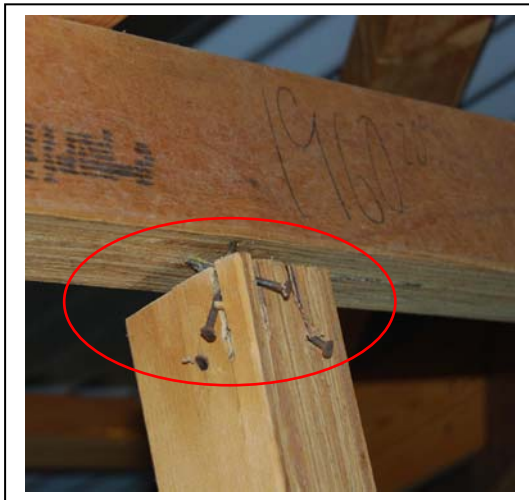
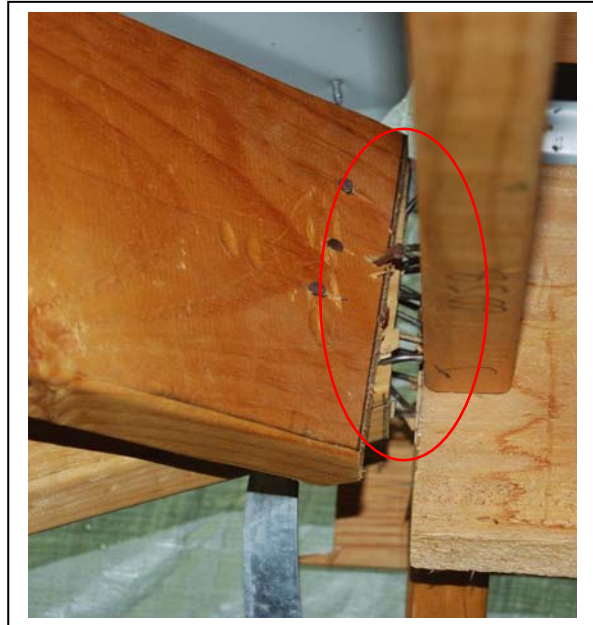
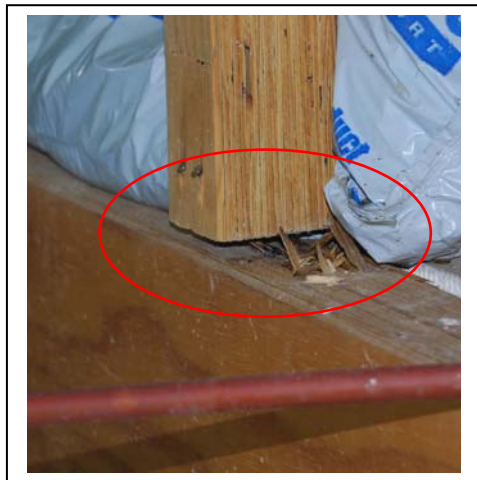
Figure 4.5 Separation of connections in the inner roof structure

In this house only 25% of the roof was lost due to failure of 2 nail batten to rafter connections. However, elsewhere in the house, where the roof remained attached to the roof structure, there was significant distress to the connections between underpurlins, struts and strutting beams. Figure 4.5 shows the movement opened up at these joints in spite of the use of a large number of skew nails.

In the strutting system, roof carpenters can appreciate the load path when the roof is loaded with gravity loads, but do not provide tie down through the same load path for uplift loads. With lightweight roof systems, wind uplift can be significantly more than the dead weight of the structure. AS1684.2 [5] has details for anchorage of underpurlins and struts under wind loads (AS1684.2 [5] Table 9.23). These details were not seen on any stick-built roofs in this study.

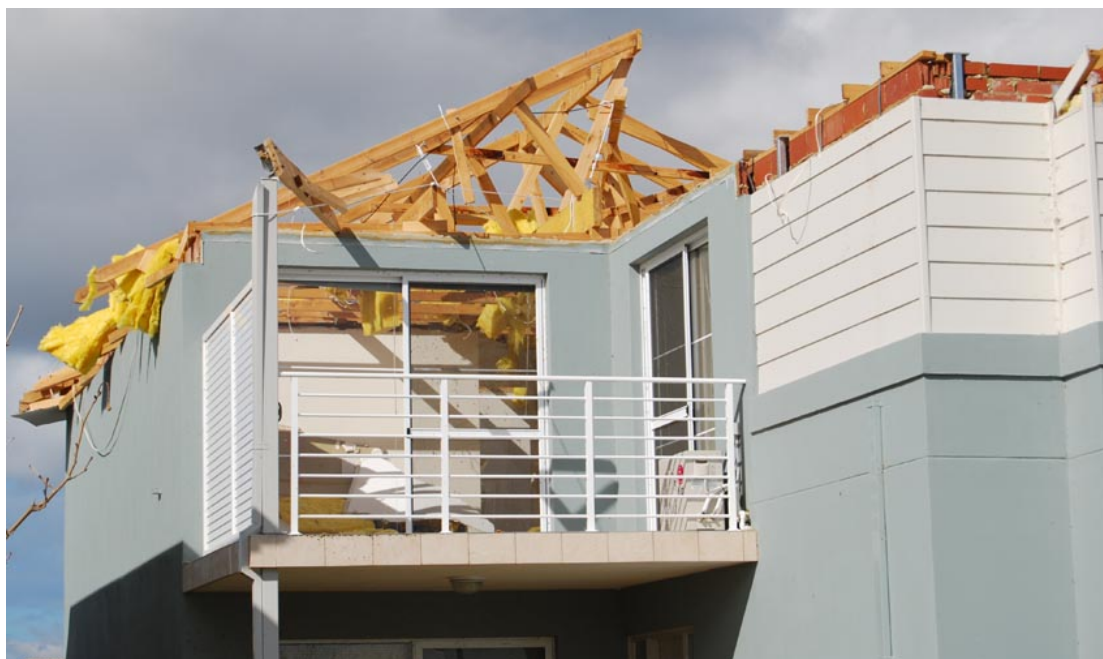
Figure 4.7 Loss of roof structure – two storey house

Figure 4.7 shows another house of recent construction in which most of the roof structure had lifted. Again, sufficient timber was left to be able to identify the construction as stick-built. On the little part of the roof structure remaining, the batten to rafter connection had failed.

In light weight (sheet) roofs, uplift forces exceed the weight of the roof at or below the design wind speed. Tie down of all structural elements in the roof is essential. A range of appropriate details of tie down connections in stick-built roofs is given in AS1684.2 [5]. However, there was little evidence of them being used in the badly damaged buildings in these events.

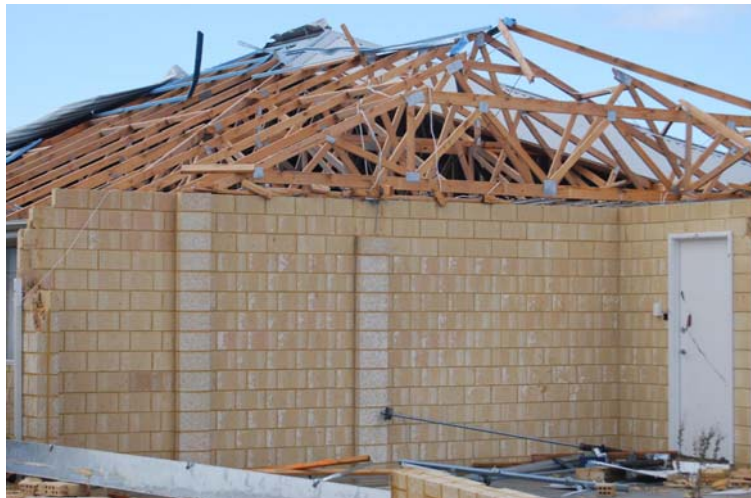
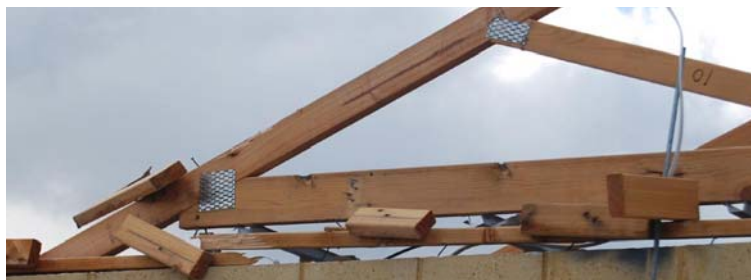
Figure 4.8 wind uplift on trussed roof

In this case, the battens were light gauge top hat sections, and the light gauge steel tore over the batten fasteners. The trusses were nailed into timber top plates which were anchored by direct nailing to the brickwork and steel straps. Figure 4.8(b) shows that the top plate has lifted in some places, but the straps had held sufficiently to keep the roof attached to the top of the walls.

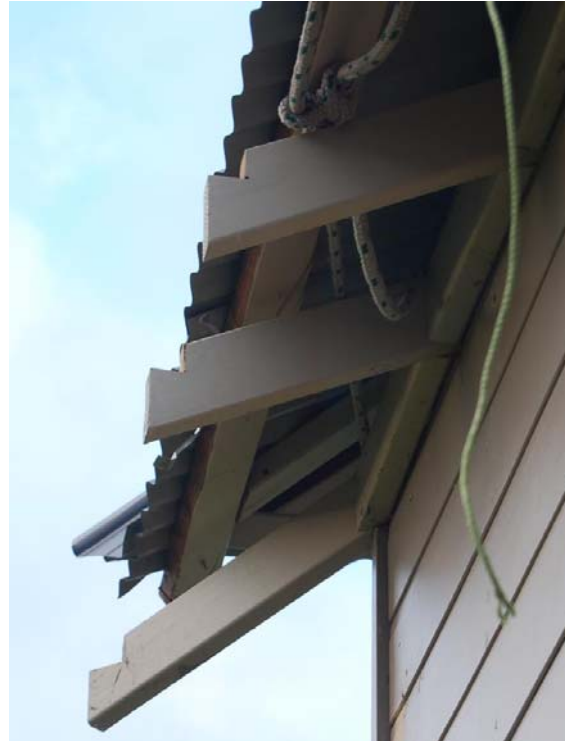
Figure 4.9 Truss loss from framed walls

Figure 4.8 showed a house that had very recently been occupied and where the trusses were tied to brick walls. Figure 4.9 shows details of a house that had been occupied for around two years and the trusses had been anchored to framed walls.

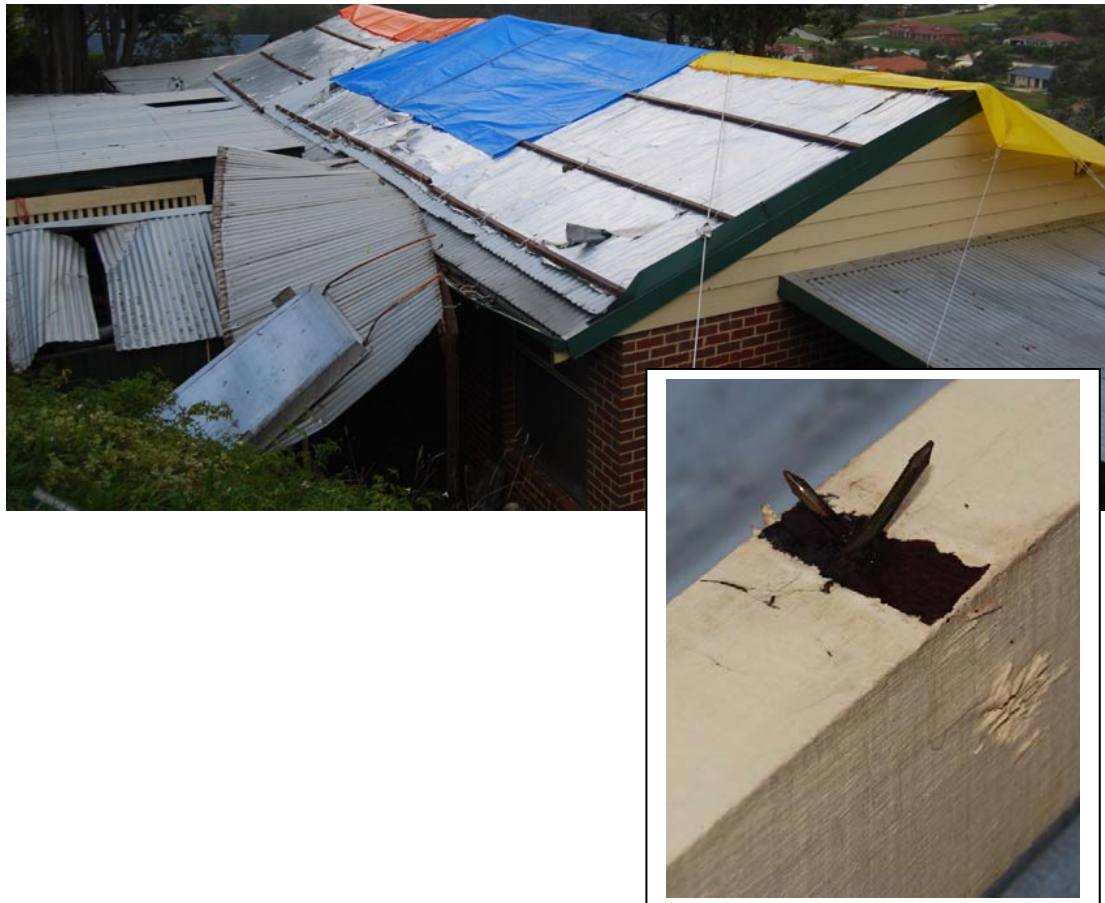
Figure 4.10 Batten loss from older truss roof
(inset shows small depth of penetration of nails in softwood trusses)

A house that was estimated at 20 to 25 years old had batten loss from half of the roof. In this case, the roof structure consisted of nail-plated pine trusses and the roof was a simple gable shape. The battens were 50 × 50 hardwood sections and the 75 mm nails skew driven for the batten to truss connection had around 25 mm depth of penetration into the softwood as shown in the inset to Figure 4.10.

While this house pre-dated AS1684.2 [5], it is important to note that the detail would not have satisfied the current requirements.

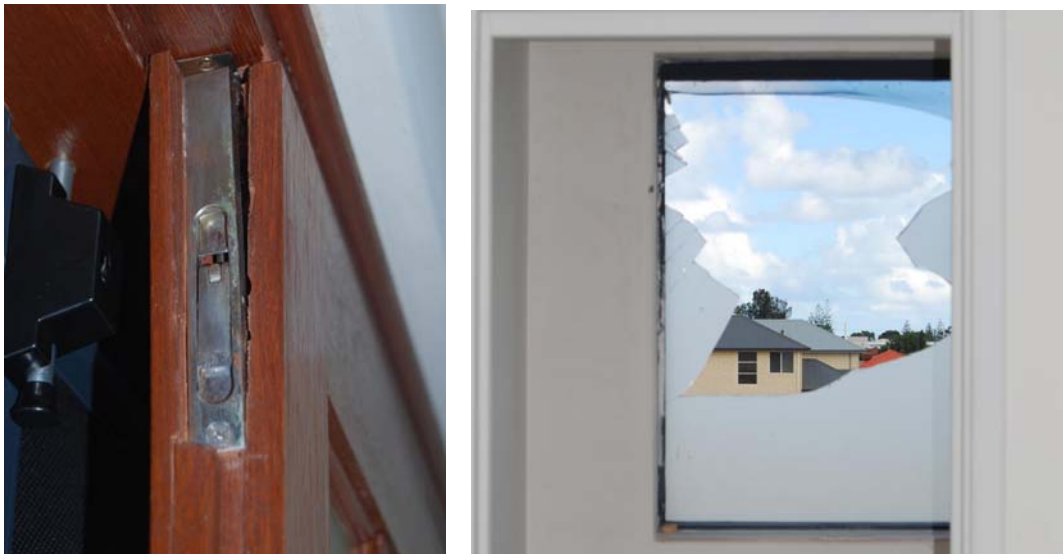
Figure 4.11 Failure of doors and windows on windward walls

The failure of doors and windows admitted high pressures through the windward wall and contributed to roof and wall loss.

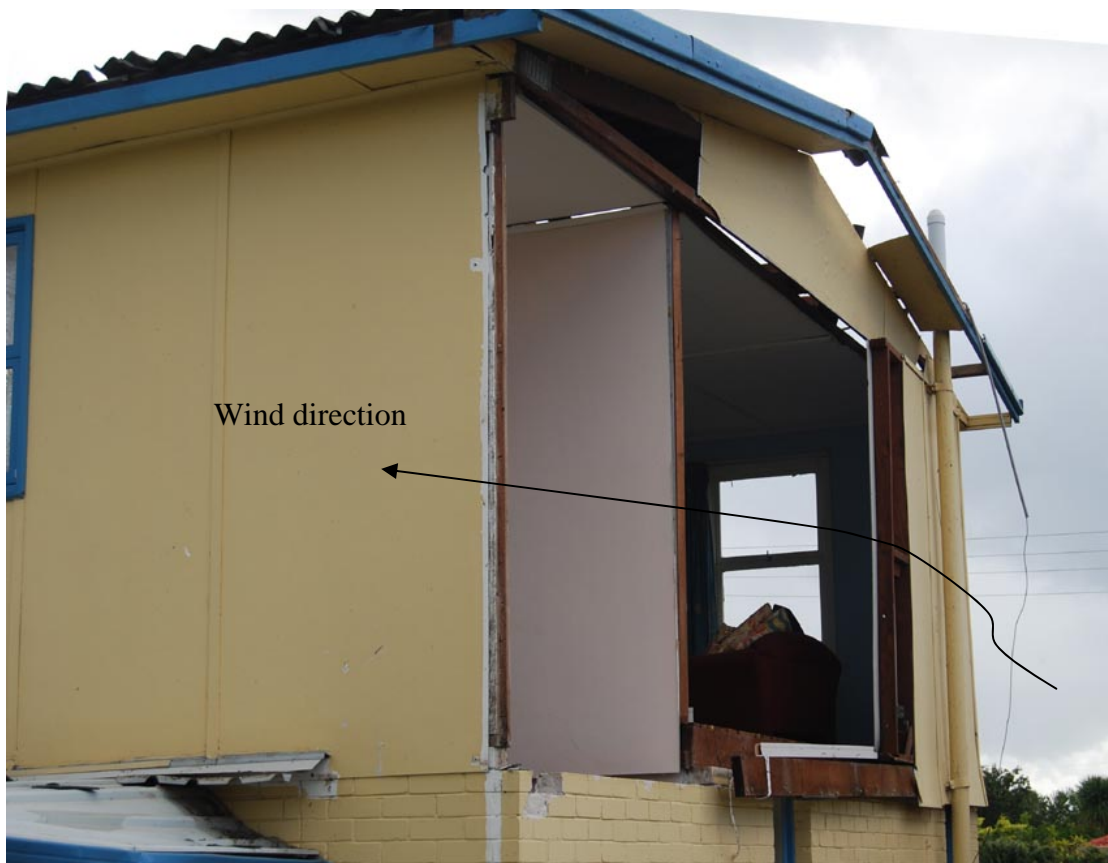
Figure 4.12 Loss of a side wall under combined internal pressure and external suction

Figure 4.12 shows a two storey house in which high external suction on a side wall combined with high internal pressures to remove a wall panel. Parts of the roof were also taken off this house. A small gap between the roof and the remaining ceiling can be seen showing that the ceiling itself had lifted.

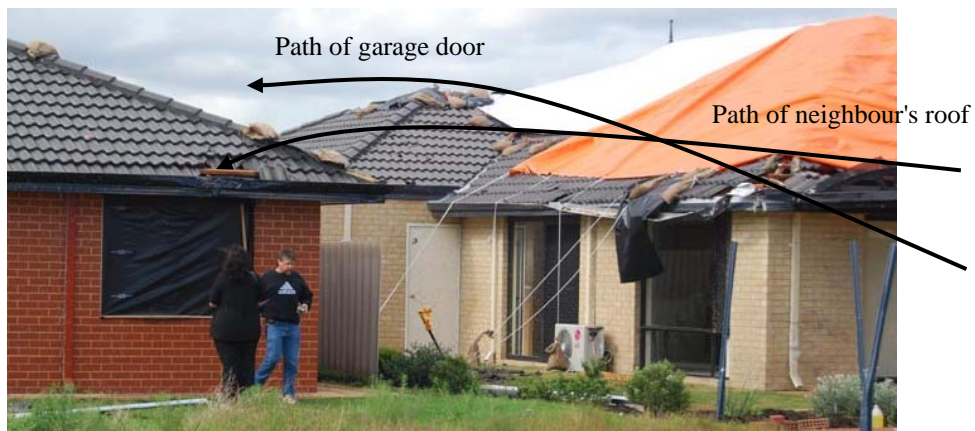
Figure 4.13 Debris damage to tiled roofs

In Figure 4.13, the house on the left was clear of the tornado's path, but sustained debris damage to both the roof and window from sections of a neighbour's roof. The houses on the right were subjected to the tornado winds, and also sustained damage from a neighbour's garage door.

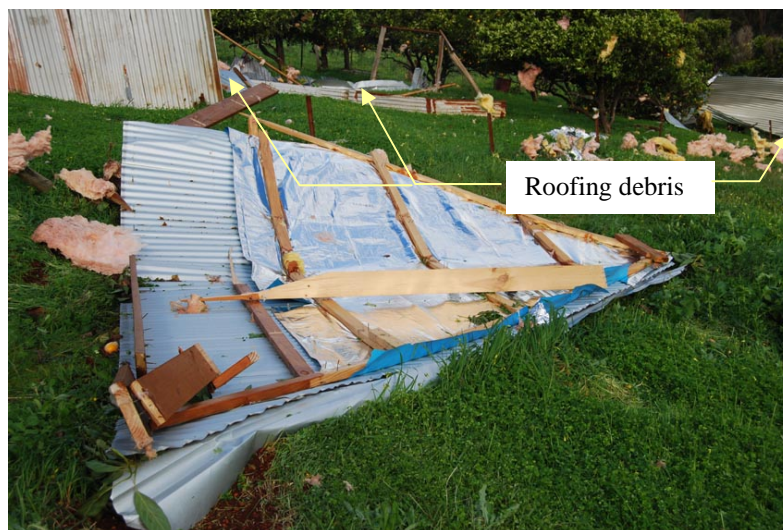
Figure 4.14 Debris strewn more than 50 metres from house

Figure 4.14 shows debris from just one house that produced at least five large sections of roof. Three of these can be seen in this photo together with some of the roof insulation. It is fortunate that this house was located in a rural setting, as it is clear that the debris generated would have substantially damaged any building it struck. However, in suburban areas, windows were broken by flying debris as shown on the left of Figure 4.13.

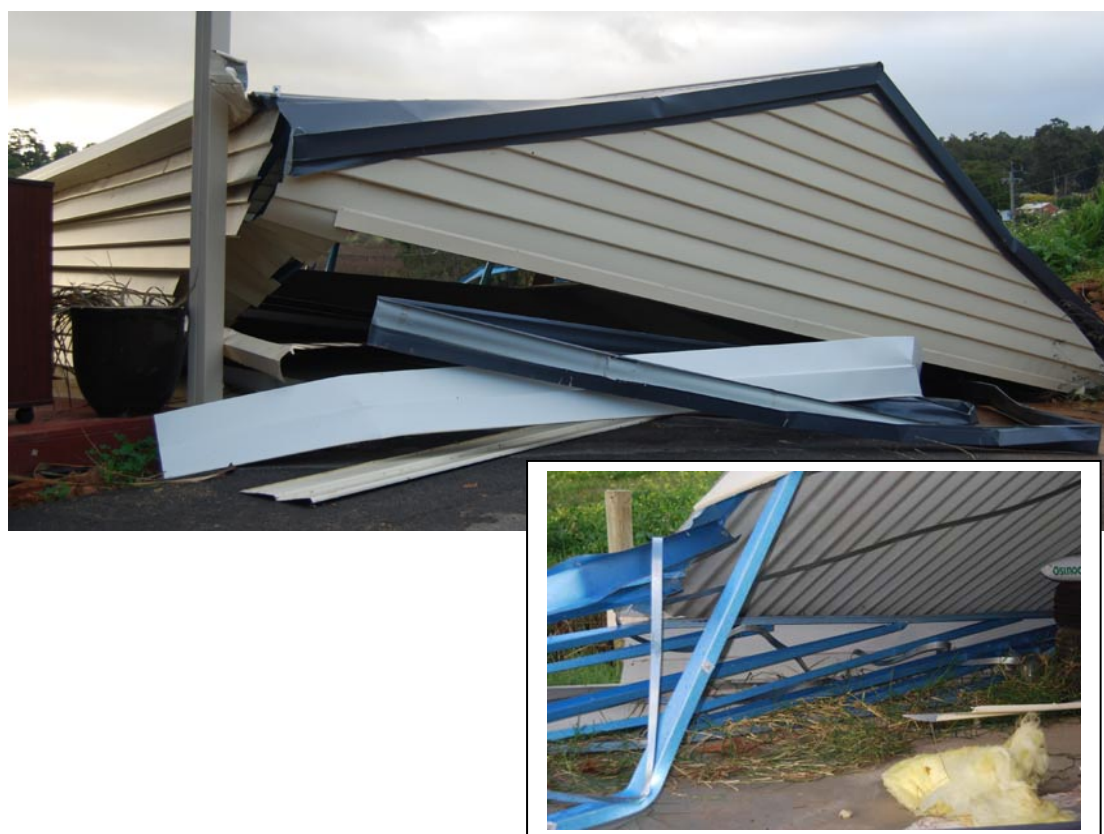
Figure 4.15 Racking failure of garage

A garage in the direct path of the tornado, shown in Figure 4.15, failed due to racking at loads well below the appropriate design load for the location.

The failure was due to inadequate fastening of the bracing. The bracing appeared to have been intended for squaring the garage during construction. rather than for resisting the wind forces. The single skin cladding was a weatherboard type product that was incapable of offering any resistance to racking.

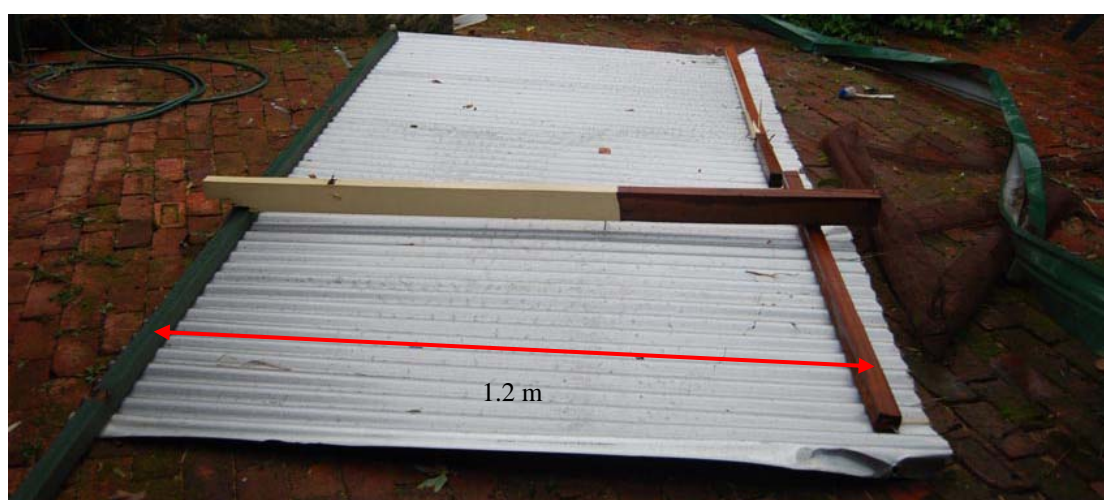
Figure 5.1 Batten spacing on verandah

Figure 5.1 shows a verandah with batten spacings of 1.2 m when the house to which it was attached had spacings of 0.9 m.

The spacing of verandah battens and rafters must be smaller or equal to the spacings used in the main roof. Batten to rafter connections must have the same or greater capacity as the batten to rafter connections in the main roof.
