General Inspection (Snapshot)

Report Six

Waterproofing systems for wet areas

December 2021

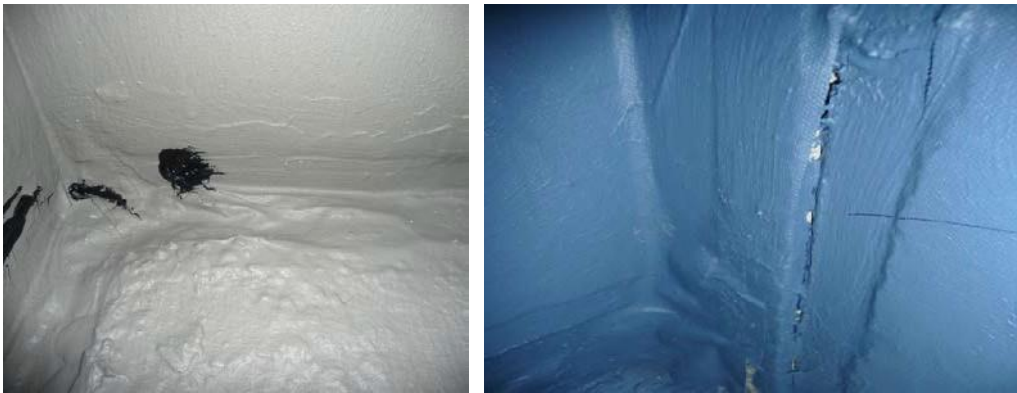
Figure 1 Examples of poorly prepared substrates

The substrates under waterproof membranes were not correctly prepared in accordance with the standards and manufacturers' installation instructions in 50 percent of the wet areas inspected for this item.

Figure 1 below shows some examples of substrates that had holes, unfilled cracks, sandy screeds, and rough surfaces.

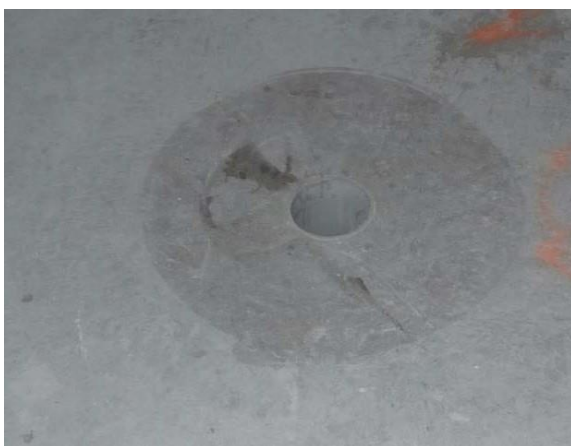
Figure 2 Example of a missing drainage flange

Building and Energy inspected seven wet areas where the drainage flanges in showers did not comply with the specifications in AS 3740-2010

Figure 2 below shows an example of a shower floor where a drainage flange was not installed.

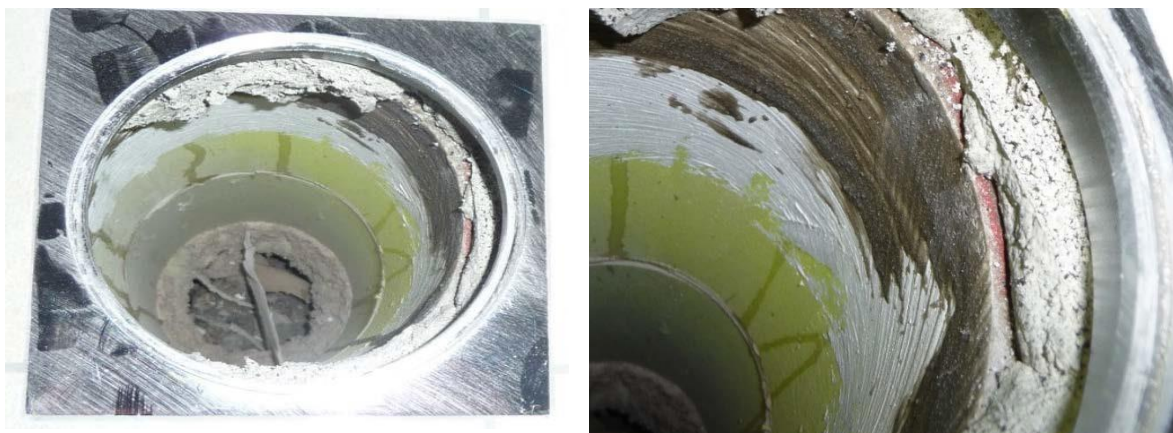
Figure 3 Incorrectly installed membrane at drainage flange

Figure 3 below shows an incorrectly installed waterproof membrane. The membrane was not carried across the top of the flange and the protrusion in the pipe could cause blockages.

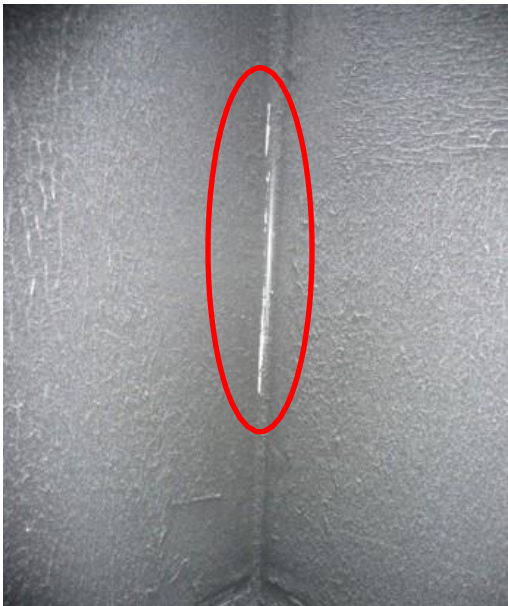
Figure 4 Example of a waterproof membrane in a shower that did not have the required thickness

Building and Energy cut samples from several dried waterproof membranes. In all nine wet areas inspected for appropriate dry film thickness, the measured sample did not have the dry film thicknesses recommended by the manufacturers. In one case, the dry film thickness was only 0.25 mm.

Figure 4 below shows an example where the thickness of waterproof membrane in the corner of a shower was inadequate.

Inadequate waterproof membrane thickness is a problem because thin membranes are more easily damaged. They are also less elastic and do not accommodate building movement as well as membranes that are the recommended thickness. Manufacturers' warranties may also be invalid if the membrane is not applied according to the manufacturers' recommendations. In one case, no waterproof membrane was installed in a shower.

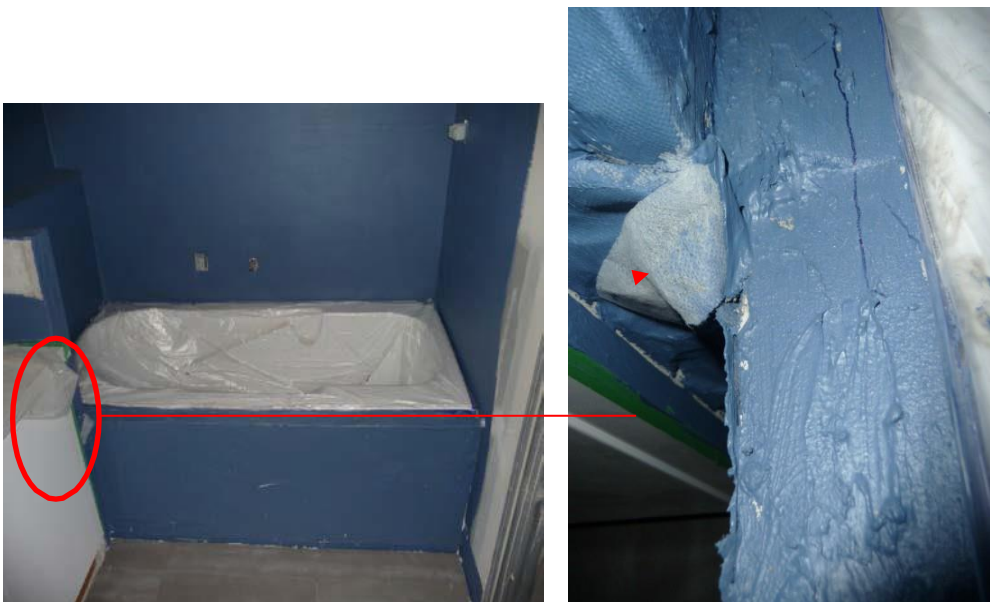
Figure 5 Example of poor workmanship around a bath

The areas surrounding the baths were rough and cracked, tape was exposed, and gaps were visible. The waterproof membrane was also not installed correctly between the bath and walls in all eight cases inspected.

AS 3740-2010 specifies that the waterproof membrane must extend under the lip of the bath. This was done satisfactorily in only one of the seven (14 percent) inspected wet areas with baths.
