**Automated Vehicles and the Readiness of Western
Australian roads (Phase 2): Suitability of WA
roads for Lane Departure Warning systems**

RR 19-07

**CURTIN-MONASH
ACCIDENT RESEARCH CENTRE**

March 2019

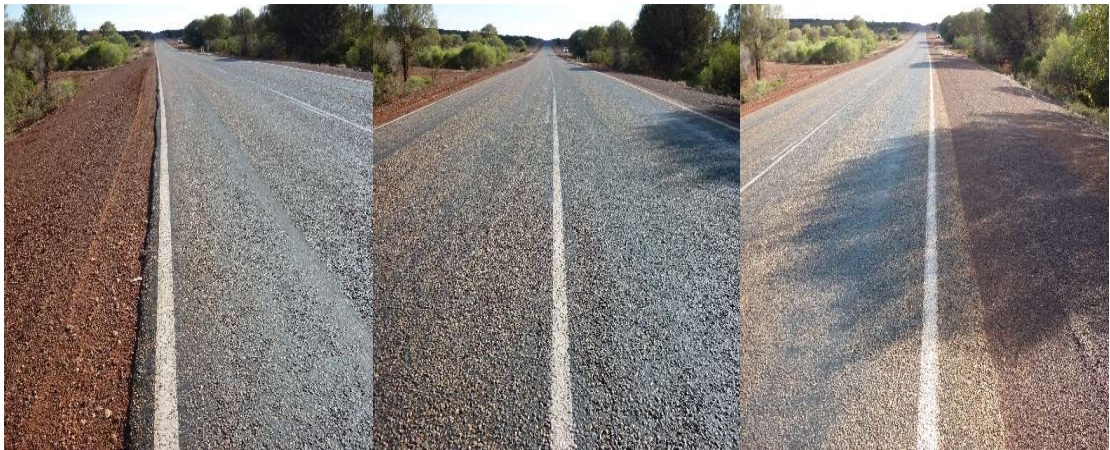
Figure 2.8 Site 1 photographs – facing southbound

Site 1 has a double one-way barrier centreline (broken in southbound direction) and conventional edge lines. This site was selected for its line type. The shoulder widths for most of the site were deemed inadequate for safe line-crossing events, but the field-work team found a small section where a wide enough sealed shoulder existed to complete the testing. There were no defects noticed with the line quality, and the time of day that testing occurred meant there were some shadows from nearby foliage that covered some edge lines. During the night testing, the lane markings were clear.

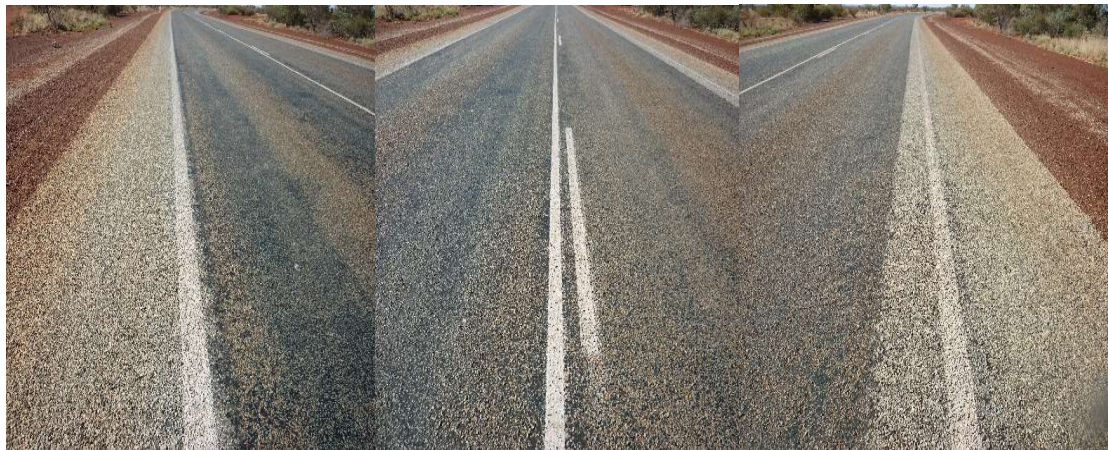
Figure 2.10 **Site 2 photographs – facing northbound**

Site 2 has a double one-way barrier centreline (broken in southbound direction) and conventional edge lines. The site was specifically chosen due to its reported red pindan presence, however, the field-work team noted that the red pindan was not obvious. The sealed shoulders at this site were a different colour bitumen to the lanes. It was considered that the LDW system may have registered the change in bitumen colour as a lane marking itself, but this was not the case. During night testing, the lane markings were clear.

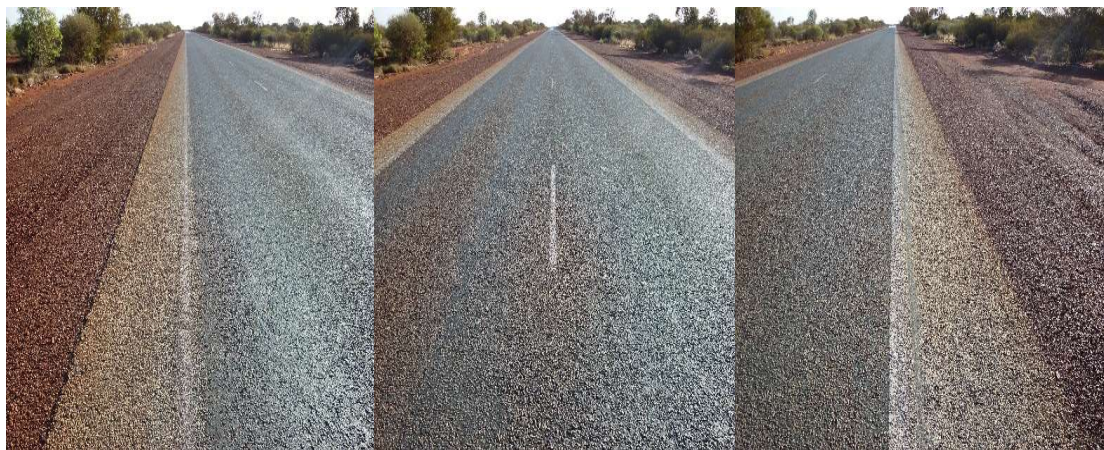
Figure 2.12 Site 3 photographs – facing northbound

Site 3 has a broken separation centreline and conventional edge lines. The site was located on a long stretch of a straight road. It was selected due to the presence of red pindan, which was noticeable by the field-work team. The lane markings were not as distinguished as others tested. The change of bitumen colour was also noted as an interesting observation, with the change of colour occurring along the edge lines. During night testing however, the lane markings were clear and the change of bitumen colour for the shoulders of the road were not obvious.

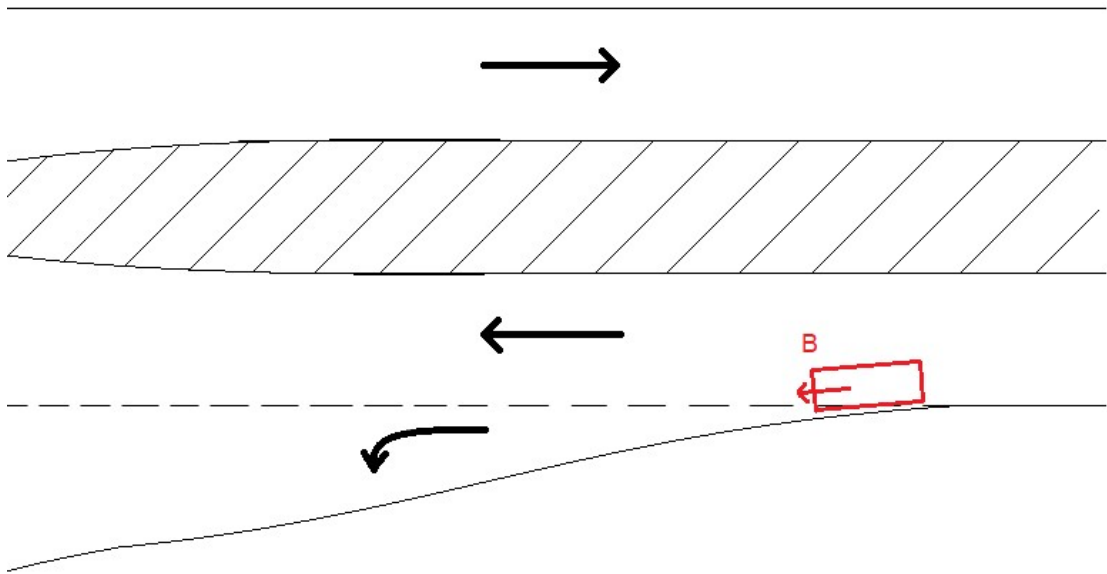
Figure 3.1 Top view diagram of line split error

This error only occurred at the start of the newly formed broken edge line. In other situations, where a line transitioned from a barrier to a broken line and a crossing event took place (over the transition), a normal warning activation was triggered.

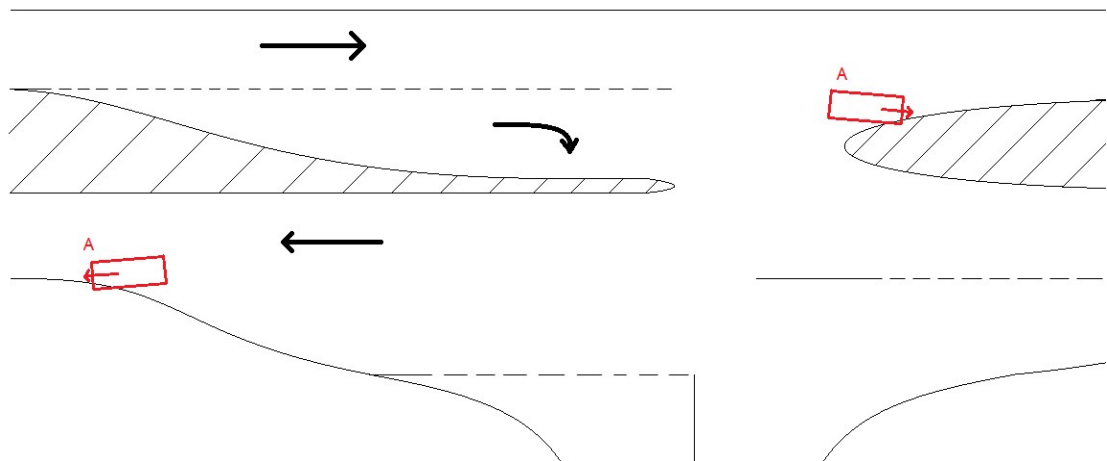
Figure 3.2 Top view diagram of line formation error

This error occurred when the trial vehicle crossed a newly formed centreline or edge line that was not parallel to the lane of travel. The vehicle crossed the lines and no warning was activated. Two event crossings are demonstrated in Figure 3.2 with the symbol 'A' representing the trial vehicle.

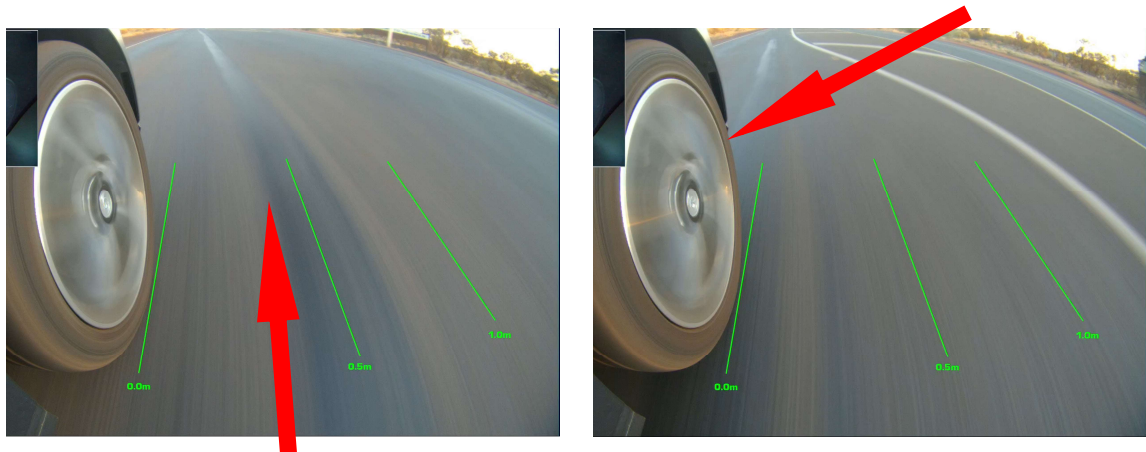
Figure 3.5 Examples of pseudo lines that triggered false positive errors

This phenomenon is not included in the results as it was not associated with a line-crossing event but is reviewed in the Section 4.3.

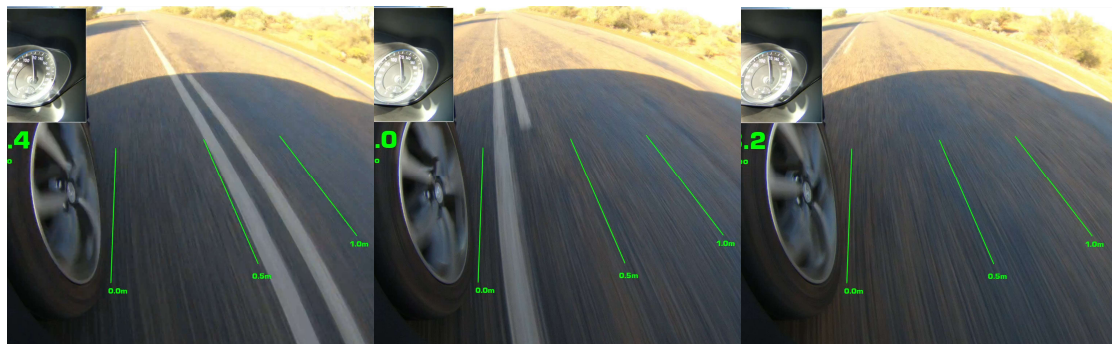
Figure 4.1 Screenshots of unforced error at Site 1

Three other events were conducted over this line segment in these conditions; one had a slightly late warning, and the other two had normal warning activations.

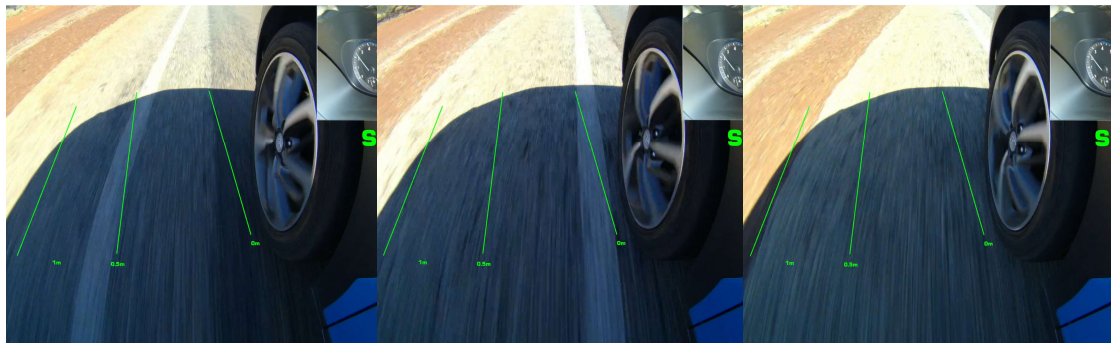
Figure 4.2 Screenshots of unforced error at Site 2

Reviewing the recorded video, the bitumen was a different shade of grey for the shoulder and part of the lane as can be seen in Figure 4.2. The different colourings may have concealed the lane markings. However, the LDW system did not seem affected for the majority of line-crossing events at this site. For all the successful line-crossing events at this site, the warning activations occurred once the wheel of the trial vehicle touched the white edge line, rather than when it crossed the change in bitumen colour. This is consistent with the findings of the previous study, such that the lines needed some thickness (width), rather than just an immediate change in surface colour, to be detected. There were also no shadows over the road at this location, and no other elements from the video recordings that attracted attention. Figure 4.2 shows screenshots of the crossing event. It should be noted that one other crossing event was tested at this exact location and no abnormalities were noted.

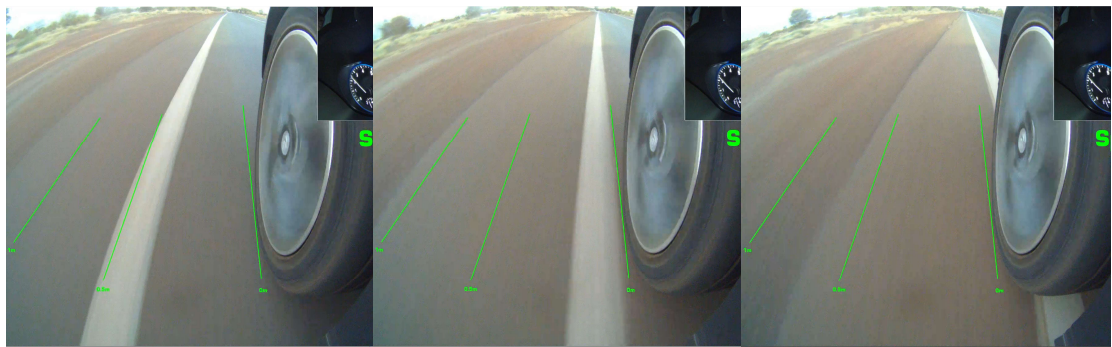
Figure 4.3 Screenshots of unforced error at Site 6

Reviewing the recorded video, it was noted again that just as the crossing event occurred, the LDW system icon changed colour indicating that either the edge line or centreline was not being tracked. The angle of crossing was normal and there was sufficient time and distance given for the system to reset after the previous line-crossing event. There were no shadows over this section of the road. Figure 4.3 shows screenshots of the crossing event. It is noteworthy that two other events were conducted at this exact location, and in both runs, the LDW system triggered warnings for the pseudo lines and the real lines.

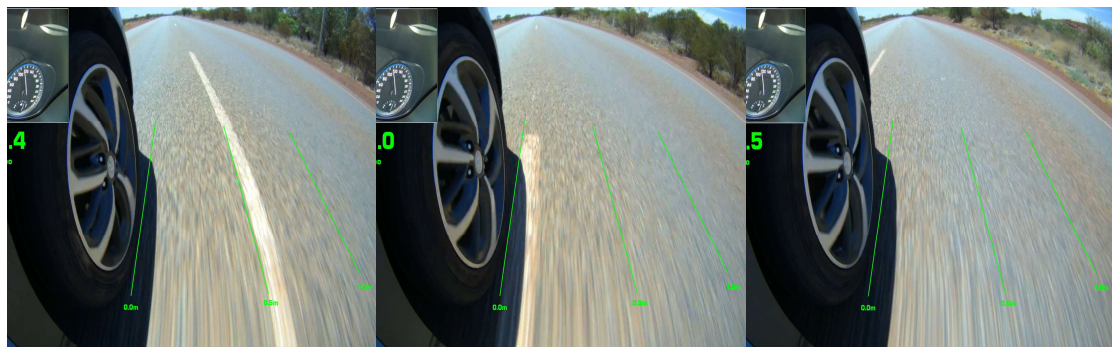
Figure 4.4 Screenshots of unforced error at Site 7

Reviewing the recorded video, the LDW was fully enabled before, during and after the crossing event. This was evident by the colour of the icon on the dashboard. The angle of crossing was normal, there were no shadows in the vicinity of the road section and no other elements from the video recordings that attracted attention. Figure 4.4 shows screenshots of the crossing event. Again, two other runs were conducted at this location and neither displayed any issues with detecting the line crossings.
