Restoring the Health of the Little River:

Riparian Survey and Management Recommendations for the Little River Catchment near Denmark, WA.

A Report prepared for the
Denmark Environment Centre.

by Apace Green Skills

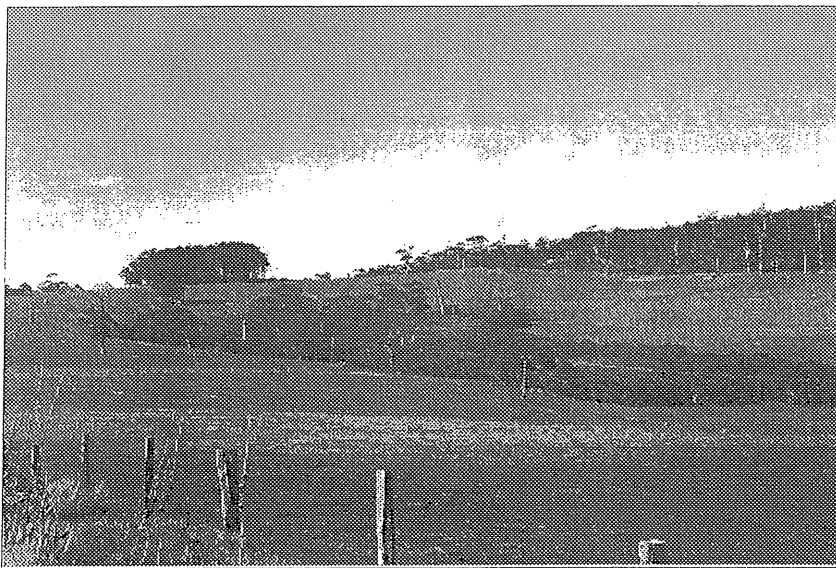
View over tributary of Little River, looking north east from Sunrise Road towards Mt Shadforth. It is recommended that remnant vegetation along this tributary be permanently fenced from stock.

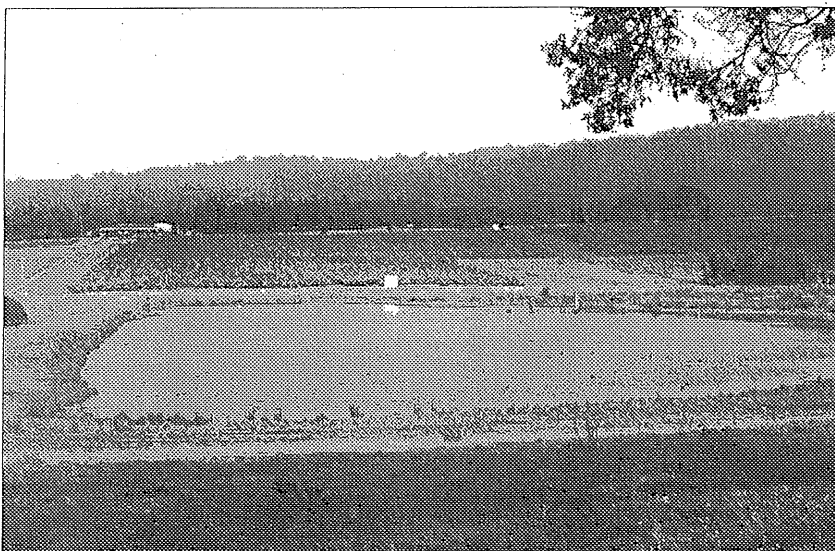
Major dam on Little River. This photograph was taken from South Coast Highway looking south. Construction of islands, and revegetation of some of the dam's fringe with native vegetation, would greatly enhance its value for bird habitat. The dam's spillway channel needs repair to allow for native fish migration.

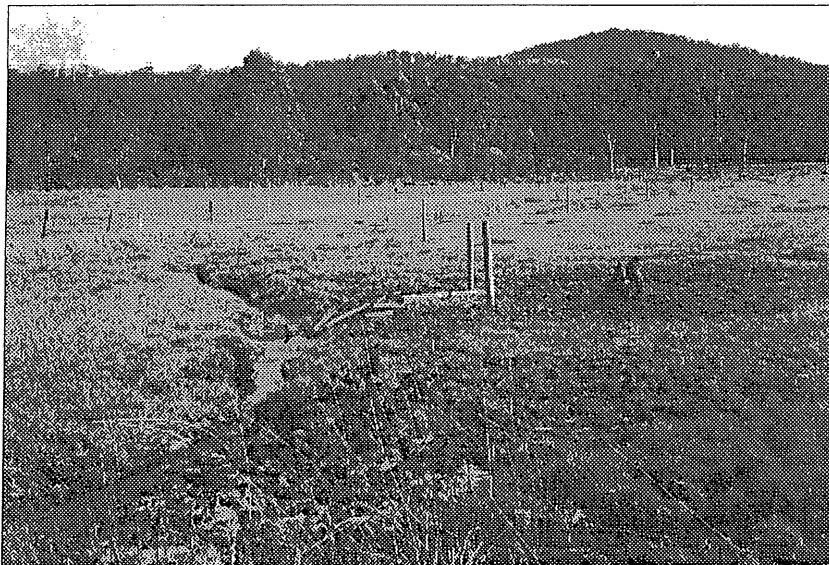
Fencing in progress on a small tributary of the Little River, close to Ocean Beach Road. In this case, the fence ought to be sited further away from the watercourse, in order to allow for several rows of trees and shrubs to be established in the riparian buffer zone.

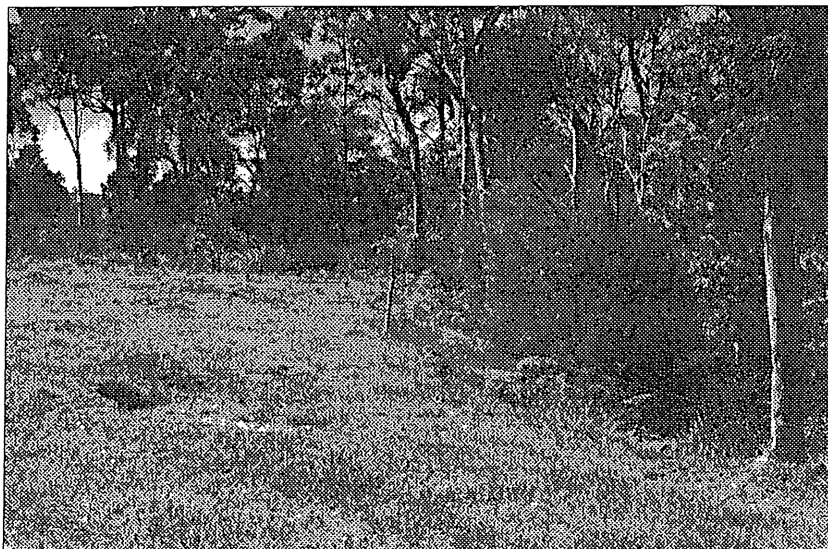
Little River fenced off with single wire electric fencing. While this does prevent cattle from damaging the riverbanks, the fence needs to be relocated, to allow for several rows of native trees and shrubs to be planted and ensure a properly buffered riparian zone.

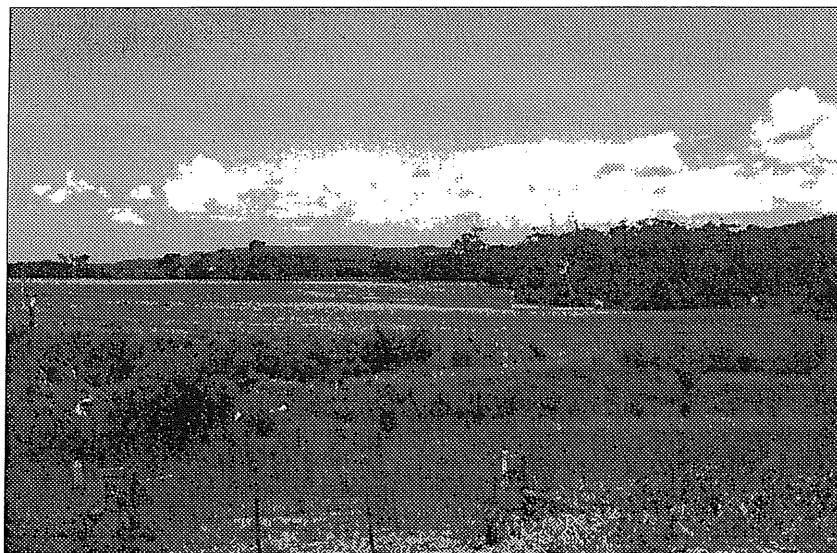
*View over the Little River valley. Little River has been fenced off along the portion visible in this photograph. However, revegetation between the fence and remnant fringing vegetation has been with Tasmanian Blue Gums. It would have been much more preferable for Karri (*Eucalyptus diversicolor*) and other local species to have been planted, in order to enhance the corridor and habitat values of the Little River riparian zone.*

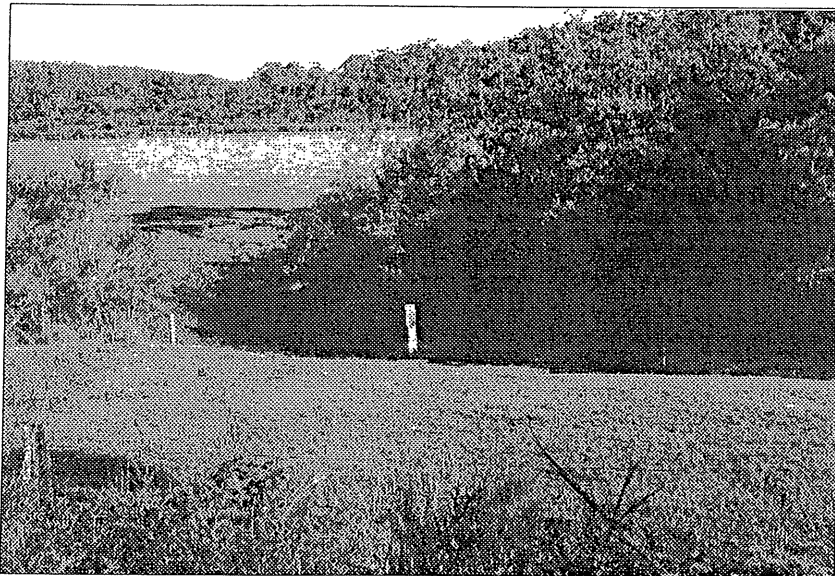
A cattle crossover point on Little River, near Lights Road. Such points can be sources of erosion if not well stabilised with gravel and, where necessary, with rock.

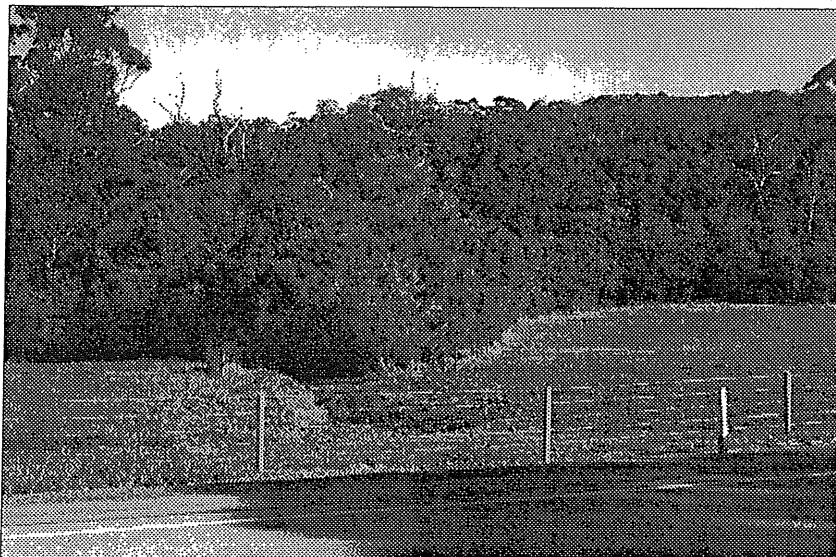
A drain from a culvert off South Coast Highway, in the vicinity of the Lights Road overtaking lane. Such drains need to be stabilised with native revegetation and, where necessary, with riffle and pool zones.
