Cocos (Keeling) Islands Coastal Vulnerability Study Assessment Report (Volume I)

Royal HaskoningDHV (RHDHV) and their sub-consultants, Bluecoast Consulting Engineers (Bluecoast), have prepared this report on behalf of the Department of Planning, Lands and Heritage (DPLH). DPLH, in collaboration with the Commonwealth Government of Australia and the Shire of Cocos (Keeling) Islands (the Shire), has commenced the process of completing a Coastal Hazard Risk Management and Adaptation Plan (CHRMAP) for the Cocos (Keeling) Islands. As the first stage of this process, this report presents a Coastal Vulnerability Assessment (CVA).

The objective of the CVA is to identify coastal hazard risks and assess the vulnerability of built and natural assets to erosion and inundations hazard. The work to meet this objective was guided by the Western Australian Planning Commission's State Planning Policy No. 2.6 – State Coastal Planning Policy (SPP 2.6).

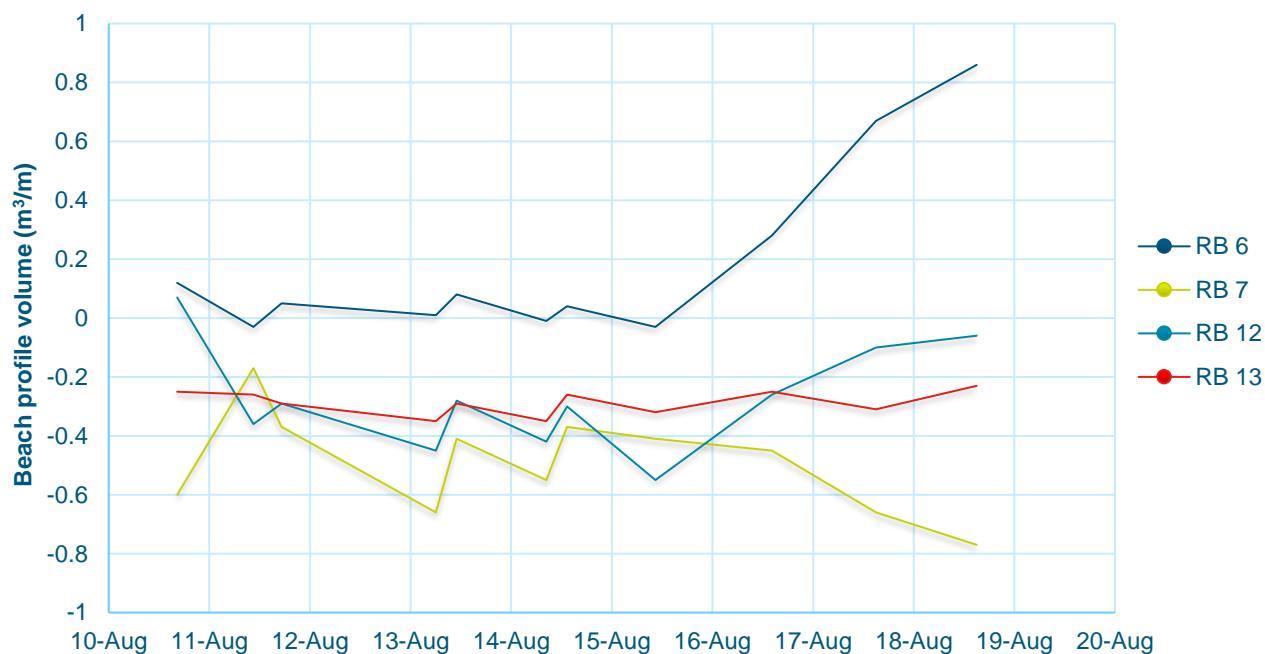
Given the low wave energy environment and the potential for sand movement both northwards with wind waves and southwards with swell made it difficult to predict the net sand longshore transport direction and rates at this site. In recognition of this, GHD arranged the construction of two temporary groynes at Rumah Baru to quantify longshore transport. The temporary groynes were constructed in July 1999 and were 32 metres in length and located 20 metres either side of the boat ramp. Soon after construction of the groynes, a substantial amount of sand was observed to have built up against the northern side of the northern groyne. **Figure 5** shows the cumulative change in the beach volume profiles over the period, the greatest change on the northern side of the northern groyne with a net increase in subaerial beach profile volume of 0.86 m³/m, which predominately occurred over a 3-day period around 18 August 1999. While this would indicate a southerly littoral drift, the temporary groynes failed in August before any conclusive results could be obtained from the groyne monitoring programme. It is not known if the temporary groynes were reconstructed or not.

Figure 5: Cumulative change in beach profile volume at Rumah Baru foreshore during 1999 temporary groyne trial.

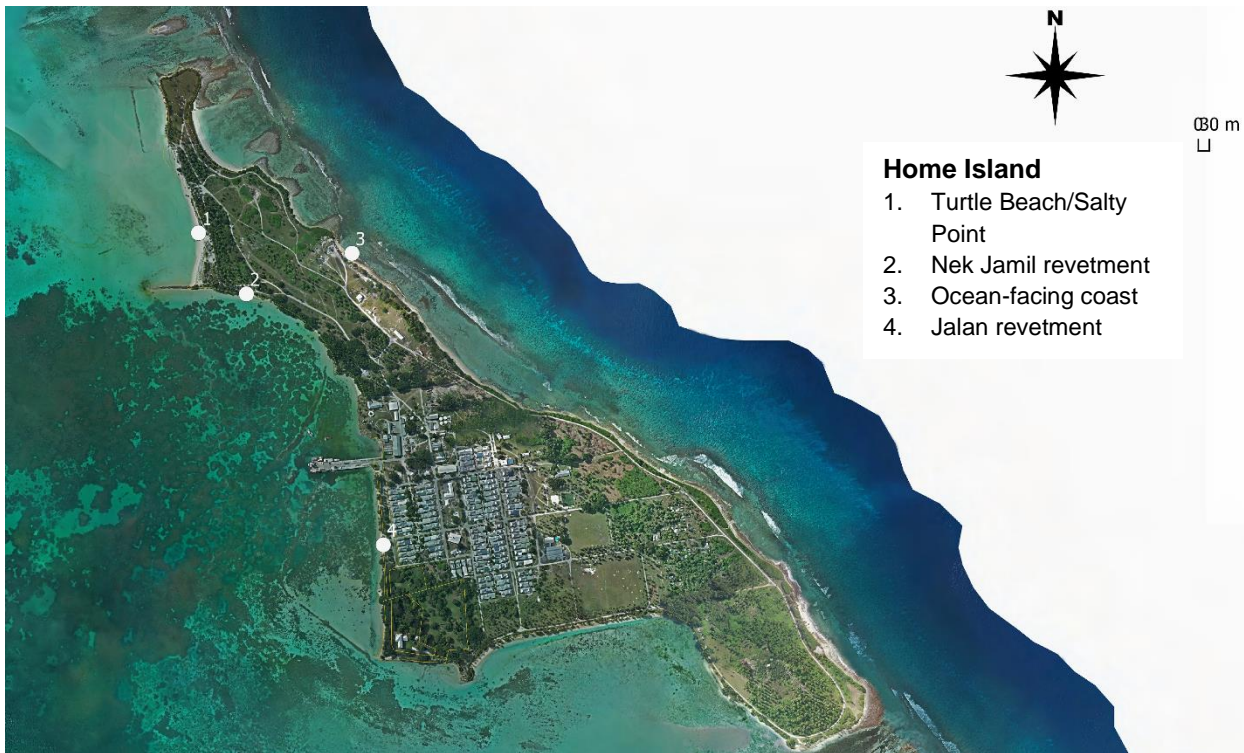
Figure 6: Location inspected as part of the site visits of the study area

additional details including discussion of the specific coastal observations and conditions of each coastal structure. This covers the locations shown **Figure 6**. General observations from the site visit(s) are:

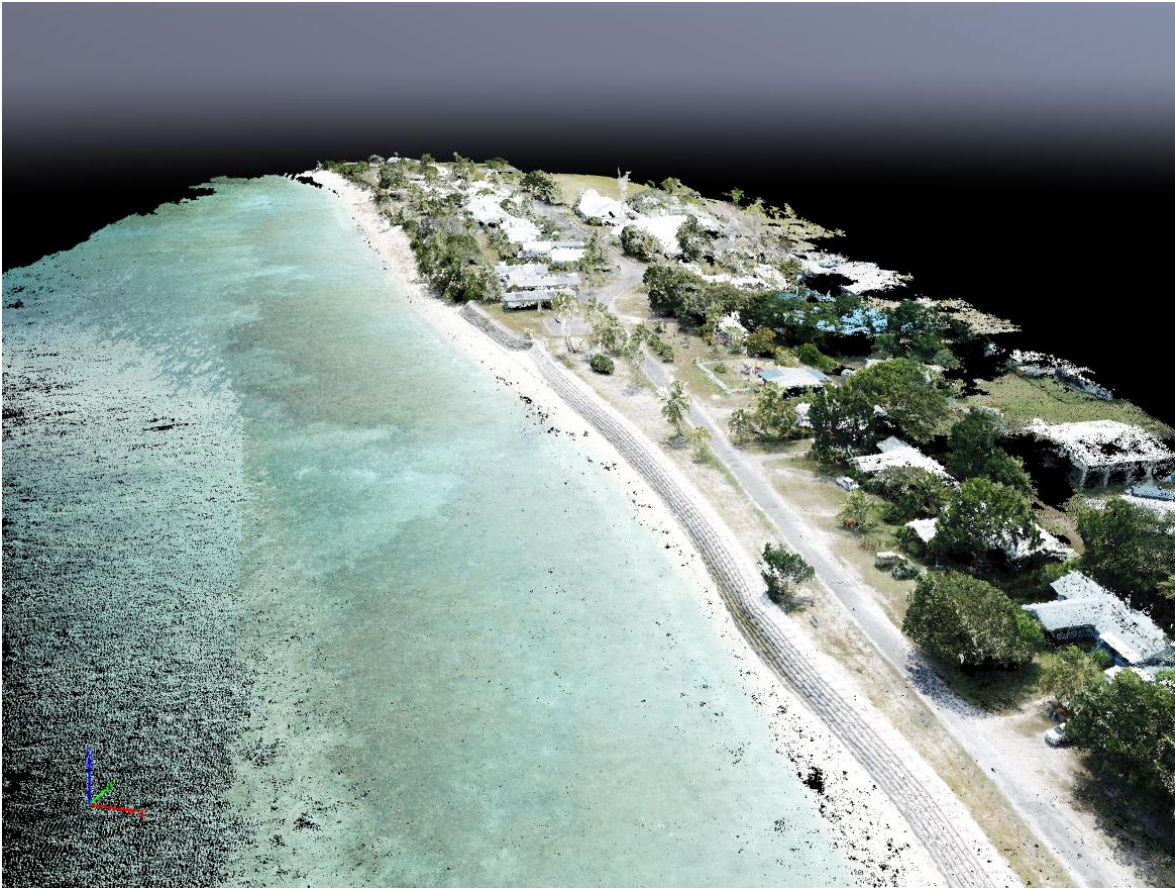
Figure 14: 3D Point cloud of the West Island settlement derived from the July 2018 drone survey using Autodesk Recap Photo.

For each survey, the flight path followed a predefined, shore-perpendicular grid and a final perimeter around the entire survey area for optimal 3D data capture. The drone height during image capture was up to 80m resulting in an image resolution of $\sim 2\text{cm}/\text{pixel}$. The outputs from the processing of drone data included a 3D point cloud prepared using Autodesk Recap Photo and a digital surface model (DSM) generated using WebODM georeferencing software. Examples of these outputs are presented in **Figure 14** and **Figure 15**, respectively.

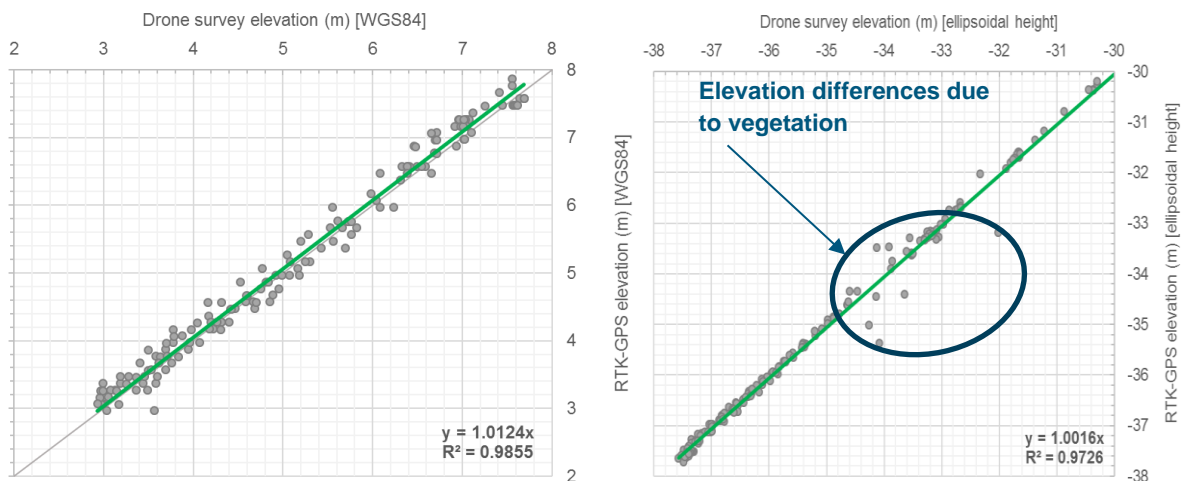
A statistical comparison is shown in **Figure 16** and **Table 6**. The absolute differences between drone and RTK-GPS derived elevations are considerably smaller for the October 2018 survey. The mean absolute difference in October 2018 was 0.11m (median is 0.04m) for all survey samples (beach transects and GCPs) and 0.03m (median is 0.02m) for the GCPs only. It is noted that the GCPs were strategically placed in areas clear of vegetation while some of the beach transect samples are taken under foliage and palm trees. As discussed above, the latter resulted in considerable elevation differences between the two survey techniques as the RTK-GPS measures ground elevations and the drone measures surface elevation (i.e. including vegetation). These differences are represented in the stated 0.11m mean absolute difference for this survey comparison, hence a more accurate description of the survey error is the median (i.e. 0.04m) or the mean absolute difference of the GCP samples (i.e. 0.03m).

Figure 16: Comparison of drone and RTK-GPS elevations for the Left: July 2018 and Right: October 2018m surveys at the West Island settlement.

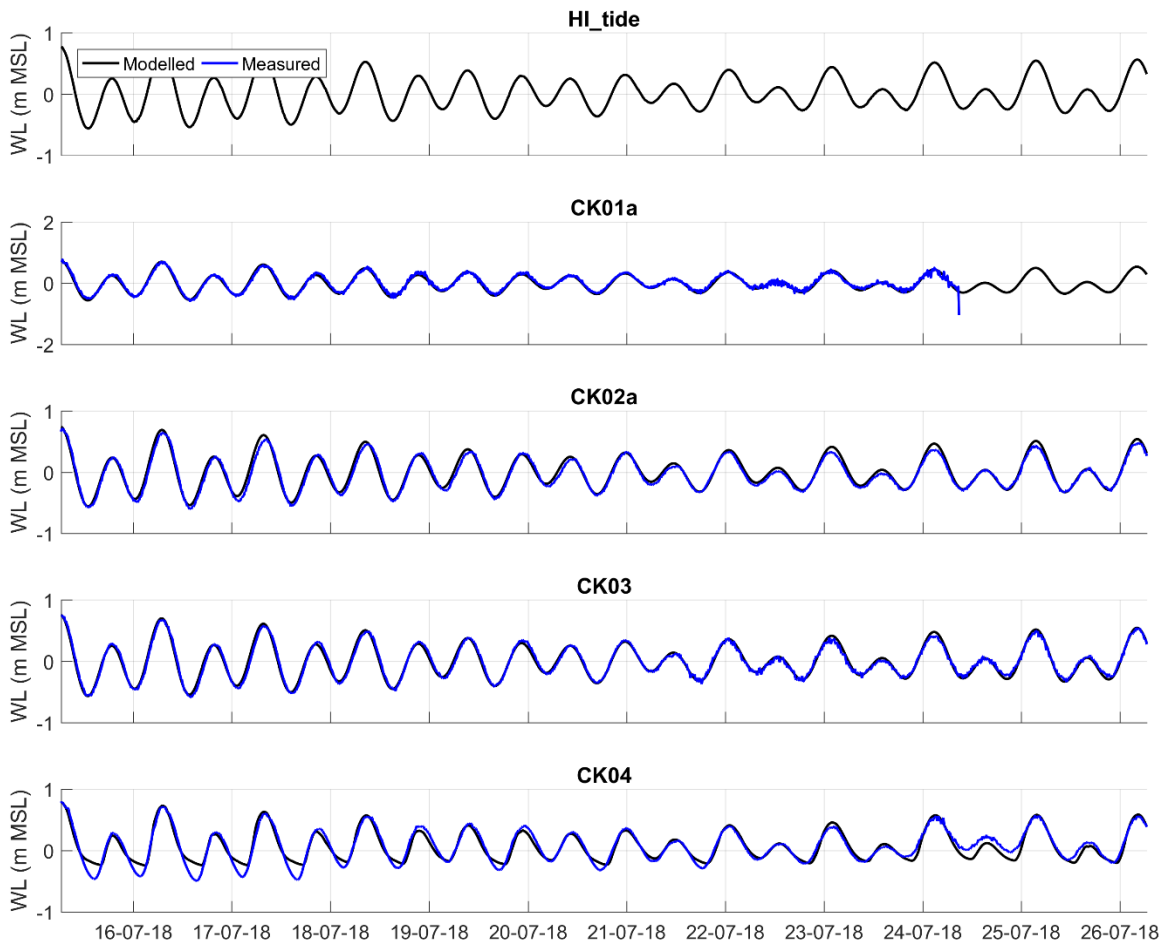
Figure 20: Comparison of measured and modelled water levels at the two offshore sites (CK01 and CK02) as well as lagoon sites (CK03 and CK04) during a 10-day period in July 2018.

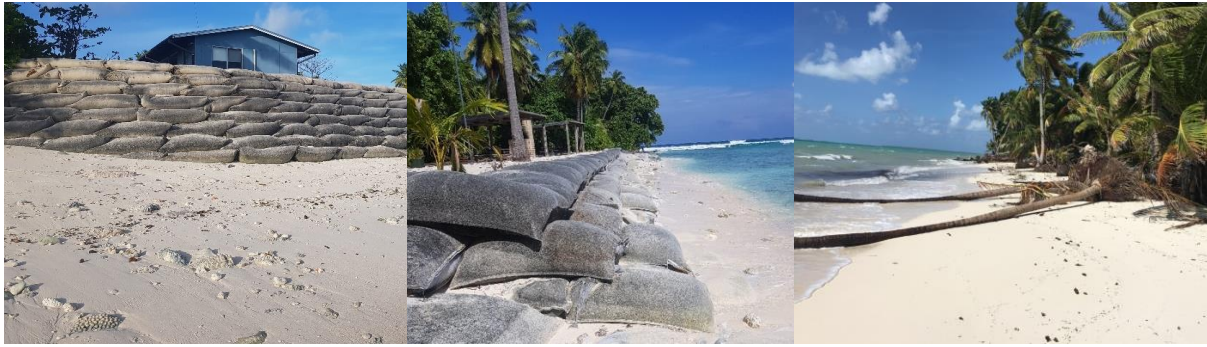
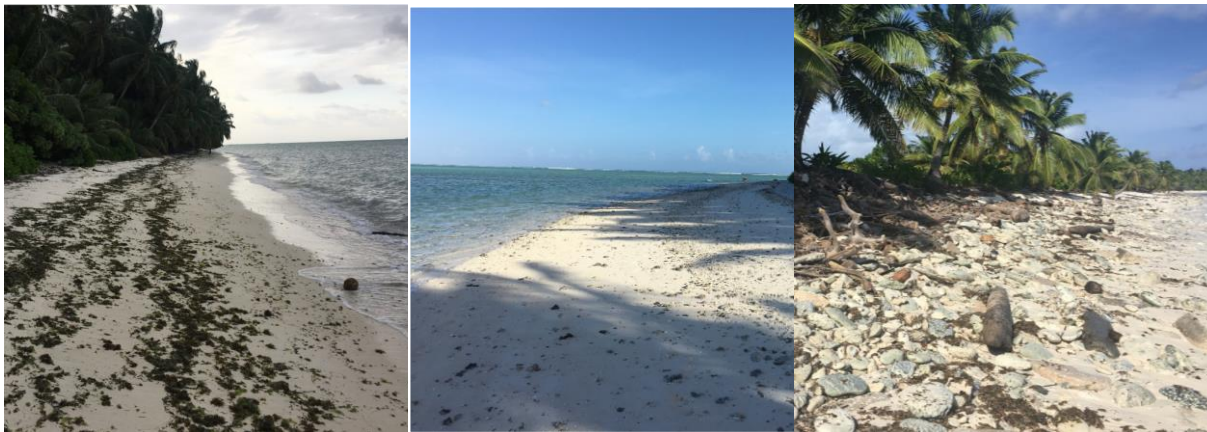
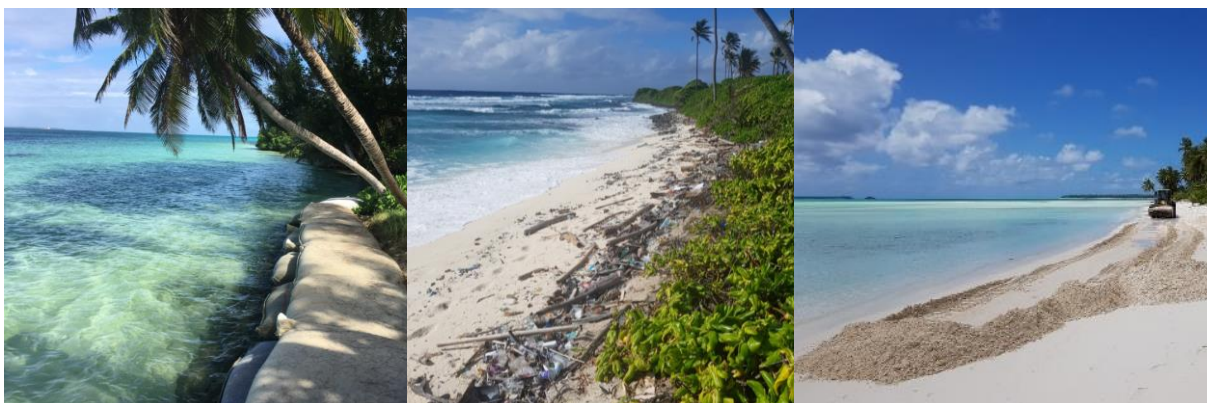
MU1: West Island Settlement

MU2: West Island, ocean-facing (north)

MU3: West Island, lagoon-facing

MU4: West Island, Rumah Baru

MU5: Scout Park/Kite Beach

MU6: West Island, ocean-facing (south)

MU7: Home Island Settlement

MU8: Home Island, ocean-facing

The study area has been broken into nine management units. The management units define sections of the coastline which share similar characteristics and provides a framework for monitoring and management as part of the CHRMAP. The definition of management unit has been based on geological features, exposure, assets and other factors. The management units are listed with a description of their characteristics in Table 17 and are illustrated in **Figure 56** and **Figure 57** for West Island and Home Island, respectively. Typical photos of each unit are also provided in **Figure 58**.

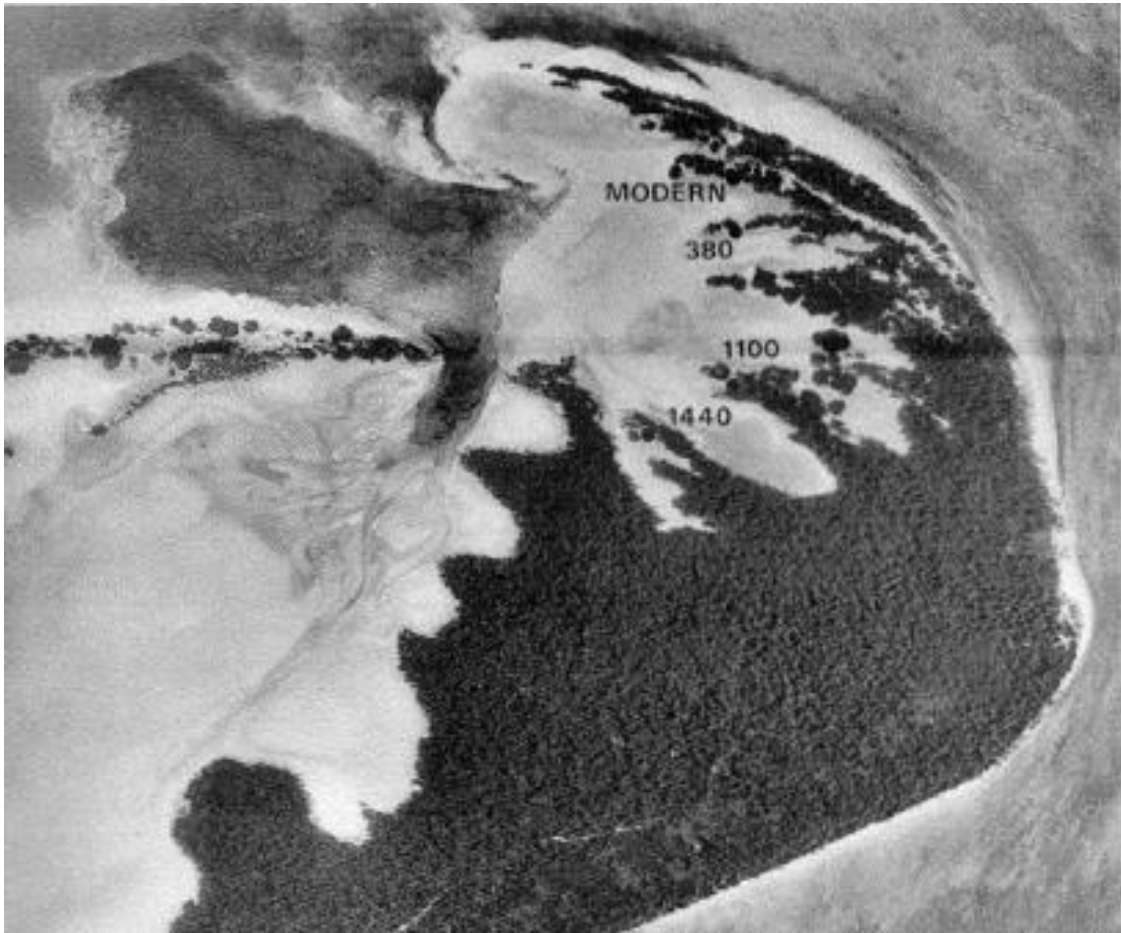
Figure 74: Aerial photograph showing the south eastern tip of West Island (source: Woodroffe et. al, 1994). Radiocarbon dates on coral shingle indicate the progressive buildout of the spits.

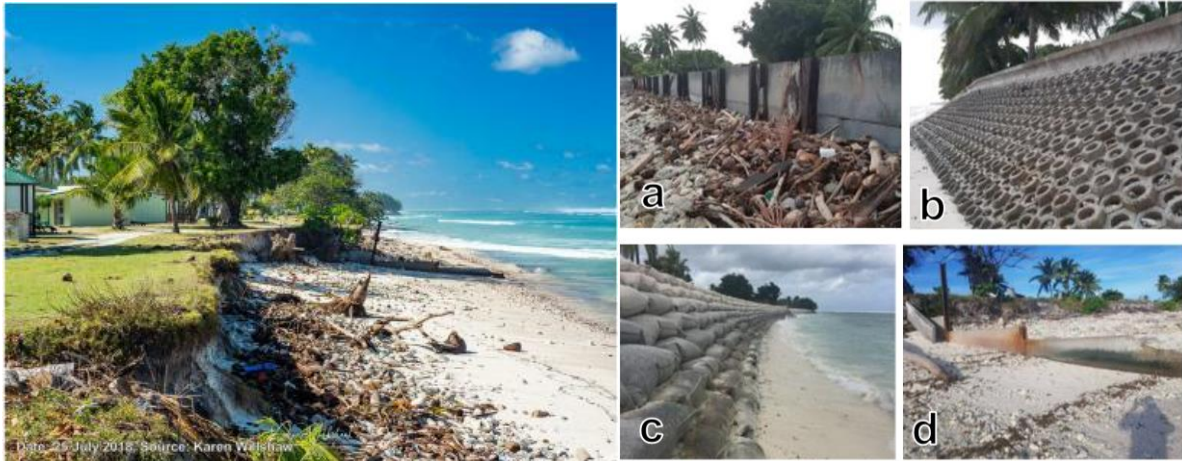
Figure 75: Recent erosion along unprotected West Island settlement shoreline (left) and on right is photographs of the series of coastal protection structures introduced to protect the West Island settlement (a) older vertical seawall (b) Seabee seawall (c) GSC revetment and (d) older groynes.

The oceanward shorelines of West Island are generally stable (see Section 6.4) but some areas are receding particularly those fronting the West Island settlement. Over the past decades a series of coastal structures have been introduced to the West Island settlement shoreline to protect the landward infrastructure (**Figure 75**). These have been built in a progress downdrift direction, starting with an old vertical seawall (date unknown) which was later replaced with a 224-metre-long sloping Seabee seawall constructed in 2000 -2001 to protect Government House (Jones and Semen, 2003). This was followed by two geotextile sand container (GSC) revetments constructed between 2014 and 2017 with a total length of 461 metres. Further downdrift of the GCS revetments an older groyne field with four short groynes have been partially re-exposed by chronic erosion.

The unprotected sections of this shoreline suffer from chronic erosion. Given the northward direction of both sediment transport and progressive introduction of coastal structures, downdrift sediment starvation has created a domino effect with each structure moving the erosion issue further downdrift. The area currently suffering the worst erosion is located to the north of the last GSC seawalls. This area is characterised by a permanent erosion scarp, mature trees that have fallen, or are in the process of falling, onto the beach and erosion debris is evident (**Figure 75**).

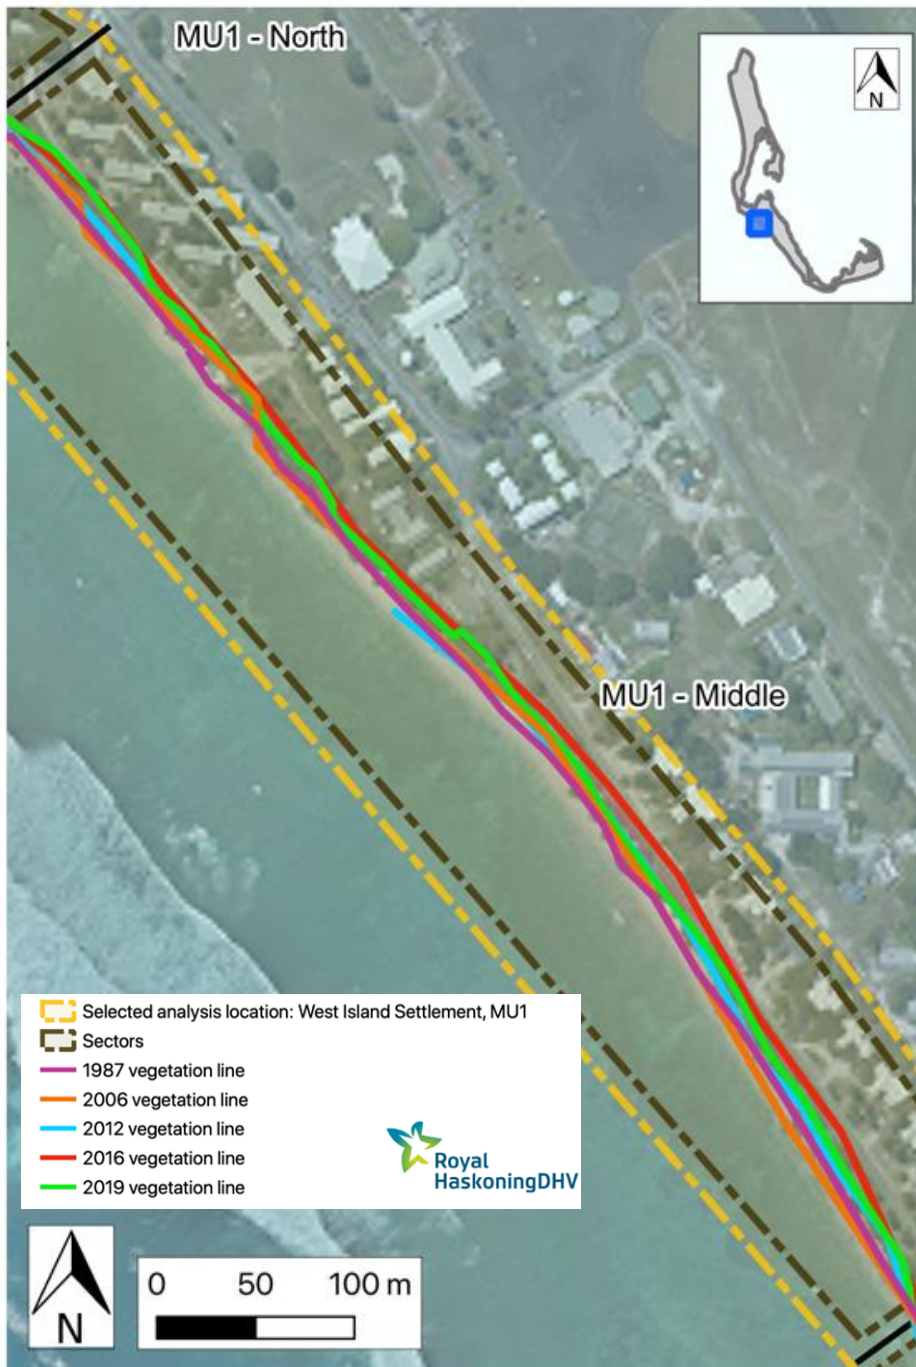
Figure 160: Historical vegetation lines at the West Island Settlement within MU1, split across the three sectors. A time series of vegetation line position and regression analysis for each sector is also shown.

The selected analysis area within MU1 comprised the 1.6-kilometre long shoreline adjacent to the West Island settlement. This area consists predominantly of a sandy beach with various coastal protection structures distributed along its length. To clearly distinguish between spatially varying trends, the management unit was divided into three sectors, MU1-North, MU1-Middle and MU1-South (see **Figure 160**).

MU1-North is a 550-metre long section of the shoreline backed by the West Island Settlement where 90 residential lots as well as commercial and industrial assets are located. There are also four low-crested concrete groynes located along the shoreline. The top panel of **Figure 160** shows that since 1987, the vegetation line has been continuously retreating with the rate of retreat increasing since 2012. MU1-Middle is a 700-metre long sector of the shoreline which is protected by the Medical Centre GSC Revetment (constructed in 2014) and the William Keeling GSC Revetment (constructed in 2017). **Figure 160** shows that the recession rate in this sector is lower than in MU1-North. The recent increase in shoreline position within this sector between 2015 and 2019 is explained by a 15-metre shoreline fill that was placed in 2017. MU1-South is a 400-metre long sector of the shoreline toward the southern end of the West Island Settlement. The Government House Seawall as well as a slab seawall are coastal protection structures in this sector. The vegetation line in this sector is observed to be the most stable in MU1.

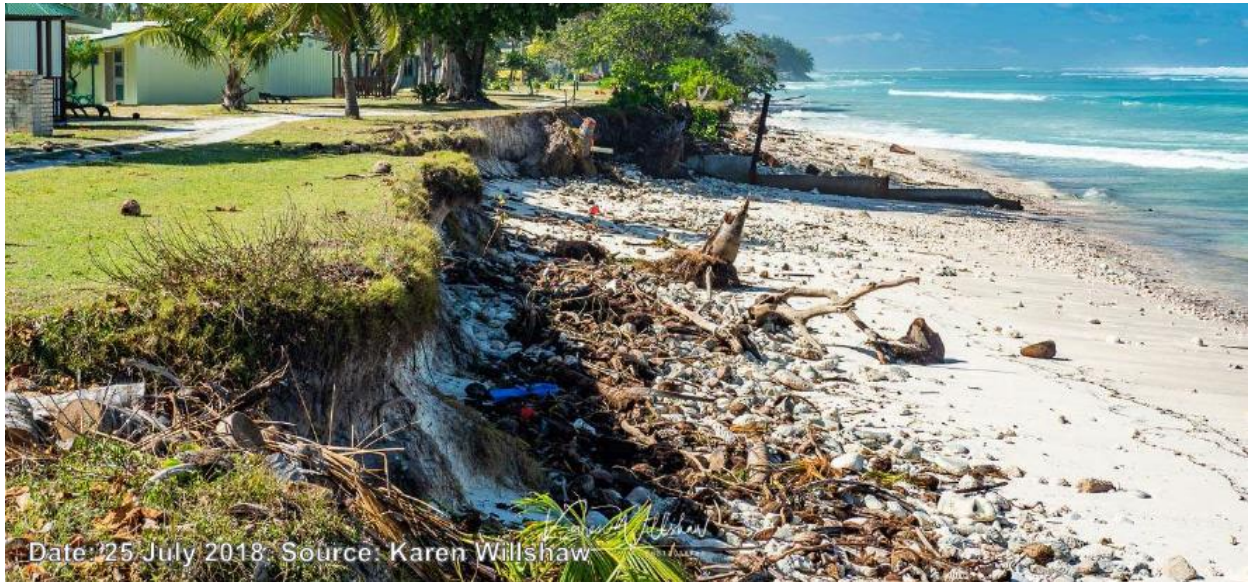
Figure 173: Photographs of XBeach calibration site shortly after the July event showing the coral rubble and other debris exposed along the lower profile (source Karen Willshaw).
