# Local Structure Plan

## Castledare

Lot 4 Fern Road and Lots 100 & 102 Castledare Place  
Wilson

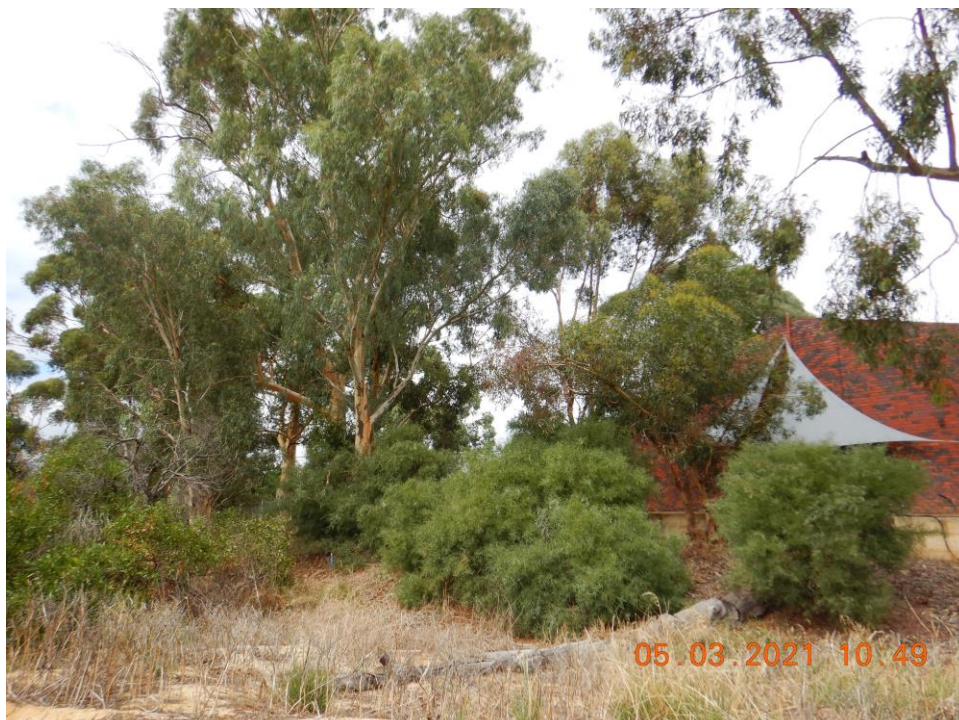
Plate 1: Non-native parkland cleared vegetation in 'completely degraded' condition

Plant Community	Description	Area (ha)
<b>Non-native parkland cleared</b>	Forest of predominantly non-native trees over weeds and planted vegetation ( <b>Plate 1</b> ).	0.17
<b>Cleared</b>	Disturbed cleared areas comprising non-native weeds and/or planted vegetation ( <b>Plate 2</b> ).	3.00

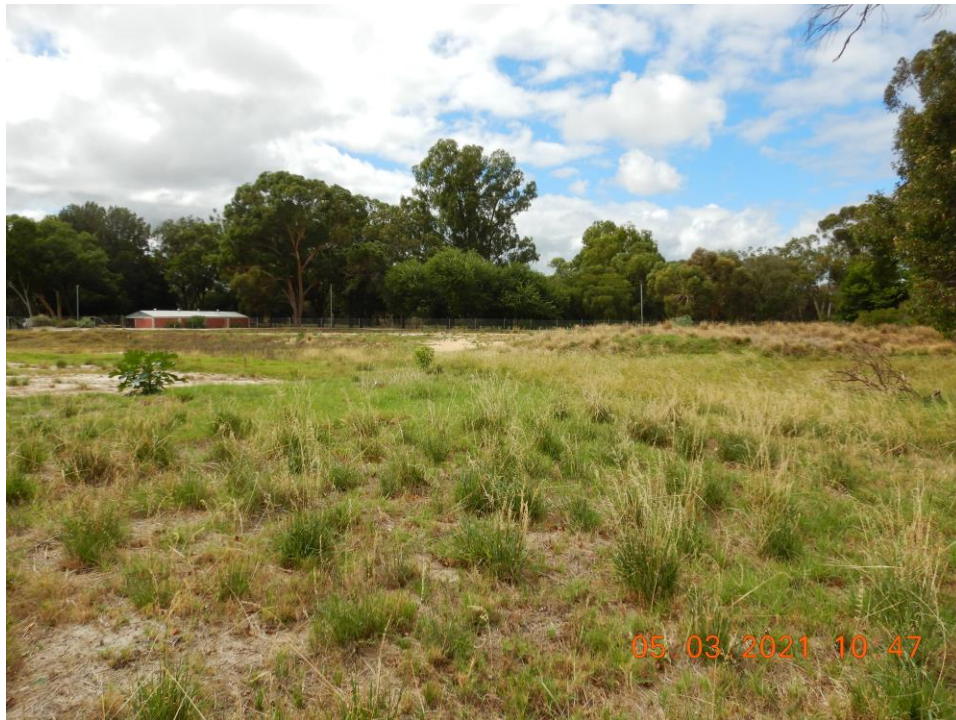
Plate 2: Cleared areas in 'completely degraded' condition

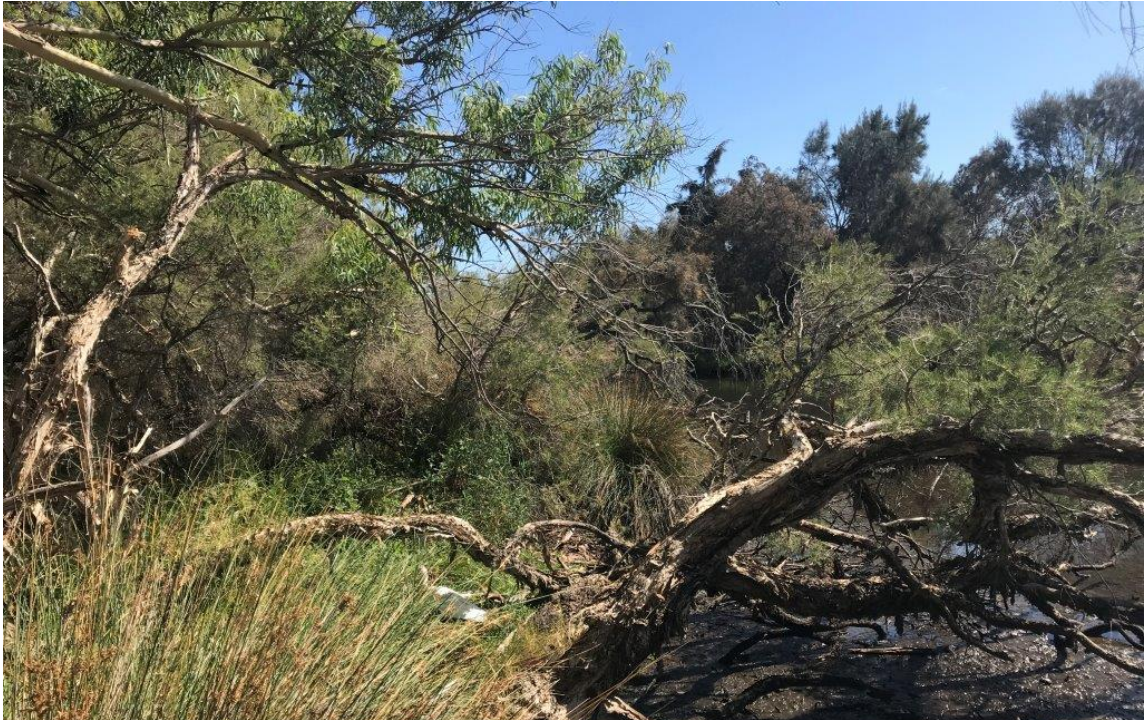
***Plate 1: Plant community ErMr in 'very good' condition***

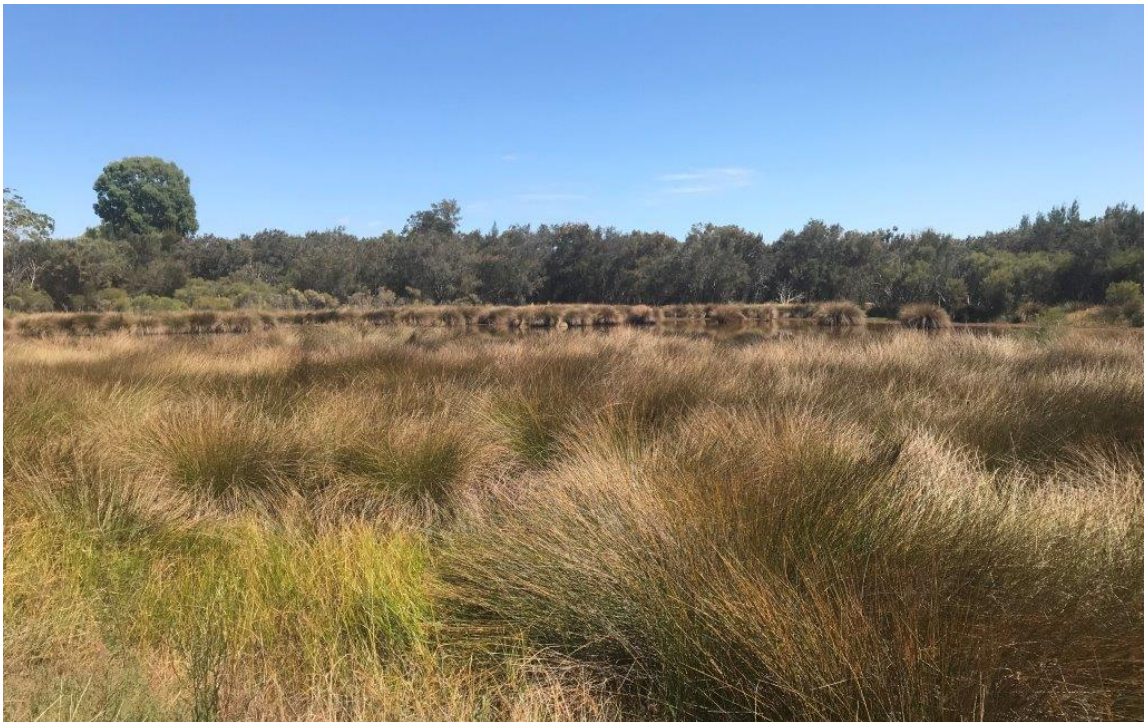
***Plate 2: Plant community Jk in 'very good' condition***

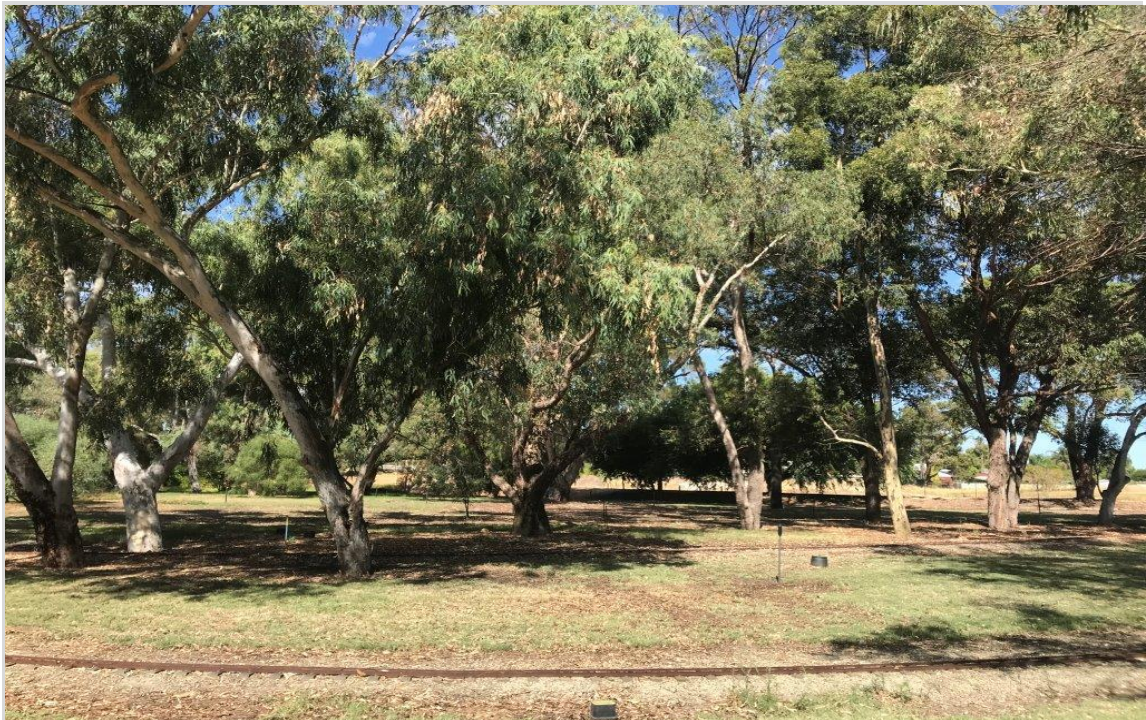
***Plate 4: Plant community 'non-native parkland cleared' in 'completely degraded' condition.***

Plant community	Description	Area (ha)
ErMr	Forest of <i>Eucalyptus rudis</i> over <i>Melaleuca raphiophylla</i> , <i>Casuarina obesa</i> over <i>Juncus kraussii</i> , non-native grasses and native and non-native herbs.	7.48
Jk	Sedgeland of <i>Juncus kraussii</i>	0.39
Revegetation	Shrubland of mixed planted native species.	0.69
Non-native parkland cleared	Forest of predominantly non-native trees over weeds and planted vegetation ( <b>Plate 4</b> ).	2.14
Cleared	Disturbed cleared areas comprising non-native weeds and/or planted vegetation ( <b>Plate 4</b> ).	4.49

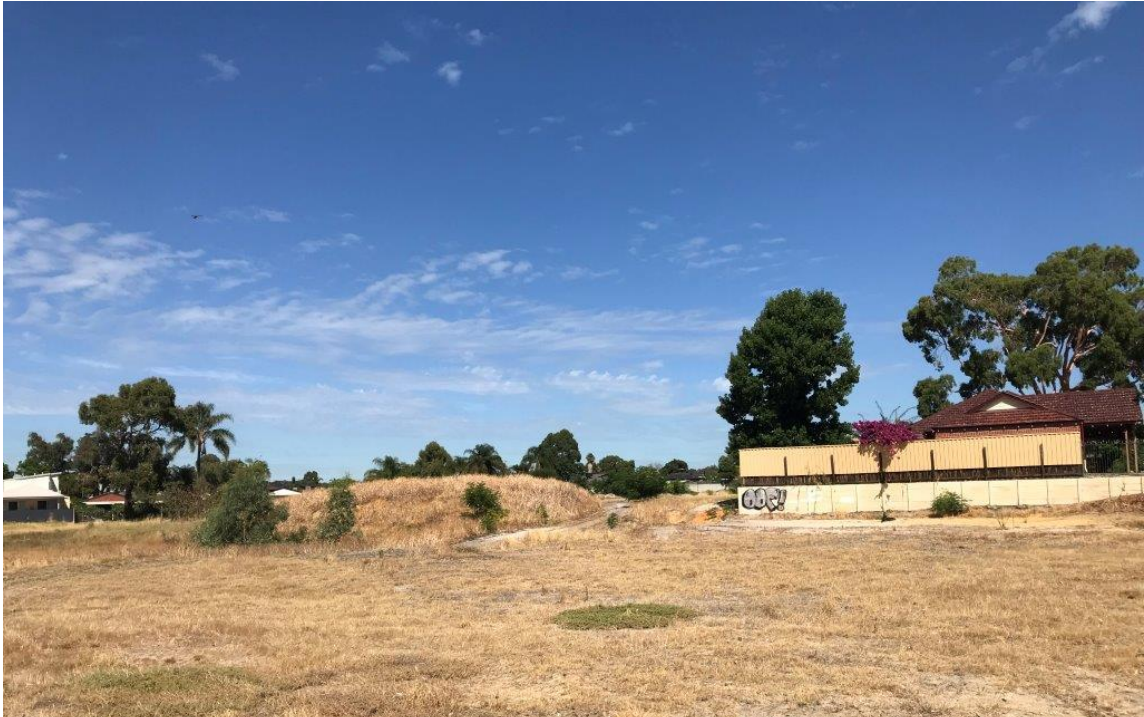
**Plate 5: Plant community ‘cleared’ in ‘completely degraded’ condition.**

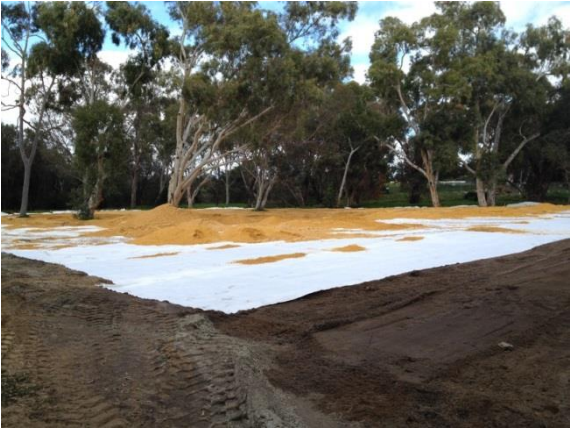
<p>Photograph 1. Open space south of Lot 102: sand and topsoil over warning barrier</p>

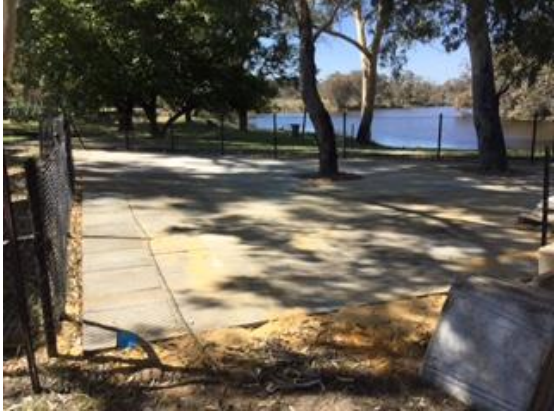
<p>Photograph 2. East of Niana Station: Paving slabs over clean fill</p>

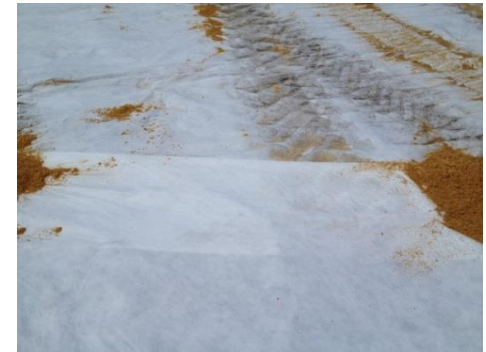
Photograph 6. Geotextile warning barrier

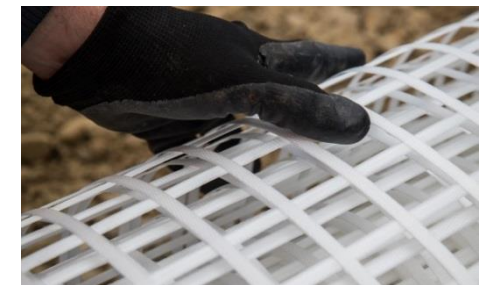
Photograph 7. Geogrid warning barrier

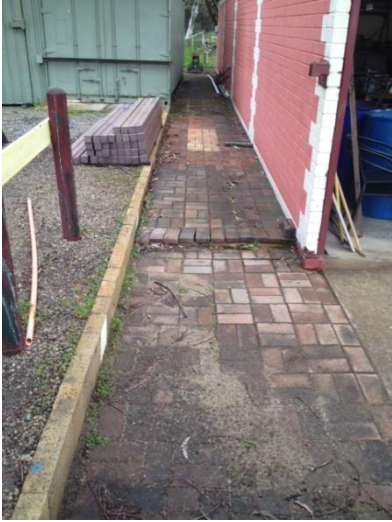
<p>Photograph 11. Hardstand around buildings associated with Niana Station.</p>

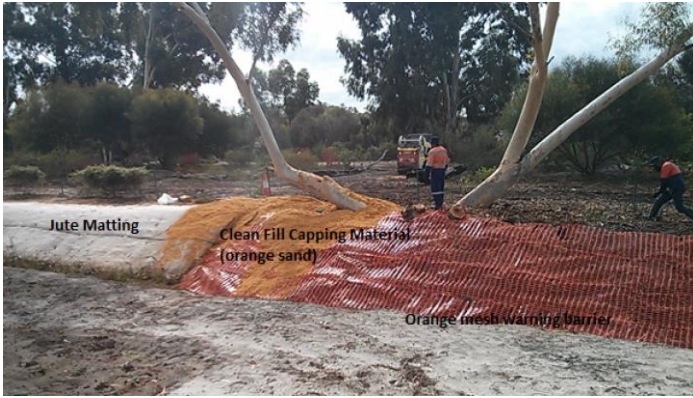
<p>Jute Matting Clean Fill Capping Material (orange sand) Orange mesh warning barrier</p>
		<p><b>KEY MANAGEMENT FEATURES REQUIRED</b></p> <ul style="list-style-type: none"> <li>• Fencing currently in place is maintained</li> <li>• Embankment remains undisturbed</li> <li>• Access continues to be restricted to Water Corporation or approved Subcontractor’s informed of Site conditions via this Asbestos Management Information plan</li> <li>• Embankment is managed through periodic inspections</li> <li>• Any erosion of the embankment is addressed to prevent reduction in the capping layer thickness</li> <li>• Embankment continues to be stabilised with vegetation</li> <li>• Roots of mature eucalypt and melaleuca trees along the embankments to be managed to ensure they do not uplift the capping layer and exposure underlying soils (see Section 5 regarding other constraints to be managed when working within the Site)</li> <li>• See Section 6 for additional information</li> </ul>
