## Structure Plan

## Lot 32 Barfield Road, Hammond Park

Report Number: PR126191-1

Version / Date: Rev 3, January 2017

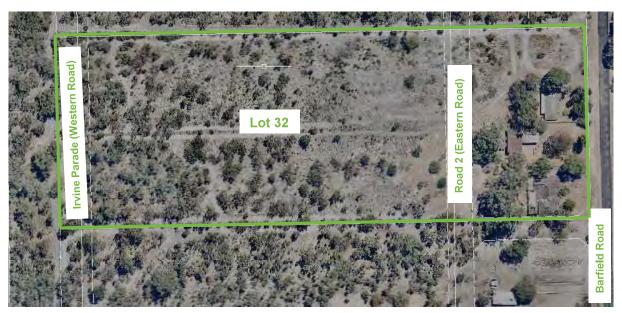
Figure 1 - Lot 32 Extents

Lot 32 is rectangular and 4.04 hectares in size. The site is approximately 24 kilometres south of Perth and 0.4 kilometres east of Kwinana Freeway. Residential properties edge the north, east and south boundaries of the property with a Catholic Primary School adjacent a portion of the west boundary.

The proposed concept for Lot 32 consists of a school site of 2.72 hectares bounded by a road on each of the eastern and western sides. The remainder of the lot will be retained as a single lot and accommodate the existing dwelling. The school lot will be amalgamated with adjacent lots to form Hammond Park Secondary School.

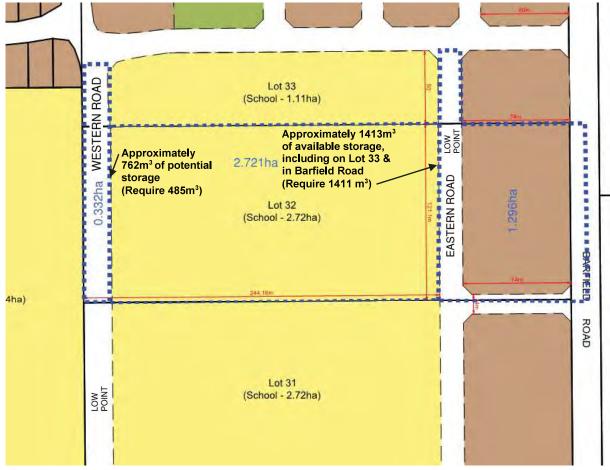
Figure 3 – 1 in 100 year ARI Catchments

The Barfield Road catchment is 0.121 ha. The 10 year ARI will be captured in drainage pits or a drainage swale, reducing the gutter flow below 1.5m. The 100 year ARI will flow towards a low point in the Eastern Road. Where possible the stormwater will be infiltrated at source.

All of this can be stored in the Eastern Road. We would recommend for Barfield Road a drainage swale be provided to store approximately 131m³ in capacity. This implies on the Eastern Road we propose to store 1282 m³. Additional storage is available for events in excess of the 1 in 100 year ARI flows.

Underground detention in the western road will be approximately 485m³ to cater for the 1 in 100 year ARI flows for the western road.

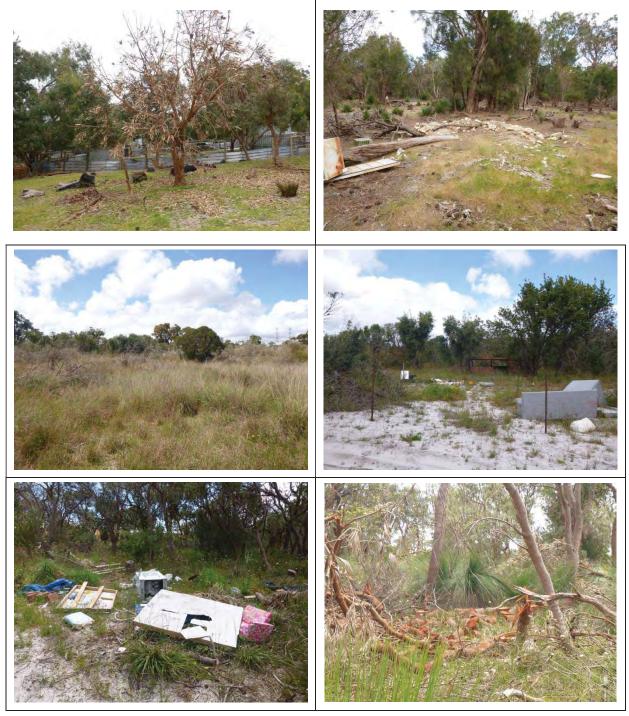
Plate 1 Vegetation condition, Left to right A, B, C, D, E and F.

As noted in section 2.3.2, access to Lot 14 was not available during the survey. Assessment of the vegetation condition is limited to an inferred assessment based on visual assessment from the property boundaries while surveying Lots 31 and 47 and from assessment of aerial photography. As such condition in the vegetated areas is considered to range from *Excellent* (2) to *Very Good* (3) while the cleared areas are *Completely Degraded* (6).

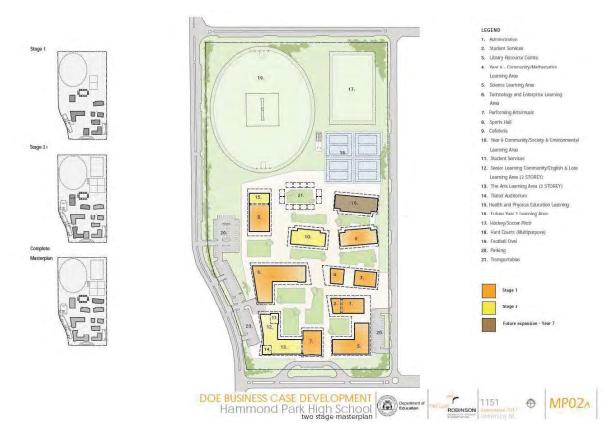
Figure 1 Hammond Park High School Two Stage Masterplan

- The High School site is bounded by four roads. A Private Primary School is also proposed opposite the site on the western boundary road.
- The High School is located within walking distance of the proposed Mandogalup Train
   Station on Kwinana Freeway
- A future train station and the town centre are located within a 400m walking distance to the south boundary of the school site.
- The southern boundary street is favoured as the potential school entrance as it has the
  potential to support school hour traffic feeding off the future arterial Barfield Road and
  Kwinana Freeway.
- A school oval is proposed alongside the primary school site to create a buffer between the two schools.

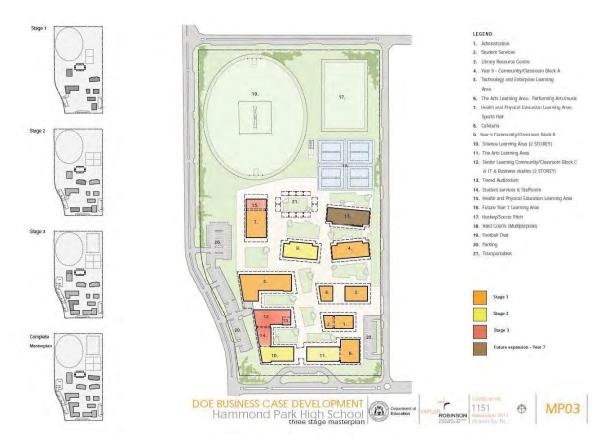
Figure 2 Hammond Park High School Three Stage Masterplan

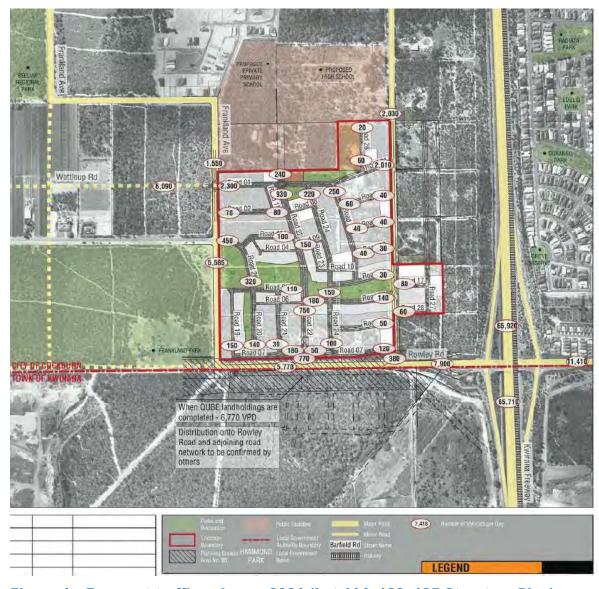
Figure 4 Forecast traffic volumes 2031 (Lot 114, 123, 125 Structure Plan)

The following plan, Figure 4 identifies forecast traffic volumes on roads in the vicinity for 2031.

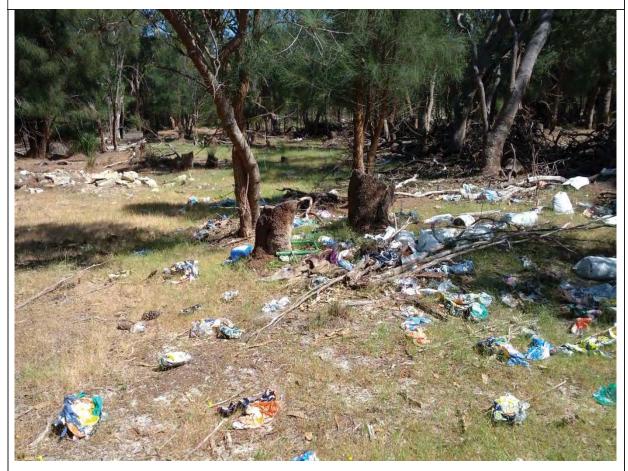
Plate 2 - Uncontrolled fill

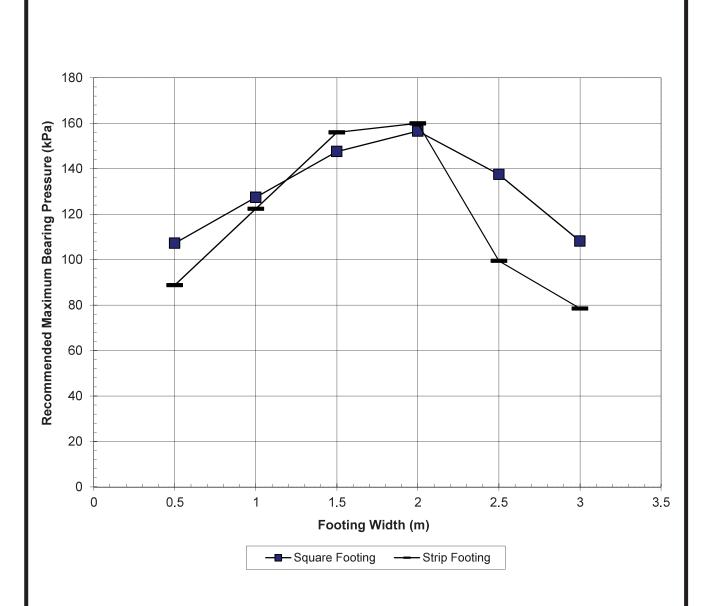
Figure 01

Notes: (1) Recommended maximum bearing pressures are based on a Factor of Safety of 3 against bearing failure

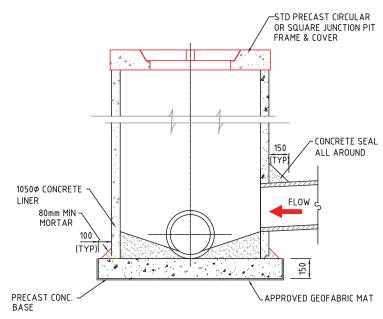
2. LESS THAN 500mm ABOVE AAMGL PITS TO BE BENCHED

STD LINER JUNCTION PIT BASE SHOWN FOR WET CONDITIONS

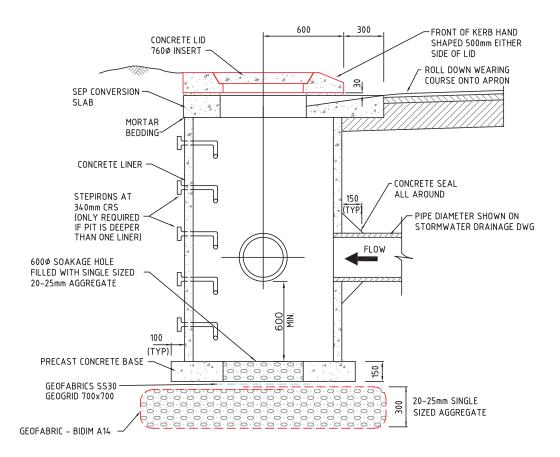
#### SINGLE SIDE ENTRY PIT WITH SOAKAGE BASE SHOWN FOR WET CONDITIONS

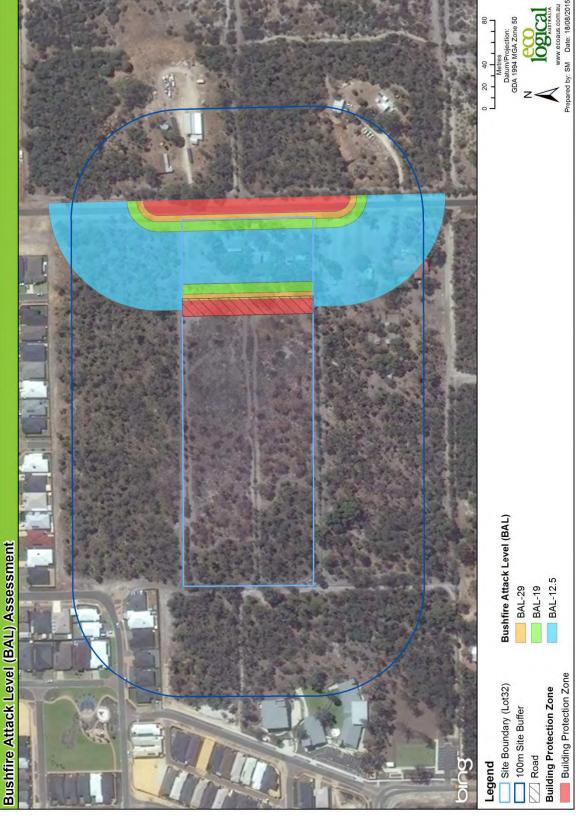
Vegetation Classification	FDI	Slope	Separation Distance	BAL	Building Protection Zone
Woodland	80	Upslope / Flat land	16 m	BAL-29	14 m

Figure 5: BAL Assessment
