Water quality snapshot: Hardy Inlet 2023

Through Healthy Estuaries WA, the Department of Water and Environmental Regulation (the department) monitors water quality fortnightly in the Hardy Inlet and its catchment.

This snapshot presents some insights from our water quality monitoring from June 2022 to May 2023.

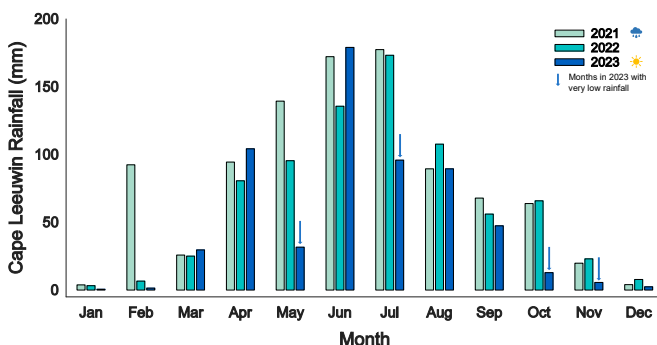
Cape Leeuwin monthly rainfall in 2021 (a wetter than average year), 2022 and 2023 (a drier than average year). Data from the Bureau of Meteorology

Rainfall in 2023 in the Blackwood catchment was very low (e.g. 600 mm at Cape Leeuwin compared with the average annual rainfall of 790 mm for the previous 30 years). It was significantly lower than 2021 (950 mm at Cape Leeuwin) which was the wettest year in the past 10 years. Monthly rainfall was very low across the year in 2023, except for the months of April and June. Rainfall in 2022 (780 mm) was between that of 2021 and 2023.

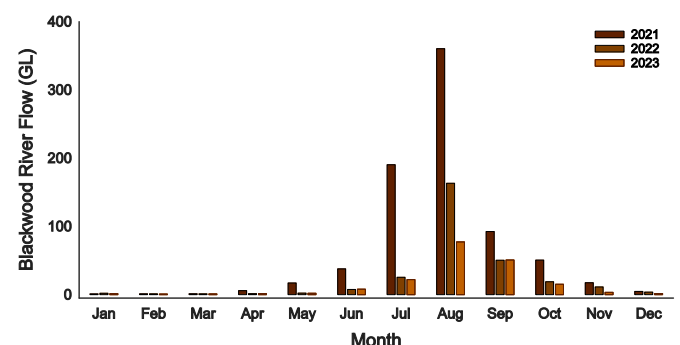
Blackwood River monthly flow in 2021–23. Data from Department of Water and Environmental Regulation station 609019

River flow and rainfall generally follow a similar pattern, but flow is also influenced by factors such as groundwater, soil moisture, evaporation and extraction. Two consecutive years of relatively low rainfall in 2022 and 2023 meant that flows in the Scott and Blackwood were low in these years, particularly in 2023 (288 GL compared with an average of 444 GL for the previous 30 years). The recent low flow years are in line with longer term trends of declining flows and rainfall because of climate change.

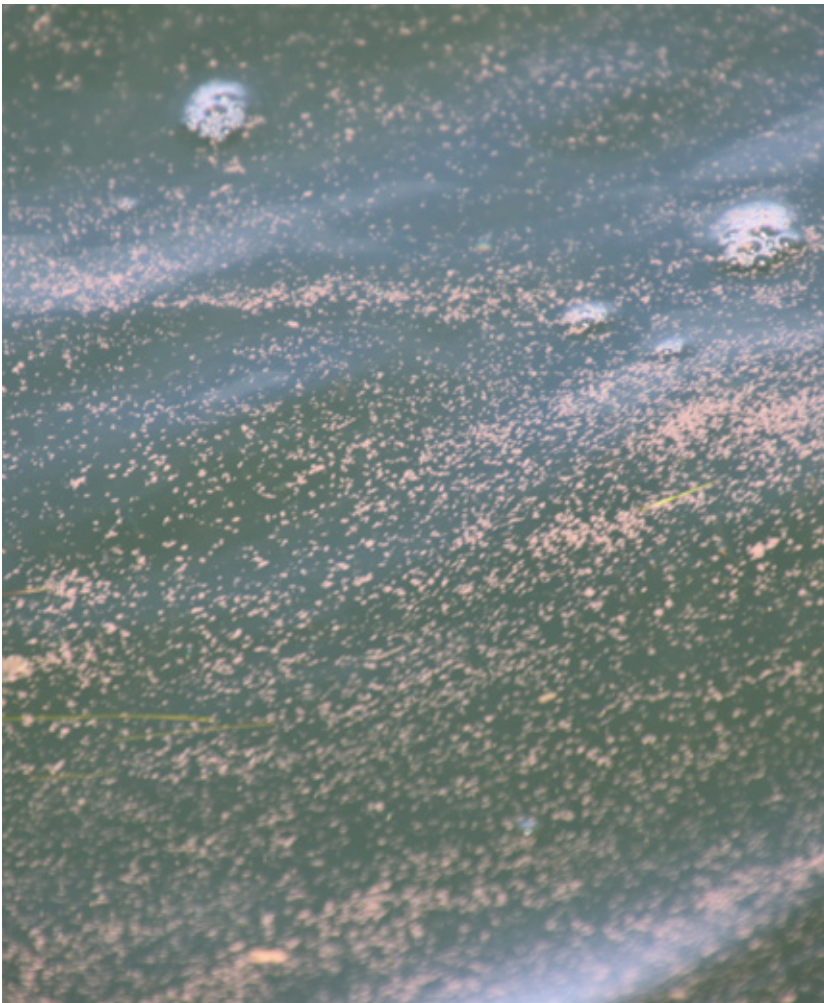
Microalgae *Trichodesmium* on the surface of the estuary

In late summer to early autumn 2023, there was occasional algal scum washed ashore between the estuary mouth and the Ellis Street boat ramp. This was caused by *Trichodesmium*, a marine species of algae that washed into the estuary from the ocean. This species of algae is potentially harmful to humans but is highly visible so easy to avoid. It resembles pink sawdust on the surface, and when it decomposes, the colour can change to purple, green and white. *Trichodesmium* regularly aggregates on the ocean surface on warm, still days, and then can enter the estuary with the incoming tide.

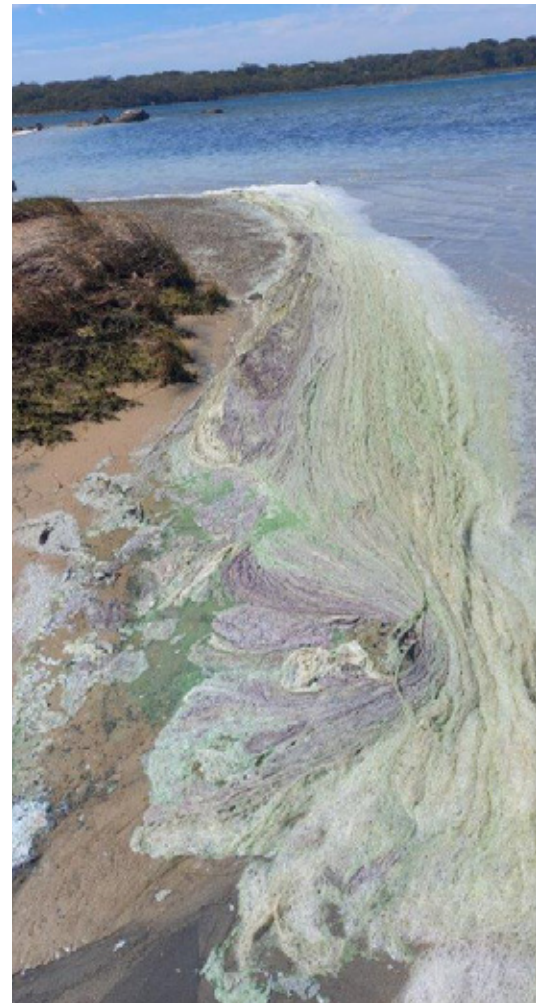
Microalgae *Trichodesmium* washed ashore and decomposing on the estuary foreshore
