COMPLIANCE REPORT

Investigation into gypsum plasterboard ceiling collapses

An investigation into the fixing of gypsum
plasterboard ceiling sheeting to timber
framing in residential homes
in Western Australia

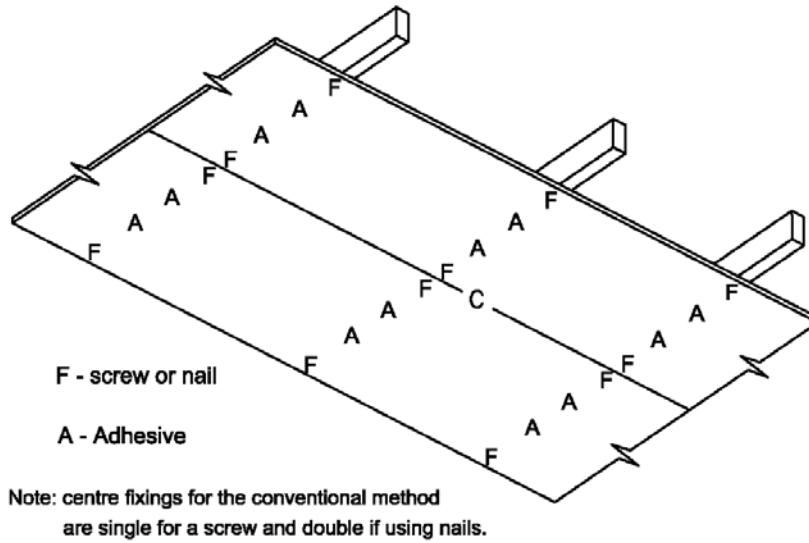
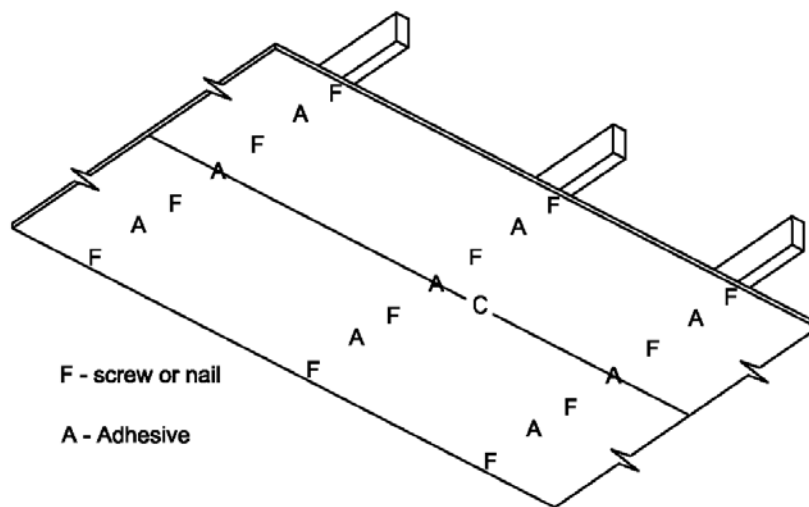
Figure 1. Conventional method and one third method of fixing plasterboard sheeting

Prior to 2007–2008 it appears that generally the conventional method of fixing was used to secure the plasterboard sheeting. This method relied heavily on adhesive to secure the sheeting in position and was considered by industry at the time to be vulnerable to failure if the adhesive was not applied correctly. The one third method of fixing was adopted by industry around 2007–2008 and is now considered to be the preferred method of fixing as time has shown it will improve the long term performance of plasterboard ceilings.

All the ceiling failures inspected by the Building Commission found that the conventional method of fixing had been used in all situations. These findings do not conclude that the conventional method of fixing is inadequate. The conventional method is an approved method under the current standard and approved for use by plasterboard manufacturers.

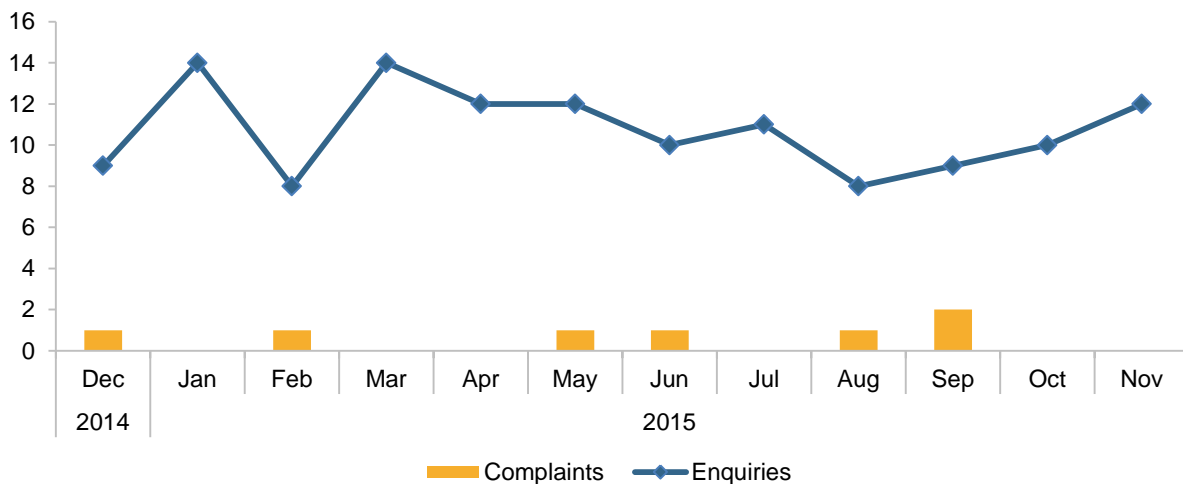
Figure 2. Consumer Protection monthly enquiry and complaint history

An assessment of matters reported to Consumer Protection revealed that in the 12 months from 1 December 2014 to 30 November 2015, partial or complete ceiling collapses were identified as the subject of 129 enquiries and seven complaints. The majority of the enquiries made with Consumer Protection (95 instances) related to residential tenancy disputes arising from delays in property owners attending to repairs and damage caused to the tenant's household goods. These tenancy matters were not referred to the Building Commission as the callers were dealing with a tenancy dispute and the caller was not the property owner. As a result of the awareness of incidents and possible causes of ceiling collapses all queries regarding ceiling failures are now referred to the Building Commission as a matter of course.

The seven complaints mostly concerned the quality of repair work following a ceiling collapse, with other cases referred to the Building Commission (see Figure 2). Typically, Consumer Protection does not refer a matter relating to building work that is older than six years, as this falls outside the scope for lodging a building service complaint.

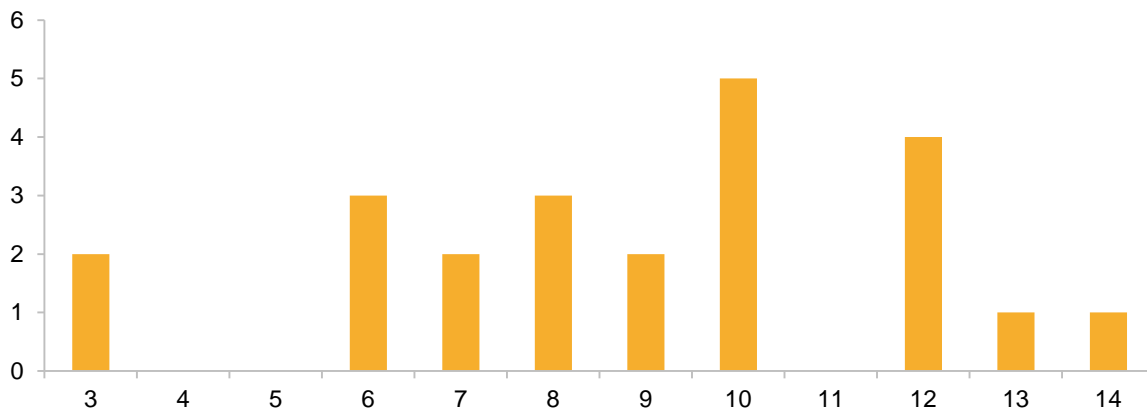
Figure 3. Years since house was constructed

Further analysis of the 129 enquiries found that 23 concerned ceilings that were sagging or cracking, but had not fully collapsed. This report excludes all cases where, based on available data, collapses were caused by external factors such as storm damage, water leaks, termites etc.

The approximate age of the house was recorded for the 23 enquiries – averaging 8.9 years since construction (see Figure 3).
