Perth Children's Hospital audit

BUILDING COMMISSION AUDIT REPORT

PERTH CHILDREN'S HOSPITAL

An audit of contractor and product performance in the construction of the new Perth Children's Hospital

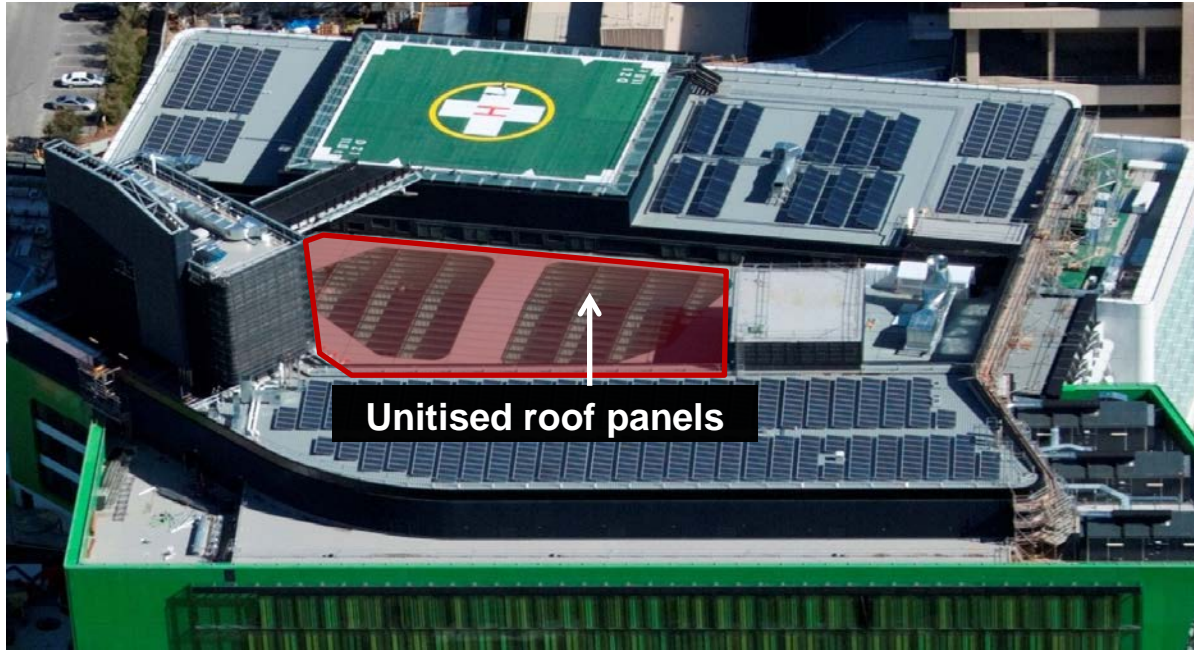
Photograph 2: Helipad and unitised roof panels at Perth Children’s Hospital

The audit team was advised that the atrium roof included 174 URPs. They are restricted to a single area of the roof located above the level seven and level eight link bridges on the north balcony (see Photograph 1). The URPs were installed in mid-2014. They were custom-designed and made-to-measure, to provide an efficient and cost-effective installation. The URPs are situated over the atrium next to the roof-top helicopter landing pad, and were therefore required to meet stringent acoustic performance requirements (see Photograph 2).

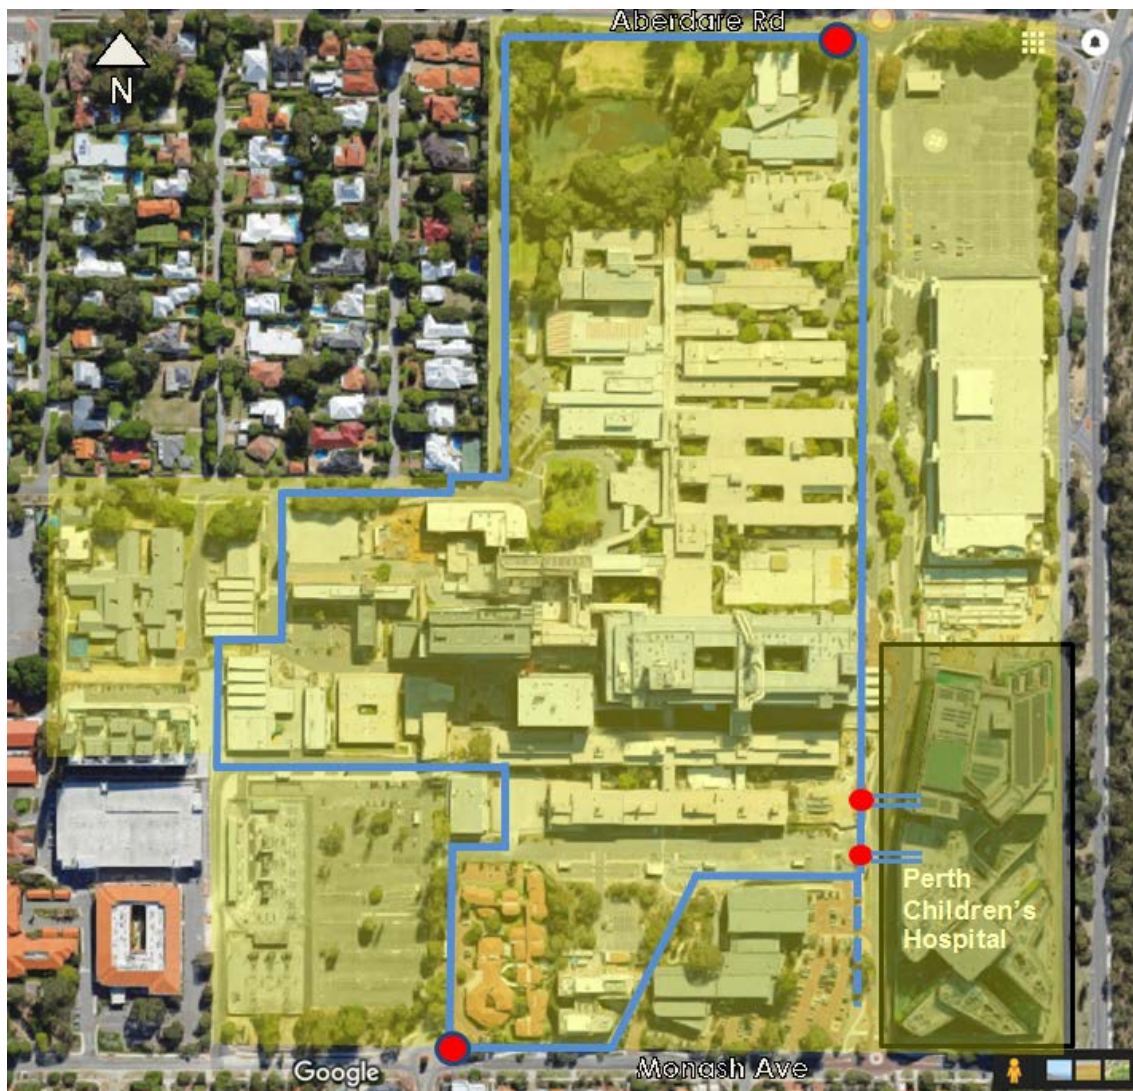
Photograph 6: Indicative plan of QEII ring main water supply

The QEII ring main consists of a concrete-lined steel piping system, with a nominal diameter of 300mm. This system is approximately 50 years old and is a typical pipe construction for that time. A length of pipe, approximately 52m long and 300mm in diameter, has been part of the QEII ring main since 1969. This section of pipe has never been connected to a building. This means that no buildings have ever drawn water from the pipe and the pipe has remained charged with water from the ring main, creating a 'dead leg'. The PCH was connected to the ring main at two points approximately 10m and 30m north of the dead leg (see Photograph 6). The water in the dead leg remained largely dormant or subject to very low flows for that period.

The water and residues from the dead leg were tested by ALS Environmental (ALS) and were found to have accumulated heavy metals, sediment and biofilm. Additionally, ChemCentre tested for lead and also found raised lead levels.

The PCH ring main connections are very close to the dead leg (see Photograph 6). Commissioning the PCH plumbing systems increased the water flow in the ring main, which has possibly drawn potentially corrosive water from the dead leg into the PCH.

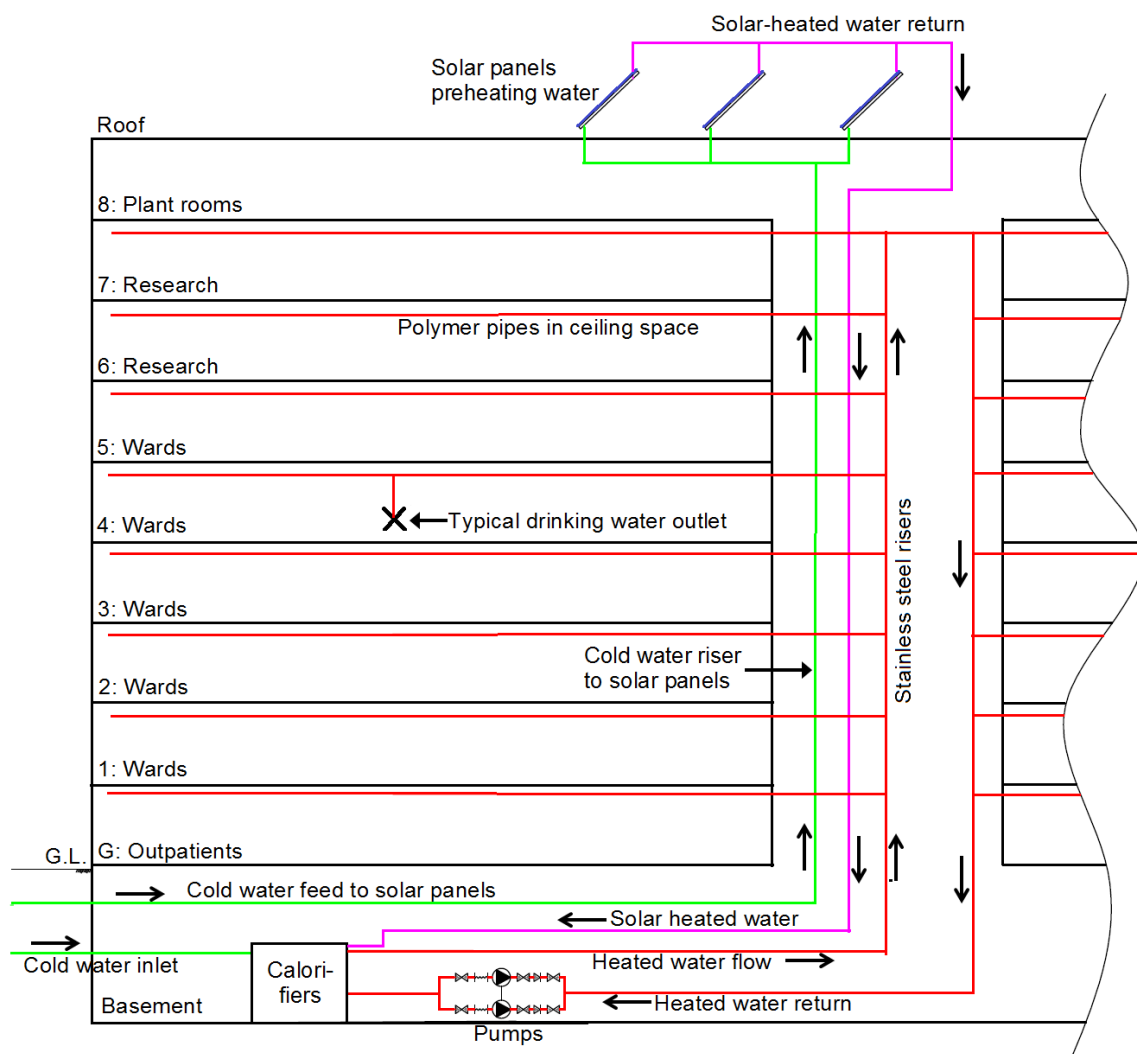
Figure 3: Indicative PCH heated water plumbing diagram

Corrosion has been detected in the stainless steel pipe network in the basement area and the supply pipes to the Central Sterile Supply Department (CSSD).

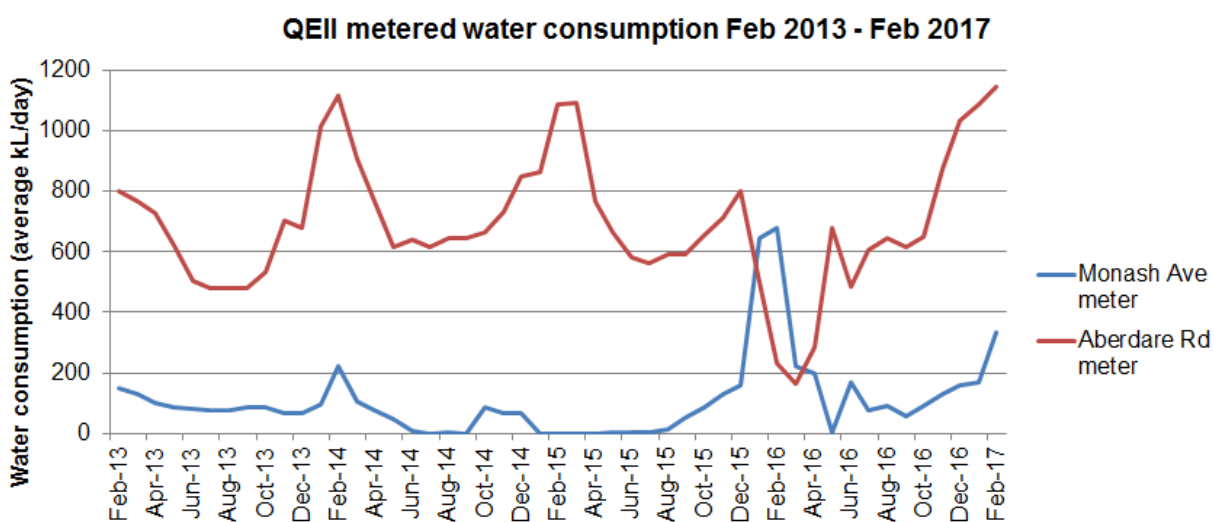
Figure 4: Comparative water flow through the north and south meters into the QEII ring main. (Data supplied by the Water Corporation.)

Flow data for QEII ring main provided by the Water Corporation showed that the southern water supply (Monash Ave) of the QEII ring main was subjected to lower flows of water for an extended period. Almost all the water used in the QEII ring main in 2015 was drawn from the northern (Aberdare Rd) connection. However, in the last months of 2015 the amount of water drawn from the southern connection steadily increased, peaking in early 2016 during the commissioning of the PCH (see Figure 4).

The increased and variable water flow in this previously low flowing section of the ring main (which contains the dead leg) may have disturbed any residues present in the pipe, allowing them to be drawn into the PCH water supply system.

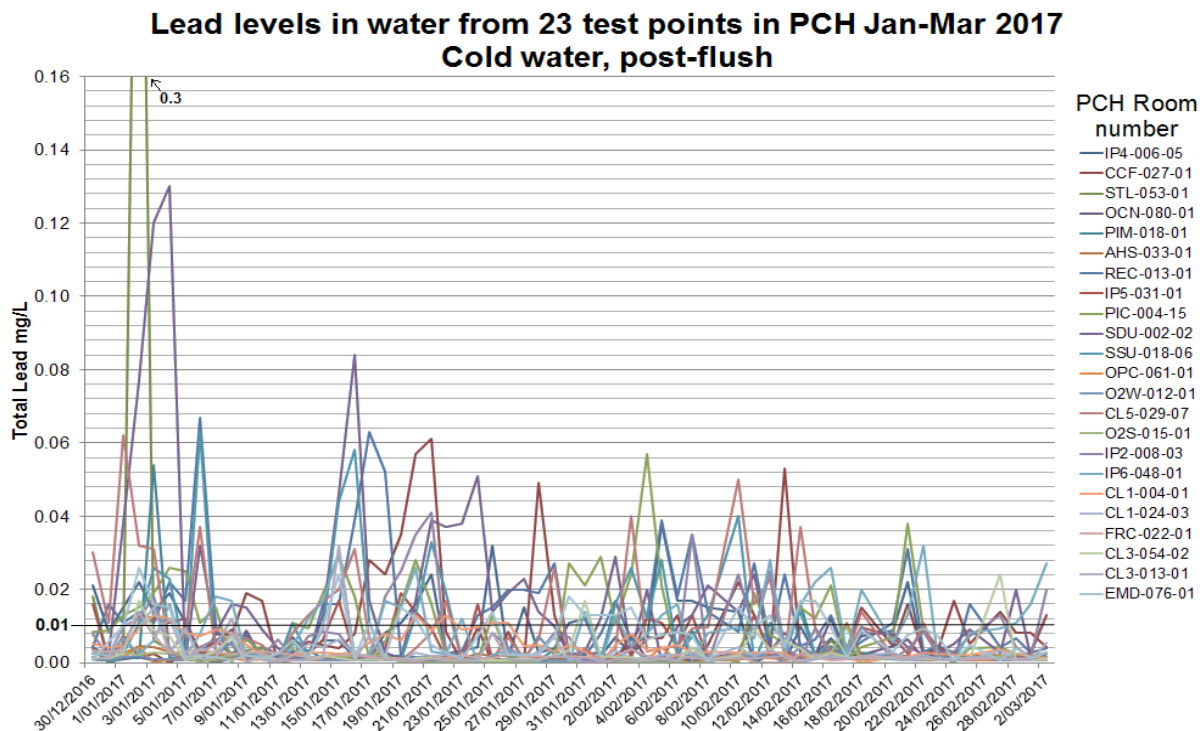
Test results consistently show that lead is present in the water, although variable in its concentration and location. Filters were installed throughout PCH in December 2016 and were operating from mid-January 2017. Test results from January to March 2017 show lead levels in PCH drinking water steadily decreasing, although there are still intermittent readings above the ADWG for lead. More recent test results show higher incidences of lead than the lowest results reported in March 2017.

Graph 1: Lead levels in PCH drinking water for January to March 2017, cold water post-flush. The different coloured spikes indicate that high results are appearing intermittently at many different test locations.

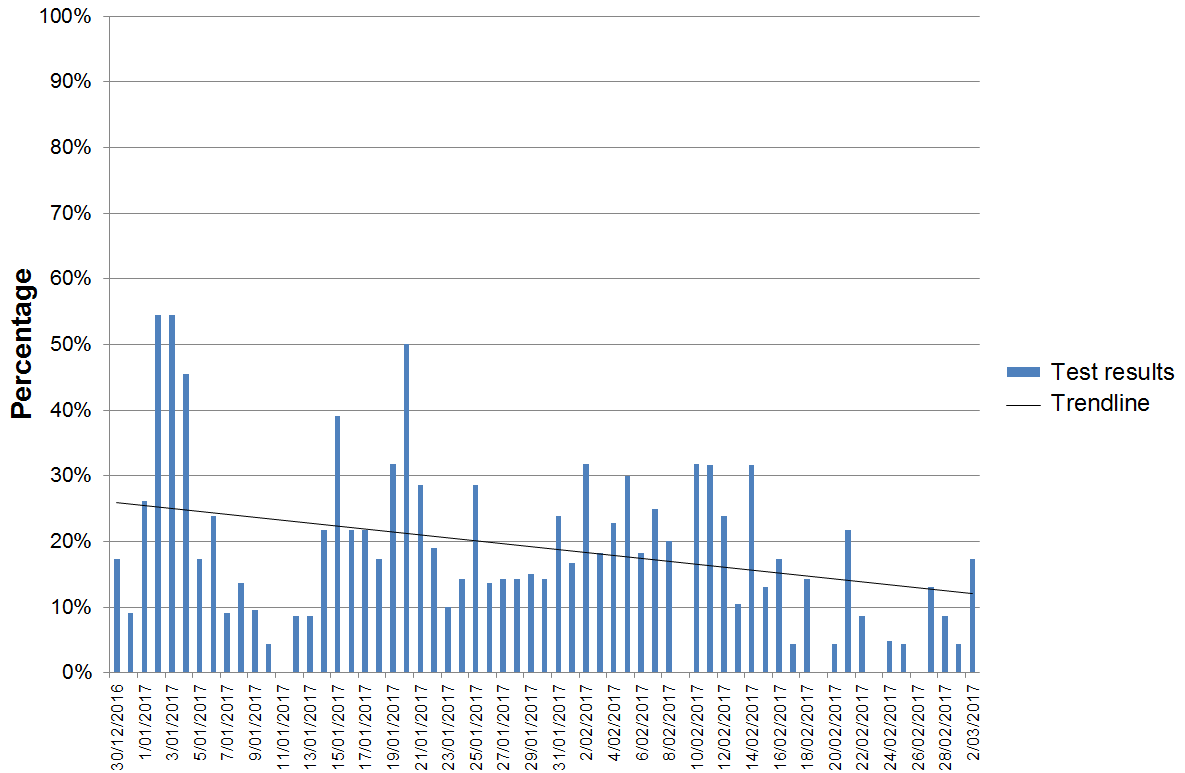
Graph 2 (above): Percentage of cold water, post-flush tests showing lead levels over the ADWG limit from January to March 2017

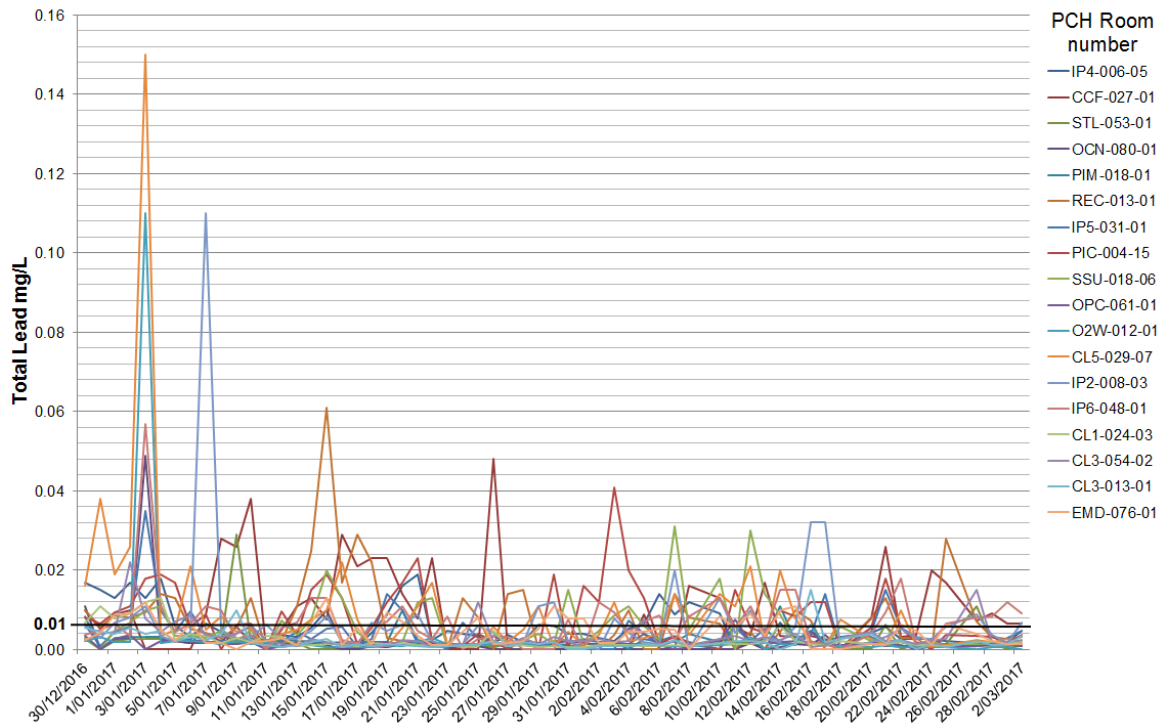
Graph 3 (below): Lead levels in PCH drinking water for January to March 2017, hot water post-flush. Note the different coloured spikes, indicating that high results are appearing intermittently at many different test locations.

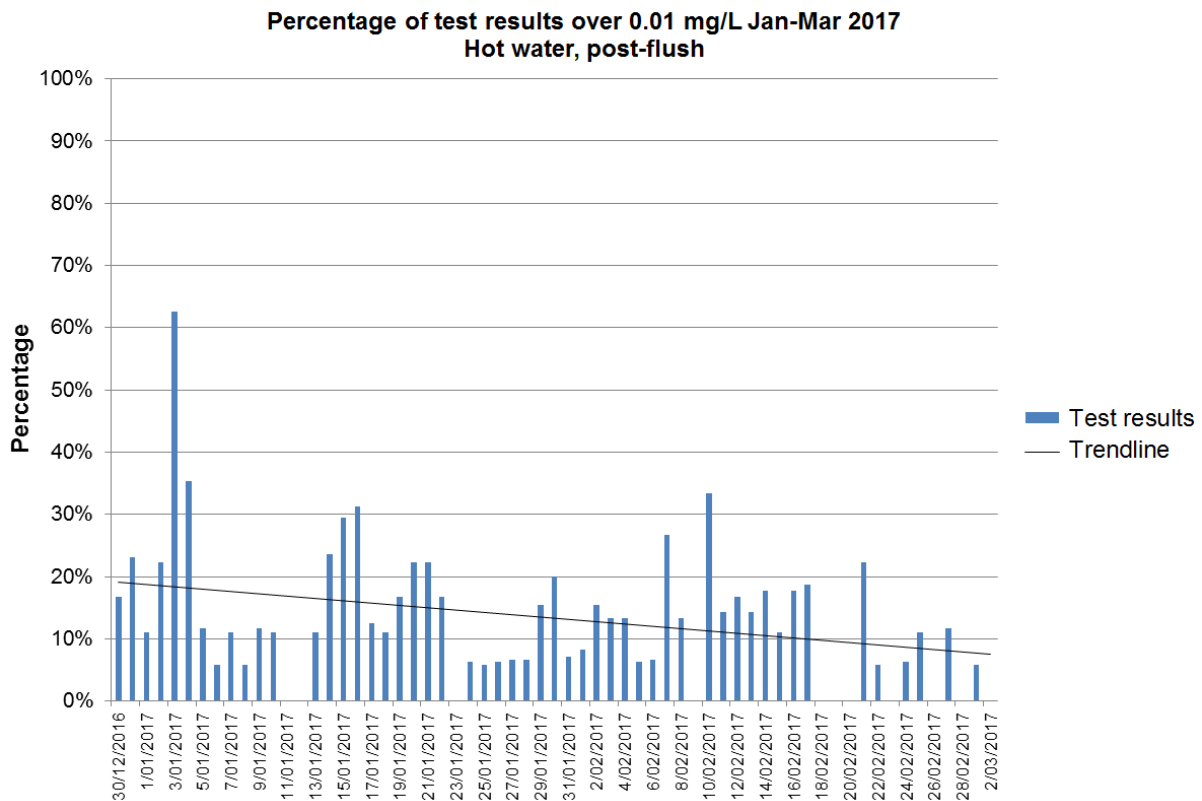
Graph 4: Percentage of hot water, post-flush tests showing lead levels over the ADWG limit from January to March 2017

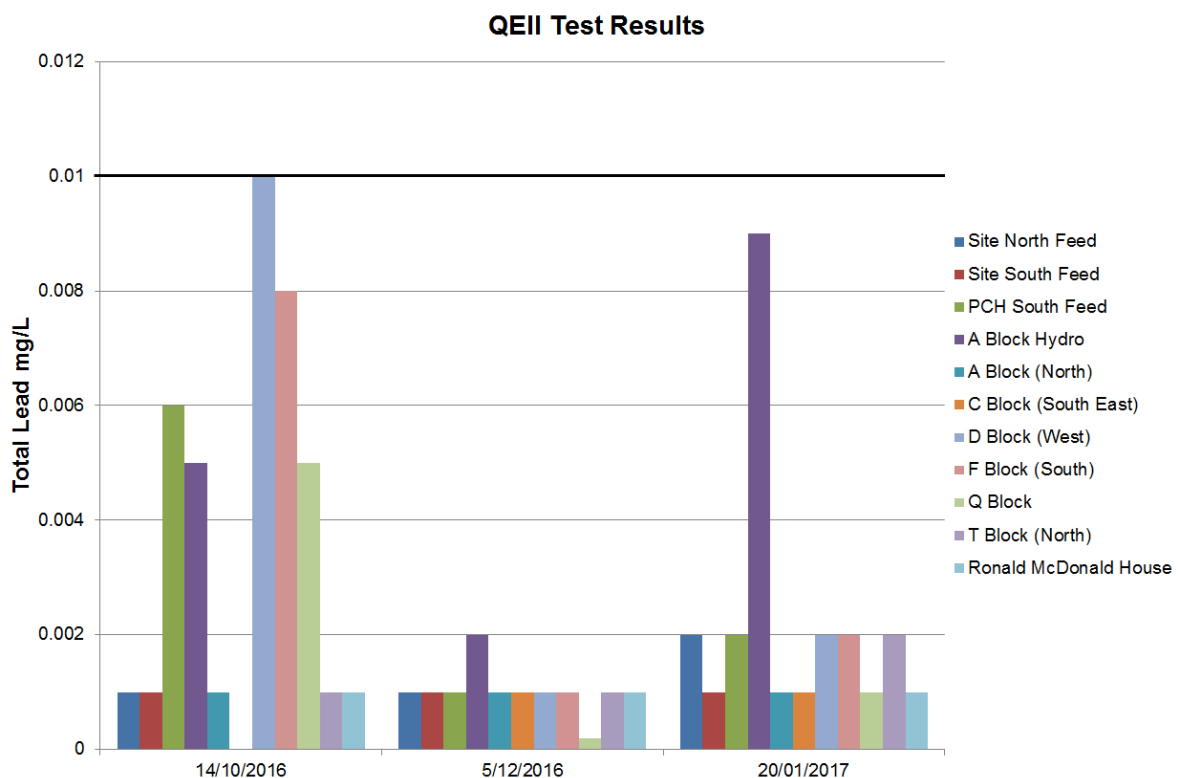
The NMHS has tested water from 11 locations within the QEII Medical Centre. These results show that lead levels in the water supply are all at or below the allowable limit in the ADWG (see Graph 5).

Graph 5: Lead levels for drinking water at 11 test locations throughout QEII Medical Centre, from October 2016 to January 2017

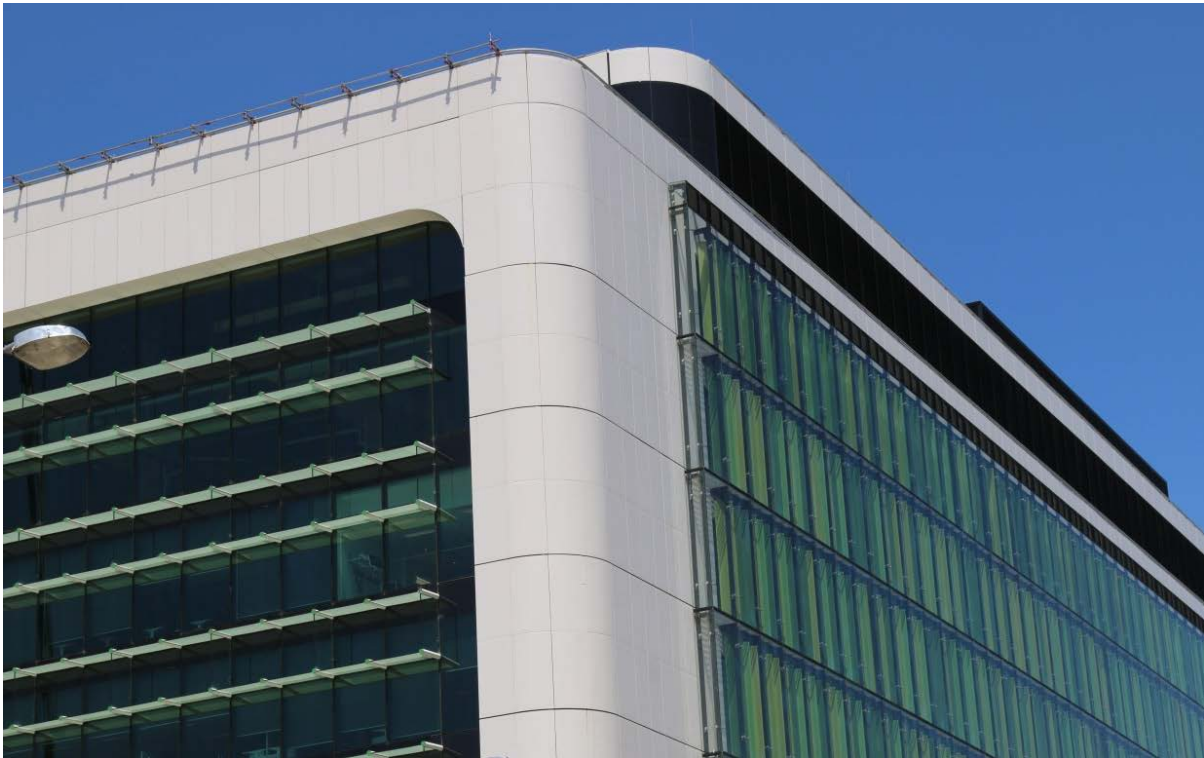
Photograph 13: White vitreous enamel panels at Perth Children's Hospital

A proportion of the vitreous enamel (VE) panels supplied to the PCH were damaged in transport from the factory in China.

The VE panels used on the hospital are a bonded sandwich panel made up of vitreous enamel-coated decarburised steel outer layers with an aluminium honeycomb internal core (see Photograph 13).

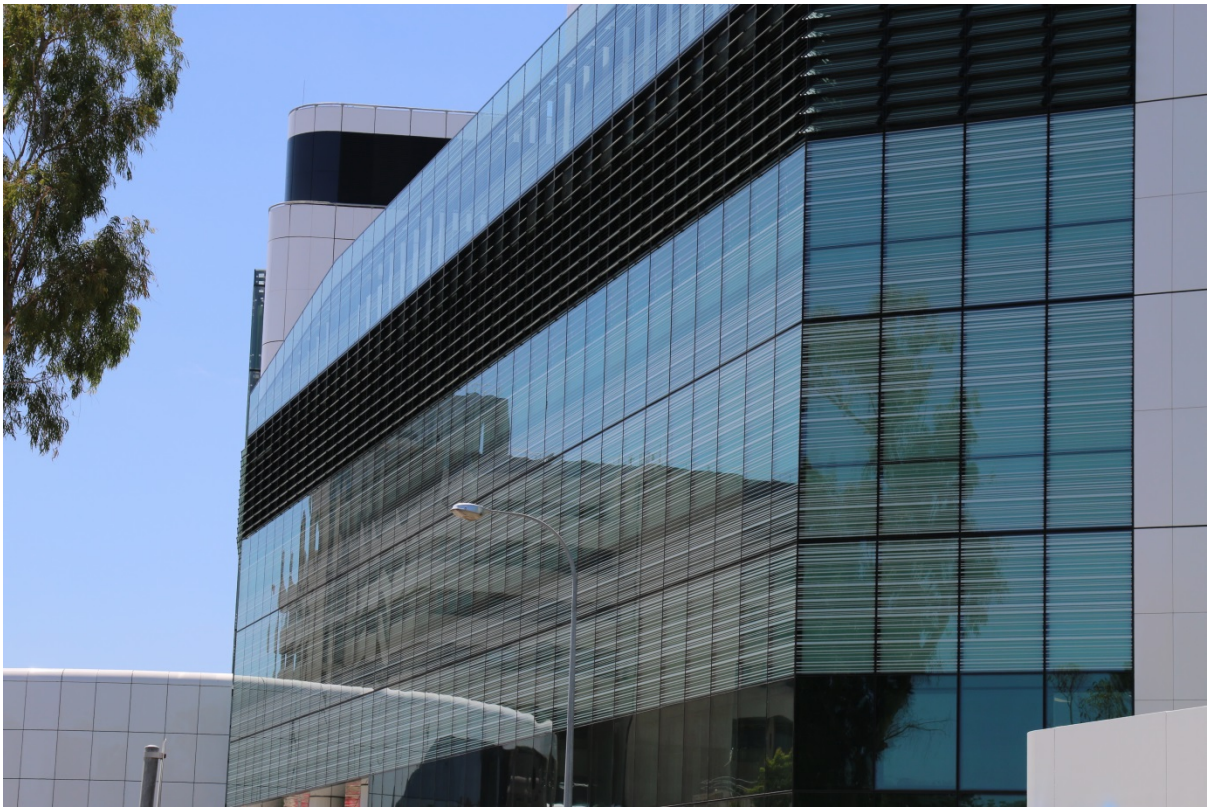
Photograph 14: Curtain wall glazing at Perth Children's Hospital

The Building Commission considers that the glazing meets the relevant requirements of the NCC 2011.
