INTERIM REPORT

Perth Children's Hospital asbestos

An interim report on the discovery of asbestos
within imported atrium roof panel products
used in the construction of the new
Perth Children's Hospital

13 September 2016

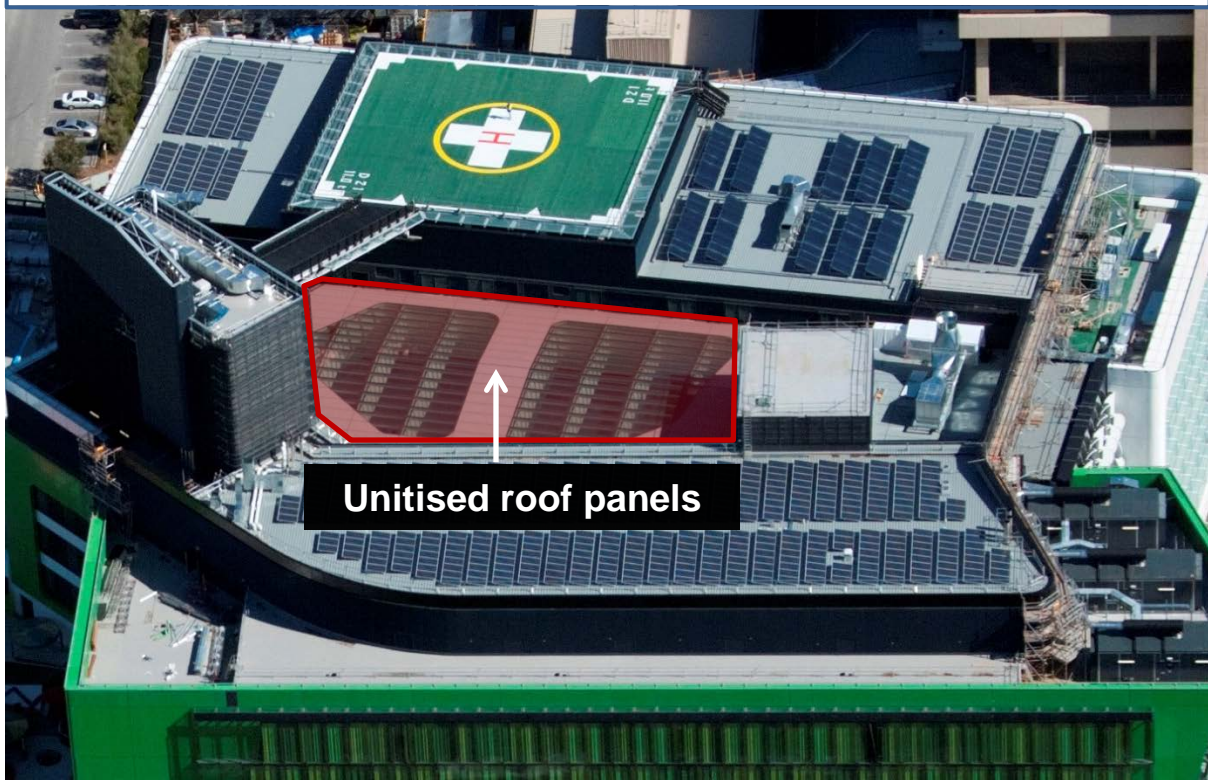
Photograph 2
Helipad at Perth Children's Hospital

The URPs are a bespoke design situated immediately adjacent to the roof-top helicopter landing pad, and over the atrium section, and as such, were required to meet a stringent acoustic performance requirement (see Photograph 2).
