CYCLONE
TESTING
STATION

Shoalwater and Roleystone WA tornadoes
Wind damage to buildings

Geoffrey N Boughton and Debbie J Falck

Report: TR54
August, 2008

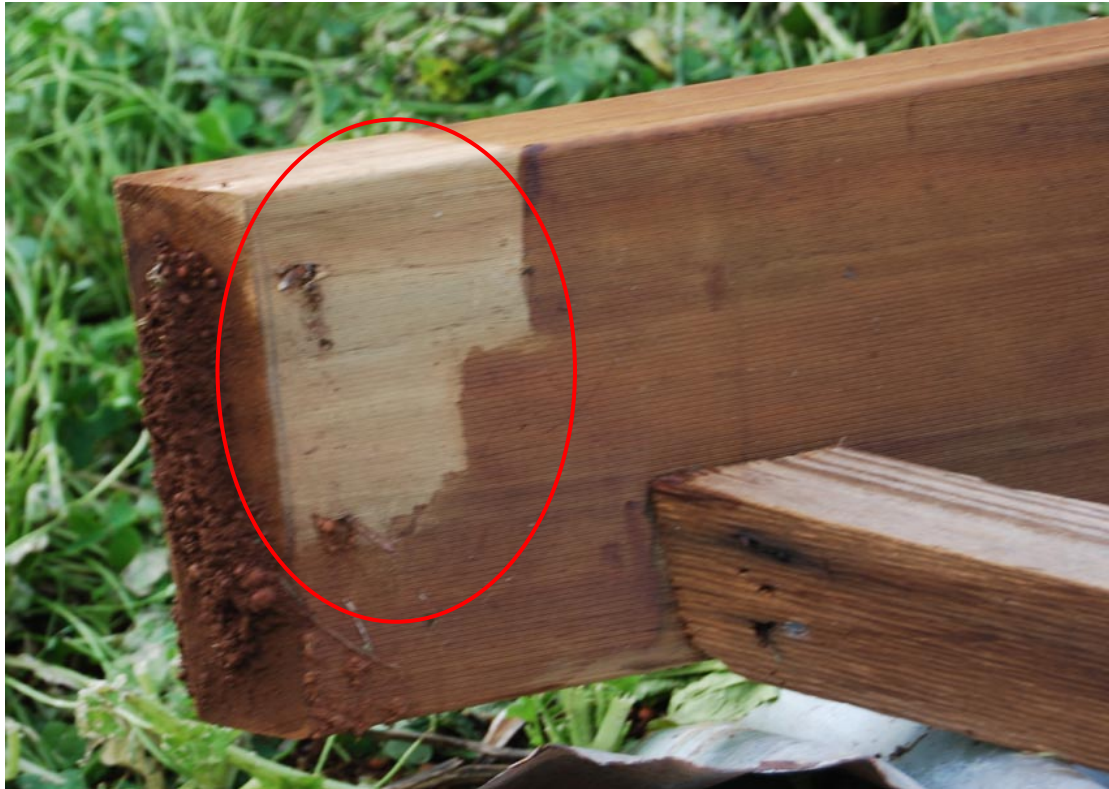
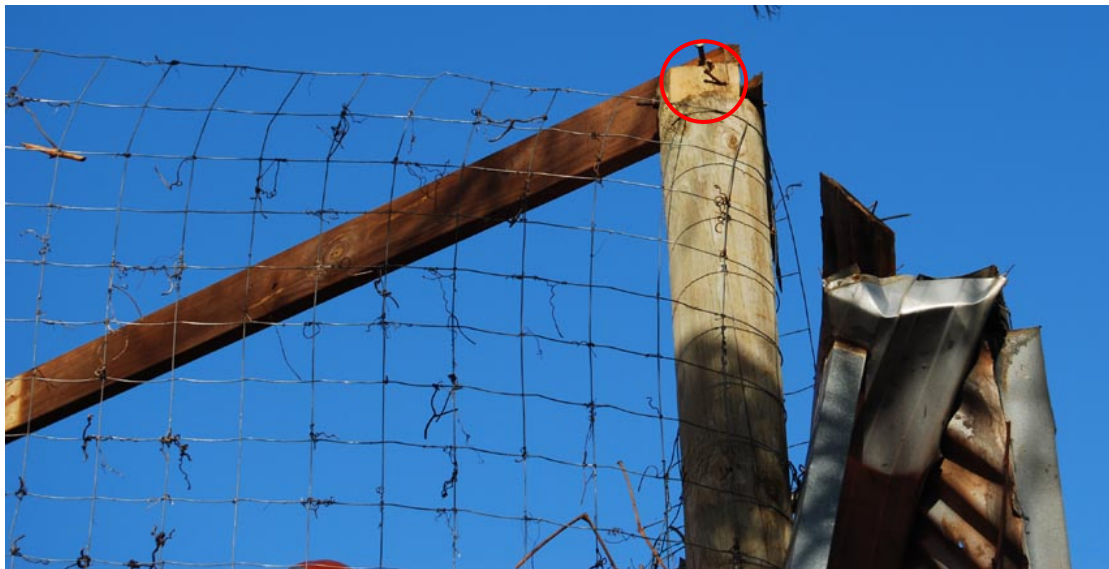
Figure 5.2 Verandah beam to post connection

Figure 5.2 shows a verandah beam to post connection that failed under wind load leading to loss of both the verandah and main roofs. This connection was made with two nails, but two M16 bolts are specified in AS1684.2 [5].

(a) Verandah beam

(b) Verandah post

The information required to correctly select and apply this detail is outlined in AS1684.2 [5]:

- The wind classification of the house is found from AS4055 [2].
- Table 9.13 in AS1684.2 [5] can be used to select a force from the roof type, wind classification, roof load width, and spacing between beam to post connections.
- Table 9.20 in AS1684.2 [5] can be used to select appropriate connections to resist wind uplift forces.
