**Automated Vehicles and the Readiness of Western
Australian roads (Phase 2): Suitability of WA
roads for Lane Departure Warning systems**

RR 19-07

**CURTIN-MONASH
ACCIDENT RESEARCH CENTRE**

March 2019

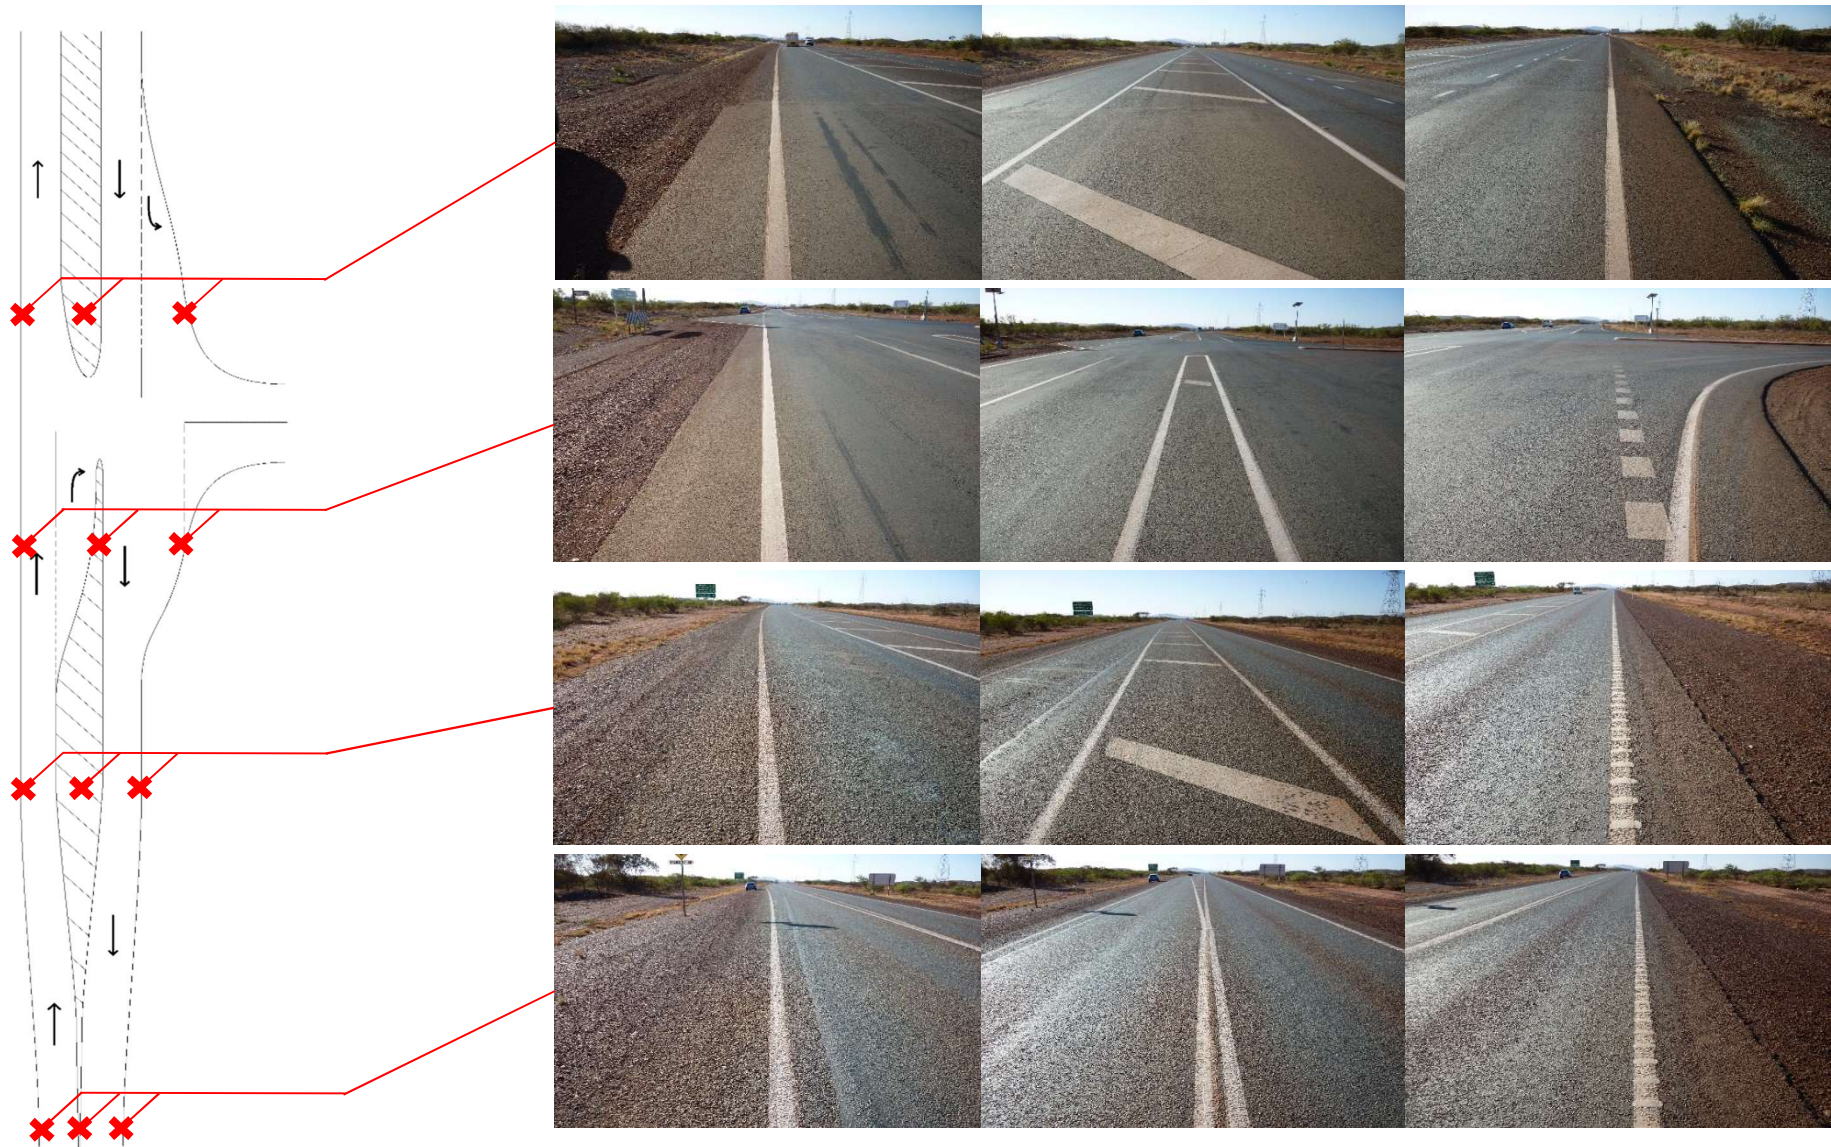
Figure 2.15 **Site 4 photographs and layout map – facing northbound**

Site 4 has a complex mixture of centrelines including median sections, turning lane lines and double two-way barrier lines. The edge lines are also varied with sections of conventional, continuity sections and audio-tactile longitudinal edge lines. This site was chosen because it has a painted median and complex layout. The lane markings were clear during day and night testing, and the road had shoulder widths suitable for line-crossing testing.

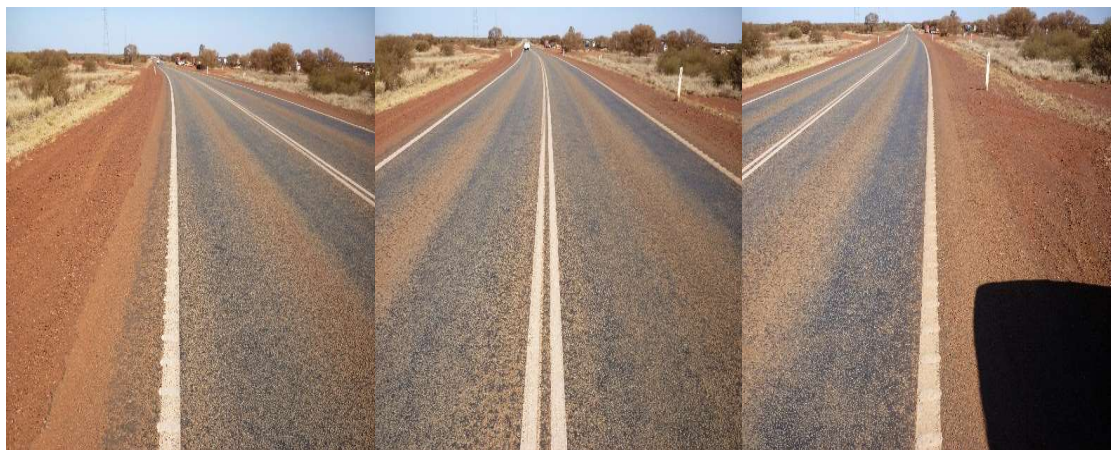
Figure 2.16 Site 5 photographs – facing southbound

Site 5 has a double two-way barrier centreline with gaps, and audio-tactile longitudinal edge lines with continuity (broken) line sections for entries to rest areas. It was chosen specifically for the change in line type between audio-tactile and continuity lines and the gaps between double two-way barrier centreline sections. Interestingly, there were some large tyre marks noted by the field-team at this site, as can be seen on the site scan. The road had some changes in bitumen colour, but the lines were clear throughout day and night testing.

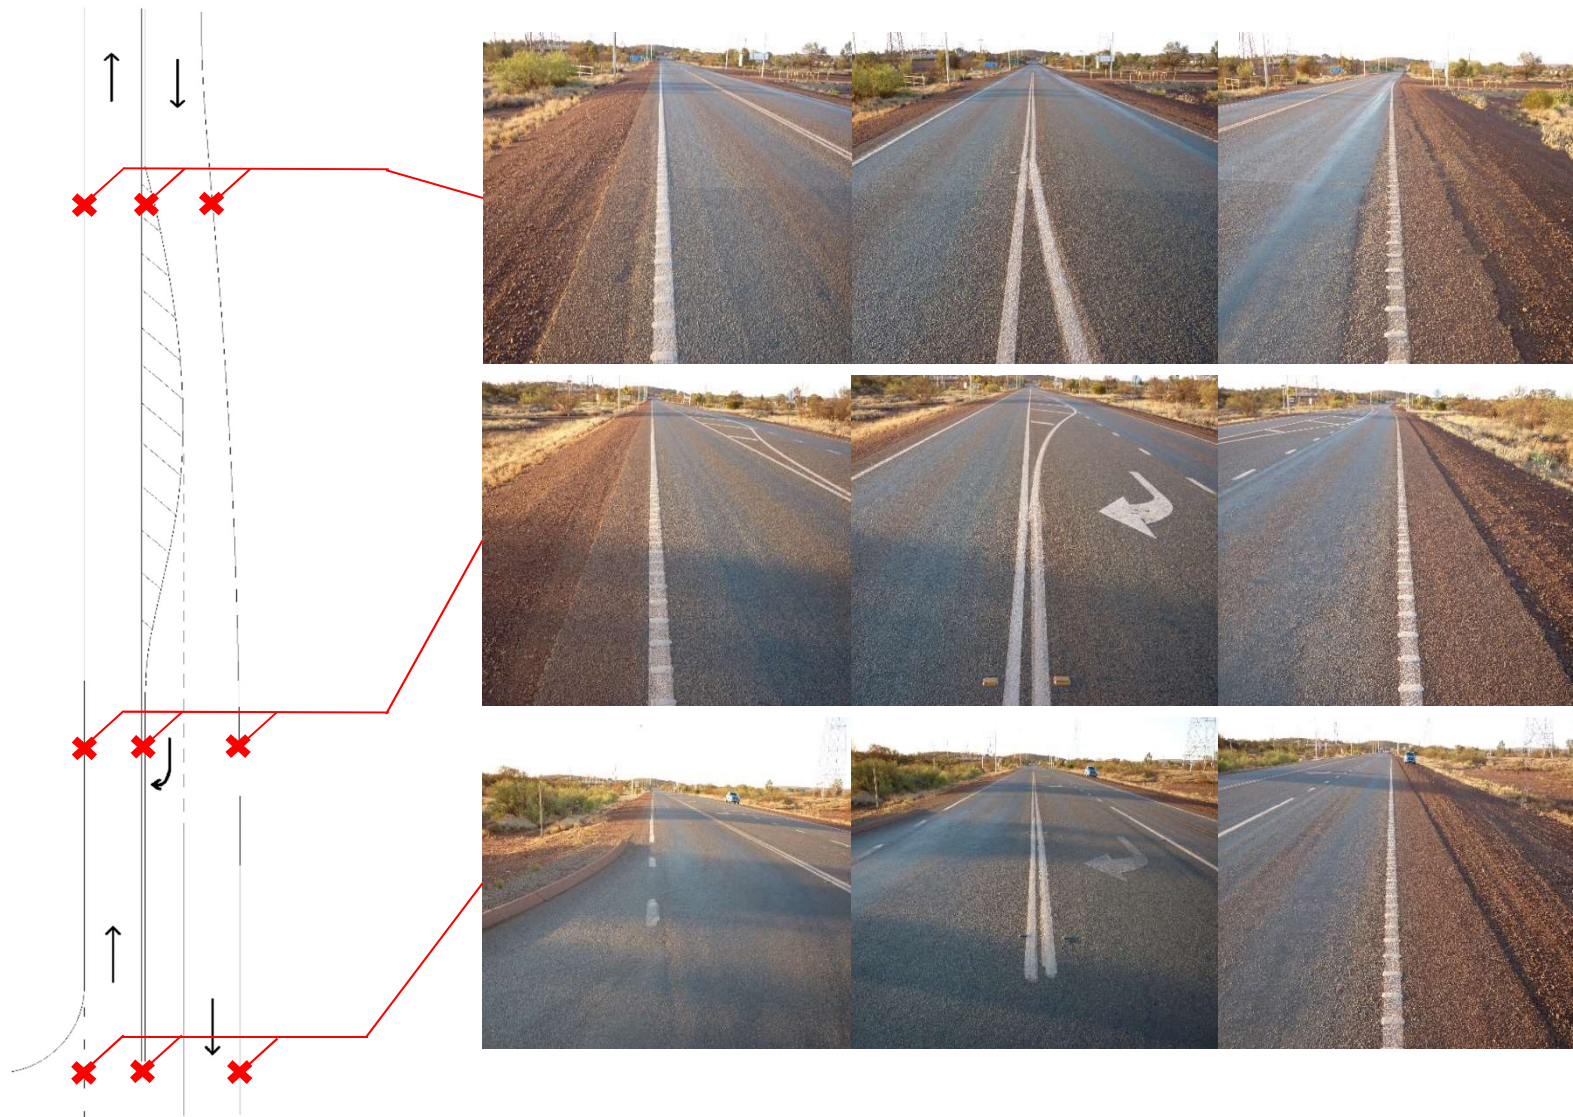
Figure 2.19

Site 6 has a complex mixture of centrelines including double two-way barrier, broken separation lines and median sections, with audio-tactile longitudinal edge lines. The site was selected for its audio-tactile longitudinal edge lines. This site also contained multiple pseudo lines that seemed to be previous lane markings that were painted over with black paint, causing some issues for the LDW system, which are discussed further in Section 4.3. The white lines at this site were clear to the field-work team both during day and night testing.

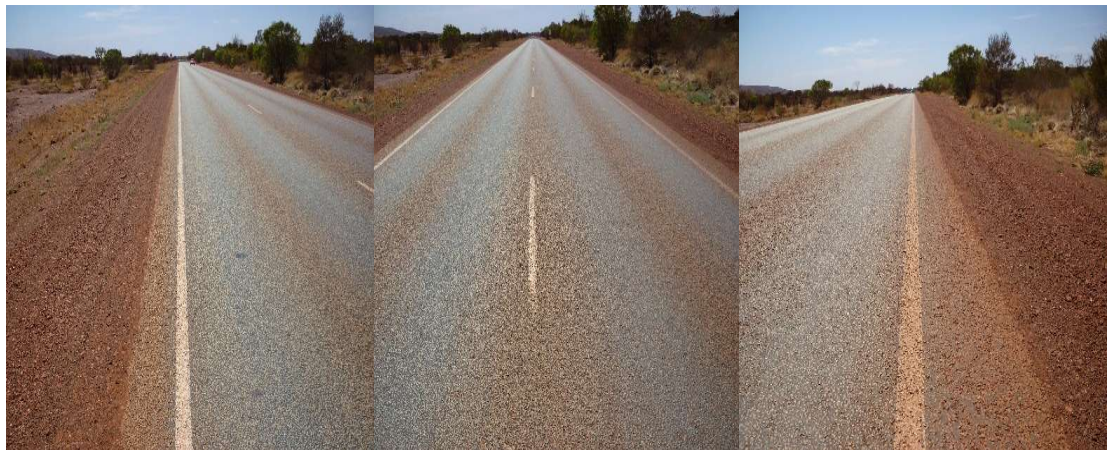
Figure 2.20 Site 7 photographs - facing southbound

Site 7 has a broken separation centreline and conventional edge lines. The site was chosen due to the presence of the red pindan and the faded edge line due to heavy vehicle traffic. The field-work team noted that the northbound edge line was more faded than the southbound edge line. During night testing the faded characteristic in the edge lines was not obvious.

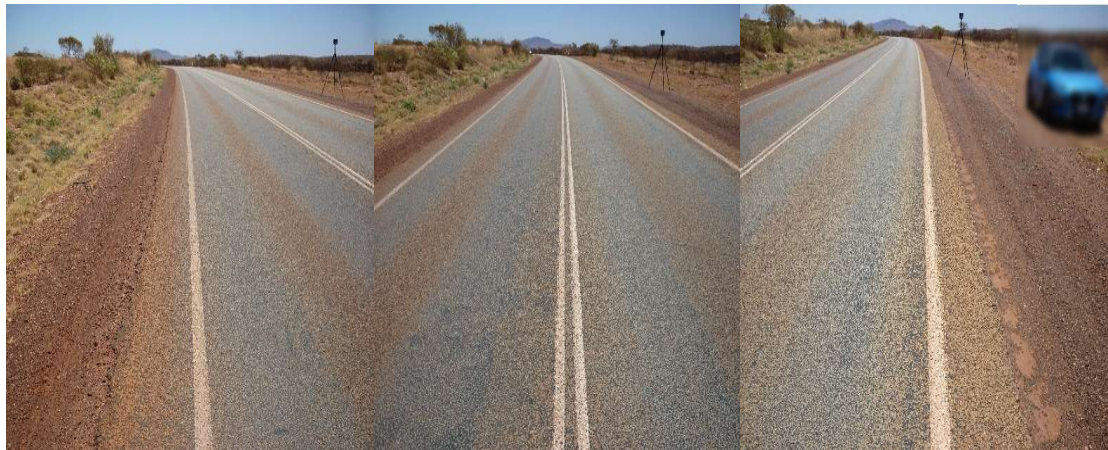
Figure 2.22 Site 8 photographs – facing southbound

Site 8 has a double two-way barrier centreline with conventional edge lines. It was located on a slightly curved road and selected for the presence of the red pindan and its apparent faded edge line due to heavy vehicle traffic. The field-work team noted that the lines were not as faded as other lines categorised as ‘faded’. The lines were clear both during daytime and night time testing. The team also noted that the red pindan was not as strong as at other sites.

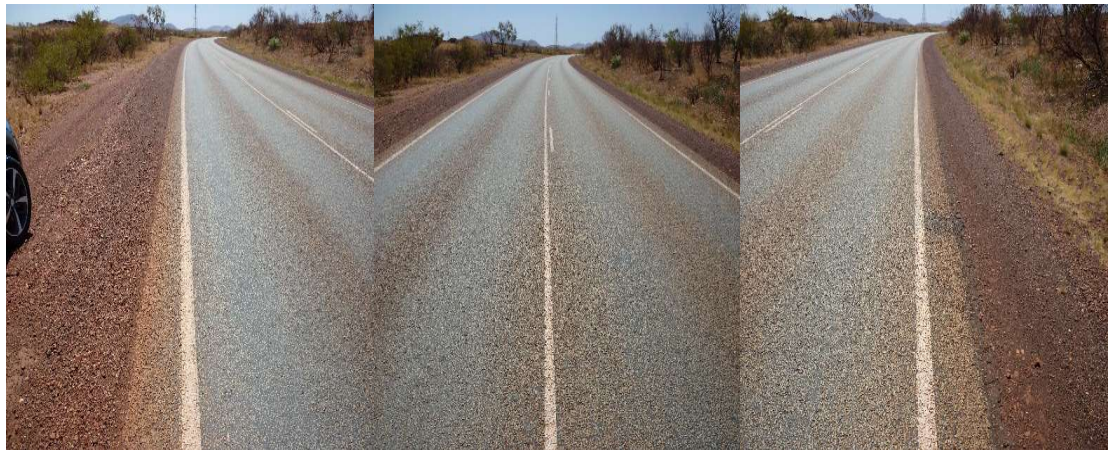
Figure 2.24 Site 9 photographs – facing northbound

Site 9 has a double one-way barrier centreline (broken in the southbound direction) and conventional edge lines. This site was selected for the presence of red pindan and its faded edge lines due to heavy traffic. The road shoulders are narrow and only provided a small distance to perform line-crossing events. The field-work team noted that the lane markings were easy to see, did not seem affected heavily by the red pindan and were not faded during both day and night testing.

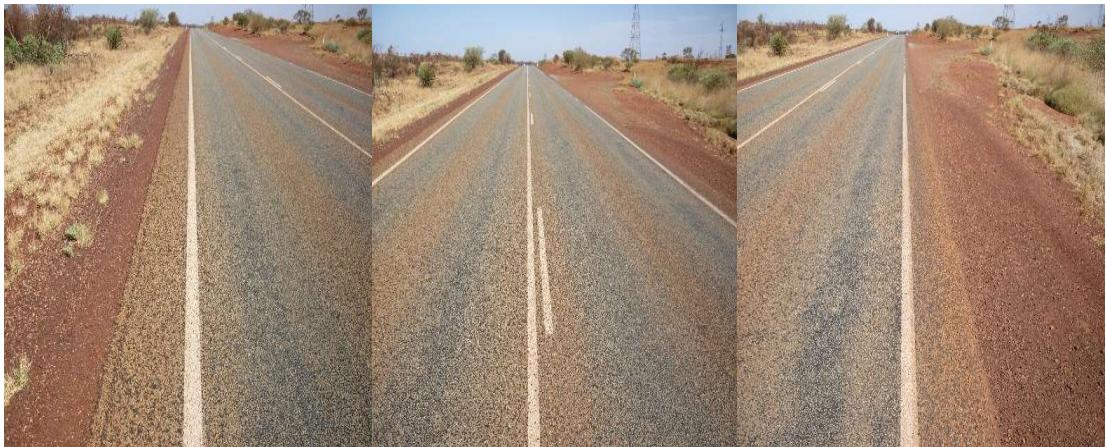
Figure 2.26 Site 10 photographs – facing southbound

Site 10 has a double one-way barrier centreline (broken in the northbound direction) and conventional edge lines. It was chosen for the presence of red pindan and for its severely faded edge lines due to heavy traffic. However, the field-work team noted that the edges were not obviously faded, and that the red pindan was also not very evident. This site also had a rest area entry point for which the edge line transitioned to a broken line for a short distance. The lane markings were clear during both day and night testing.

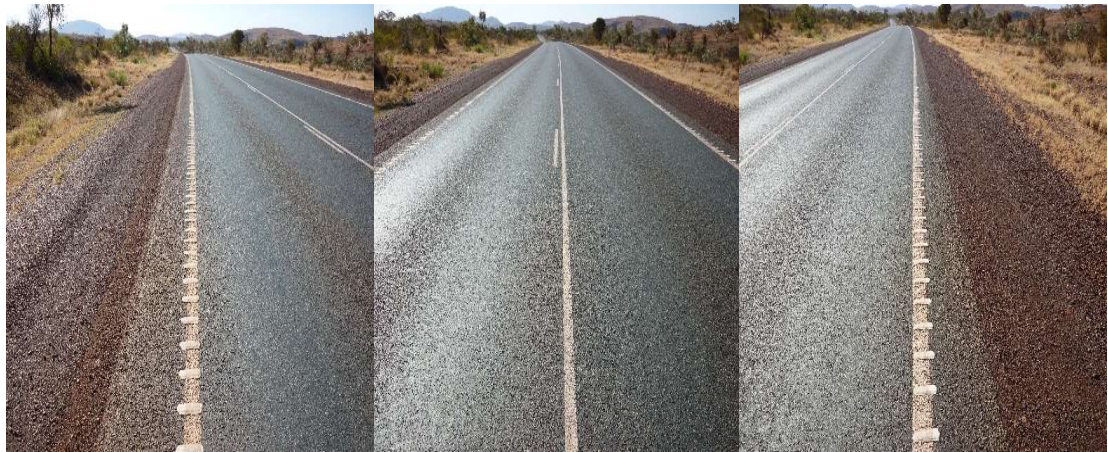
Figure 2.28 Site 11 photographs – facing southbound

Site 11 has a double one-way barrier centreline (broken in the southbound direction) and audio-tactile longitudinal edge lines. This site was chosen for the presence of red pindan, and for its audio-tactile longitudinal edge lines. The field-work team noted that the audio-tactile longitudinal edge lines provided a strong vibrating sensation to the vehicle when performing a line-crossing event. The red pindan was not noted to be evident as the lines were clear to the team during day and night time testing.

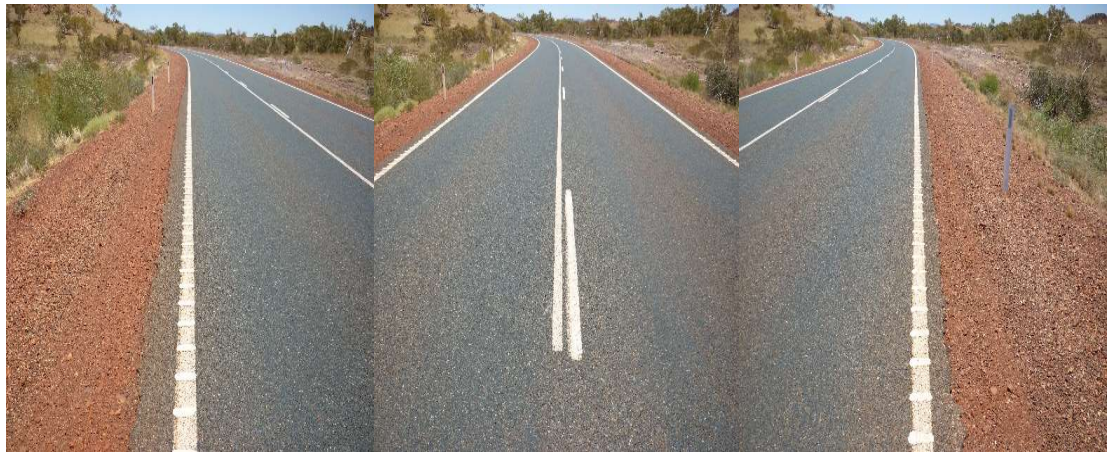
Figure 2.30 Site 12 photographs – facing northbound

Site 12 has a double one-way barrier centreline (barrier in the southbound direction) and audio-tactile longitudinal edge lines. The site was chosen due to the red pindan presence, but the field-work team noted that there was minimal sign of a change in appearance of the line colour. The lane markings were noted to be very evident during day testing, and the shoulder widths were noted as small. There was no night testing completed due to time constraints.

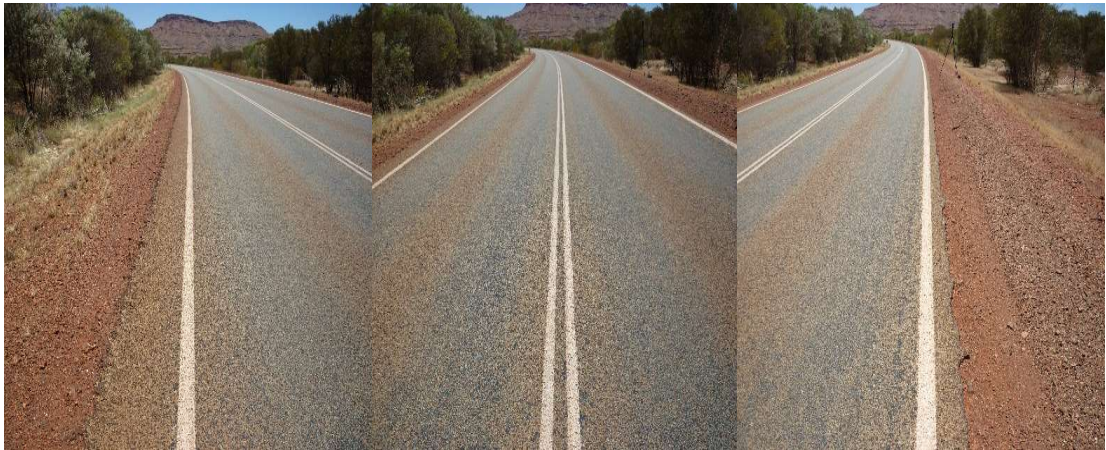
Figure 2.32 Site 13 photographs – facing southbound

Site 13 has a double two-way barrier centreline and conventional edge lines. It was positioned on a long curving road. This site was specifically chosen due to the presence of red pindan dust. However, the field-work team noted that the red pindan was not very apparent and that the lines were clear during day testing. This site was not tested at night.

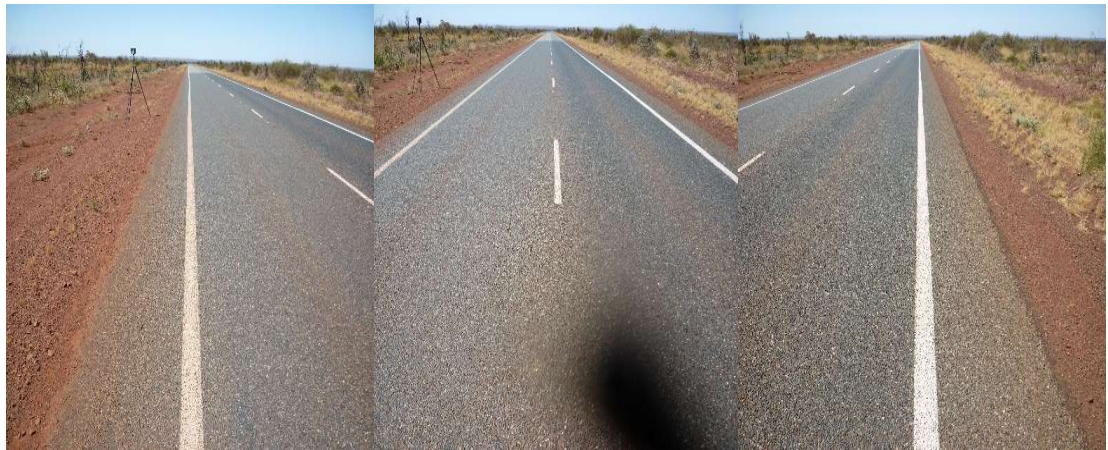
Figure 2.34 Site 14 photographs – facing southbound

Site 14 has a broken separation centreline and conventional edge lines. It was on a long straight road with ample sight distance. The shoulder widths were suitable for line-crossing events and the lane markings were clear even though the site was selected for the red pindan presence. Night testing was completed at this site.

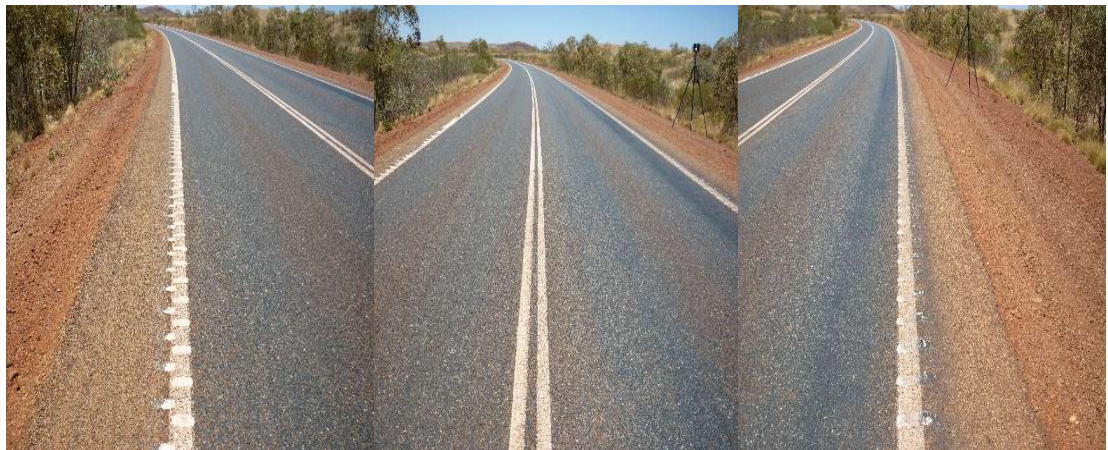
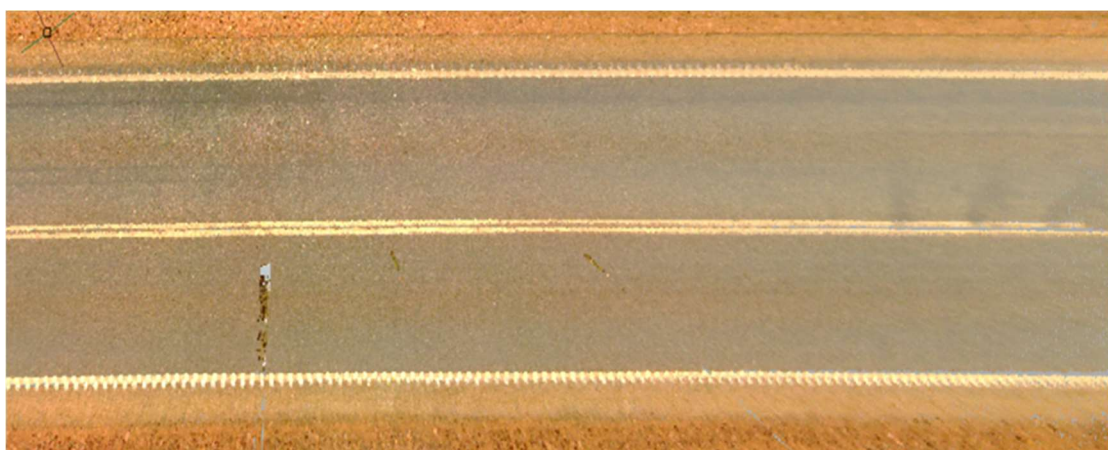
Figure 2.36 Site 15 photographs – facing southbound

Site 15 has a double two-way barrier centreline and audio-tactile longitudinal edge lines. It was chosen for the presence of red pindan, but the field-work team noted that the red pindan was not very evident. The shoulders, however, were a close colour to the dirt on the roadside. The lines were clear to the team during day testing. This site was not tested at night conditions.

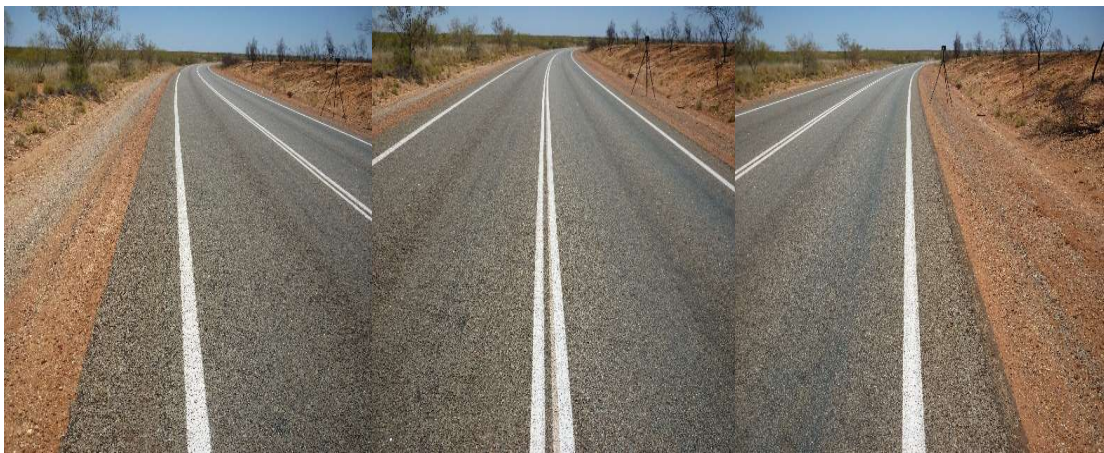
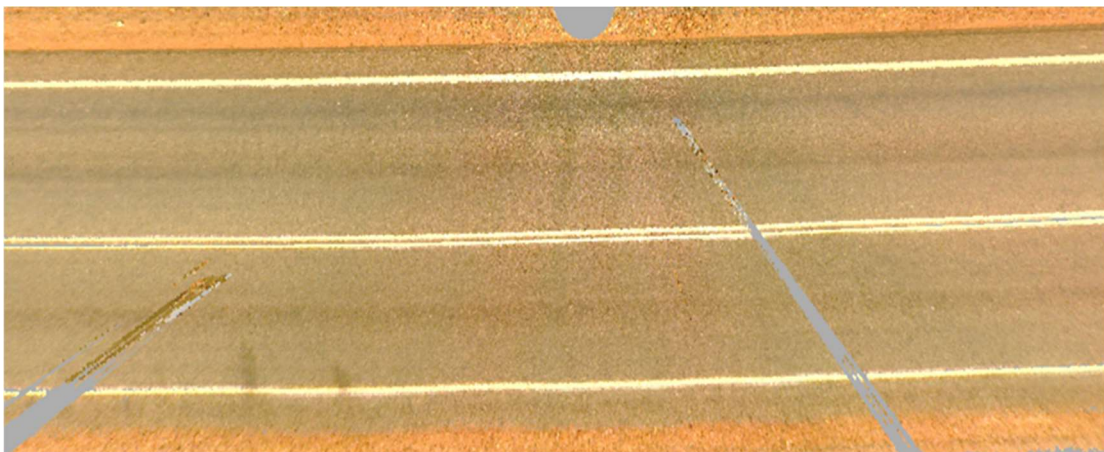
Figure 2.38 Site 16 photographs – facing southbound

Site 16 has a double two-way barrier centreline and conventional edge lines. This site was chosen due to its apparent faded edge line, although the lane markings were noted to be very evident. No night testing was completed for this site.

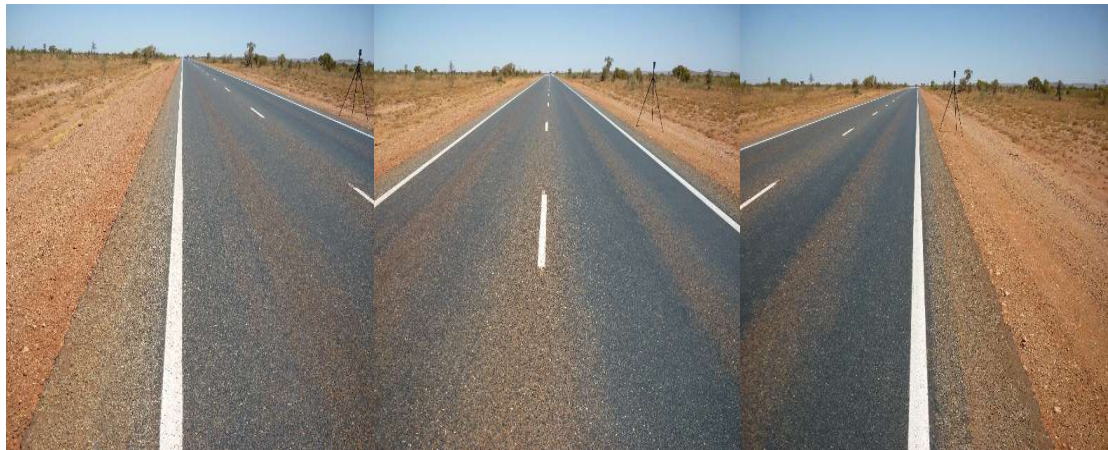
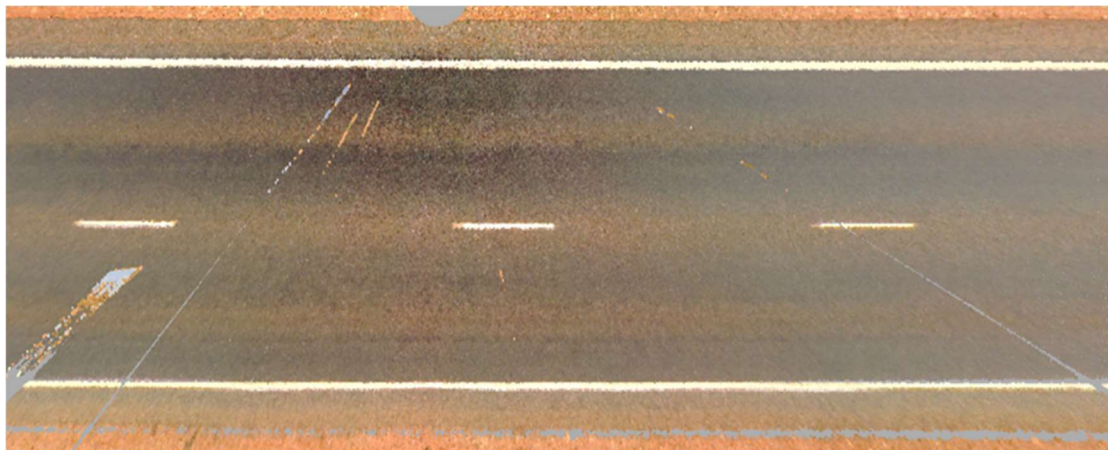
Figure 2.40 Site 17 photographs – facing southbound

Site 17 has a broken separation centreline and conventional edge lines. It was located on a long stretch of straight road and was chosen for its apparent faded edge line. However, the field-work team noted that the lane markings did not seem faded and were very evident during both day and night testing.

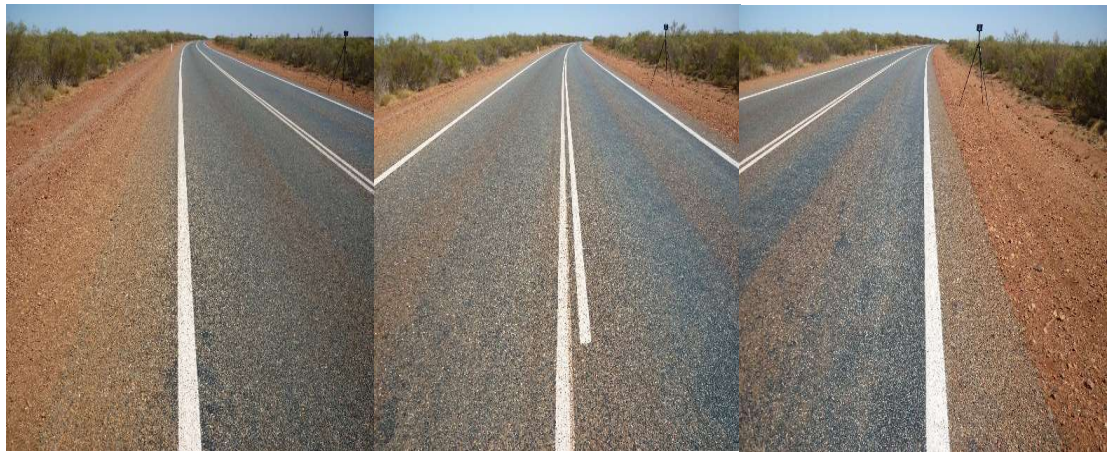
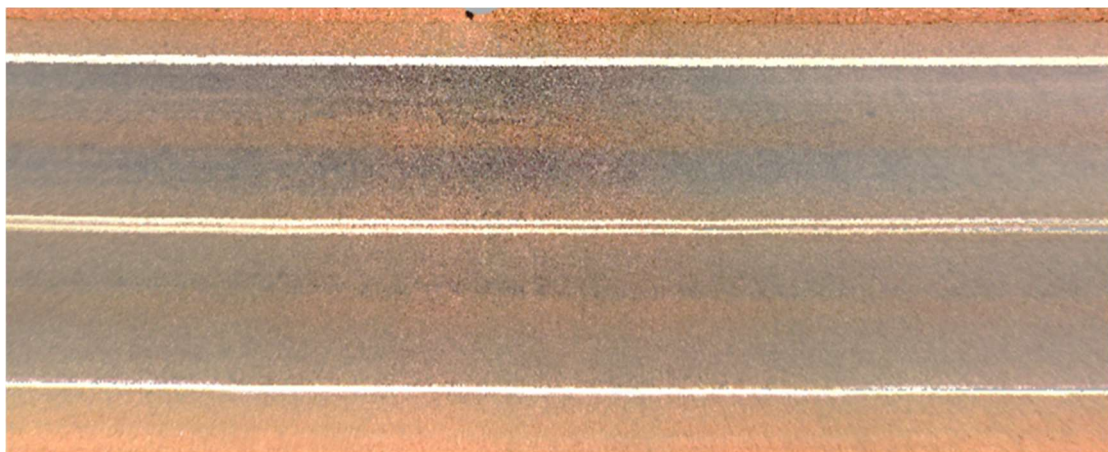
Figure 2.42 Site 18 photographs – facing southbound

Site 18 has a double two-way barrier centreline and conventional edge lines. This site was specifically chosen due to the presence of red pindan dust. However, the lines were noted to be very clear during day and night testing and were not affected greatly by the red pindan.

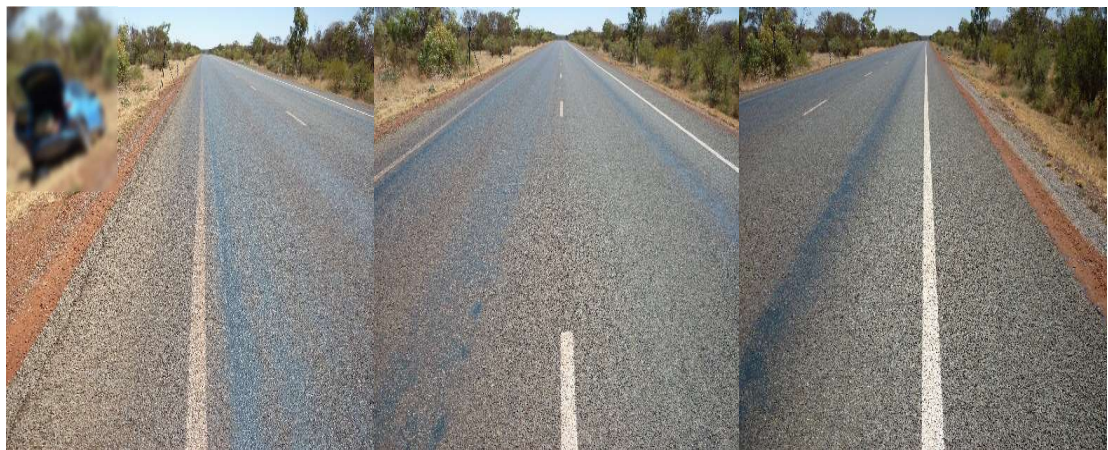
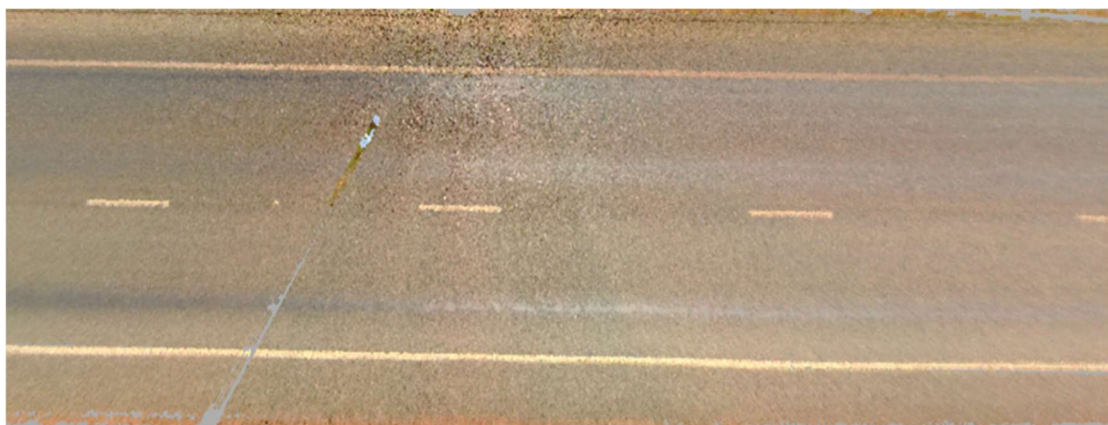
Figure 2.44 Site 19 photographs – facing southbound

Site 19 was discovered while travelling between Site 14 and Site 15. It was selected by the field-work team to be tested because of its severely faded edge lines. It seemed that the edge lines were faded due to heavy traffic as the site was located just after a curve where it was common for heavy vehicles to take the inside of the corner (hence the line being faded only on one side). The site had a broken separation centreline and conventional edge lines. This site also had evidence of the red pindan dust affecting the colour of the white lines.

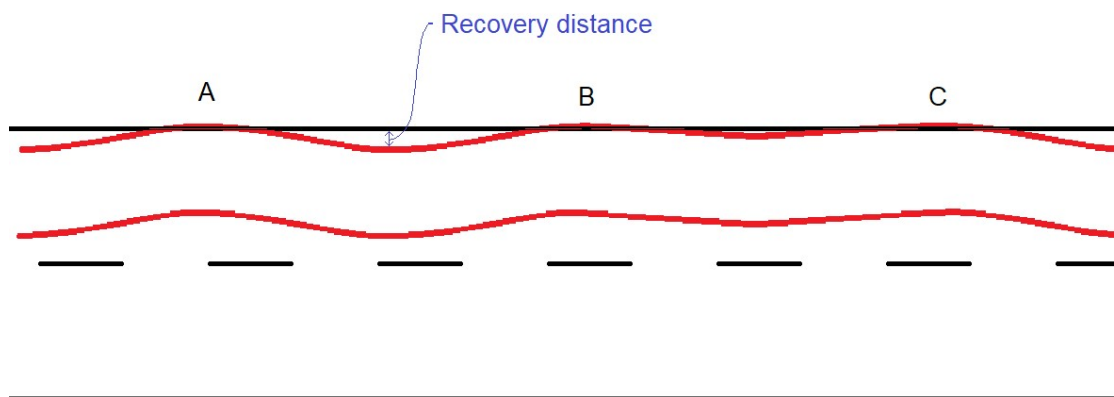
Figure 3.3 Wheel path of trial vehicle demonstrating recovery distance

Figure 3.3 demonstrates an example wheel path of the trial vehicle (shown in red) where the recovery distance was short. Crossing events 'A' and 'B' in the diagram are successful but crossing event 'C' is not successful due to the lack of recovery distance between events 'B' and 'C'.

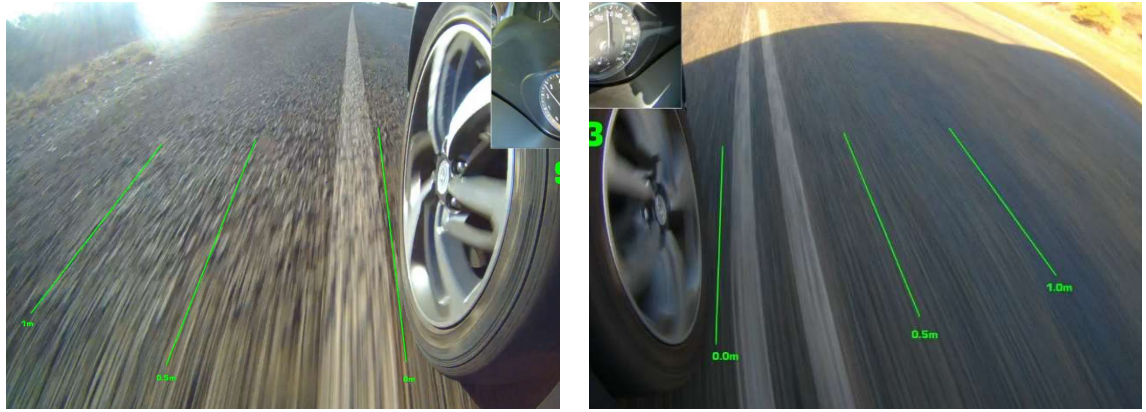
Figure 3.4 Examples of recovery distance before LDW non-activation

Screenshots of some of the maximum recovery distances are shown in Figure 3.4. It is likely that the lack of recovery distance was a contributing factor to the absence of the LDW activation.

In the post-processing analysis, this was classified as a forced error.
