Restoring the Health of the Little River:

Riparian Survey and Management Recommendations for the Little River Catchment near Denmark, WA.

A Report prepared for the
Denmark Environment Centre.

by Apace Green Skills

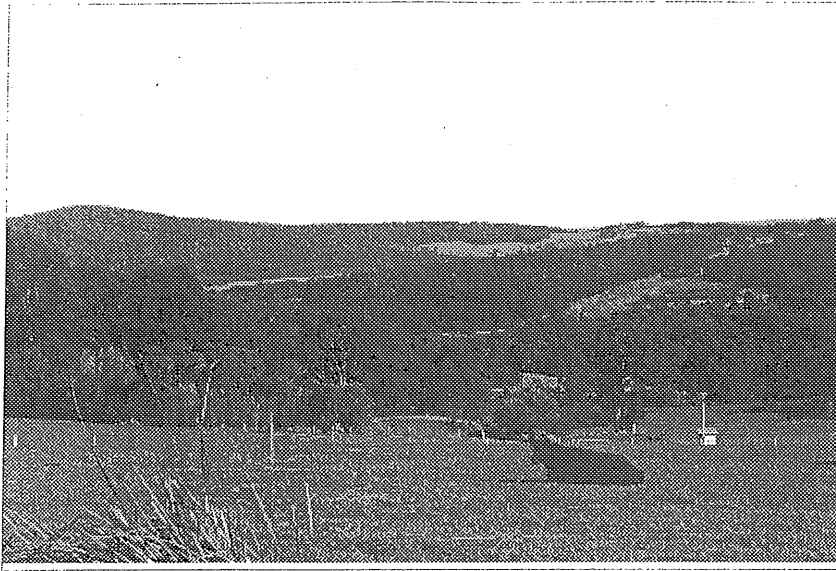
General view over Little River Valley from Mt Shadforth Road, looking south, with Mt Hallowell in the background. Significant areas of high quality remnant forest remain in the catchment.

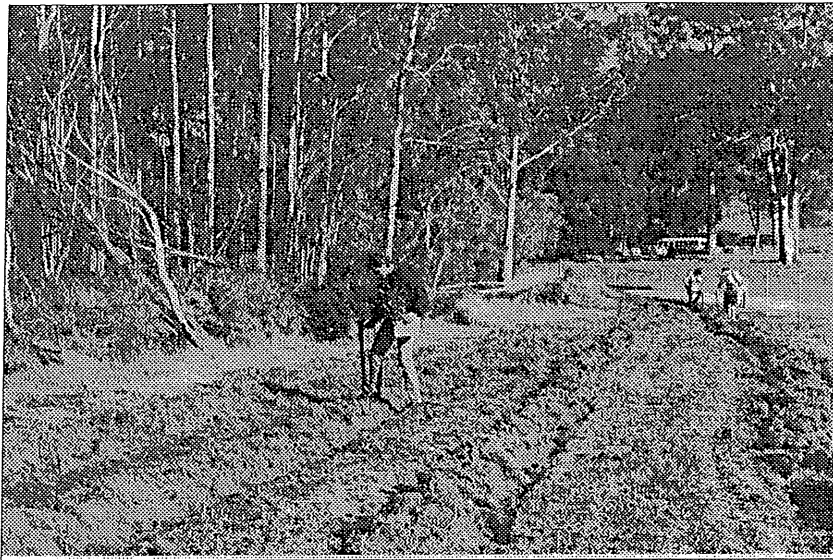
Tree planting in progress on ripped, mounded and sprayed revegetation site next to the Little River, close to the Broken Bridge vineyard site (July 1994). Apace Green Skills and the Denmark Environment Centre established a range of native trees and shrubs on this site, including Karri (Eucalyptus diversicolor), Yate (Eucalyptus cornuta), Golden Wreath wattle (Acacia saligna) and WA Peppermint (Agonis flexuosa). Shire of Denmark fencing subsidies were used to assist the landholder with fencing material costs, and trees were provided through Greening Western Australia's Plants for Conservation Program.

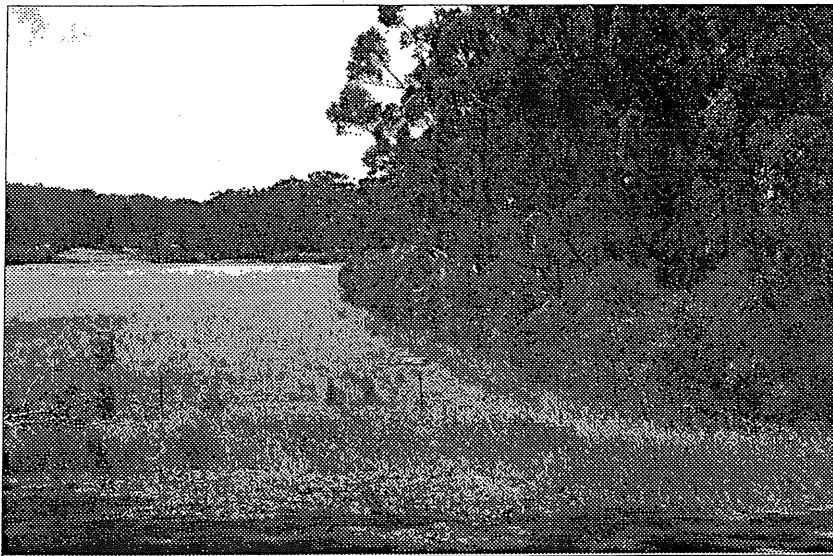
The same site (from a different view), photographed 29 months later, showing successful survival and growth rates. (November 1996).

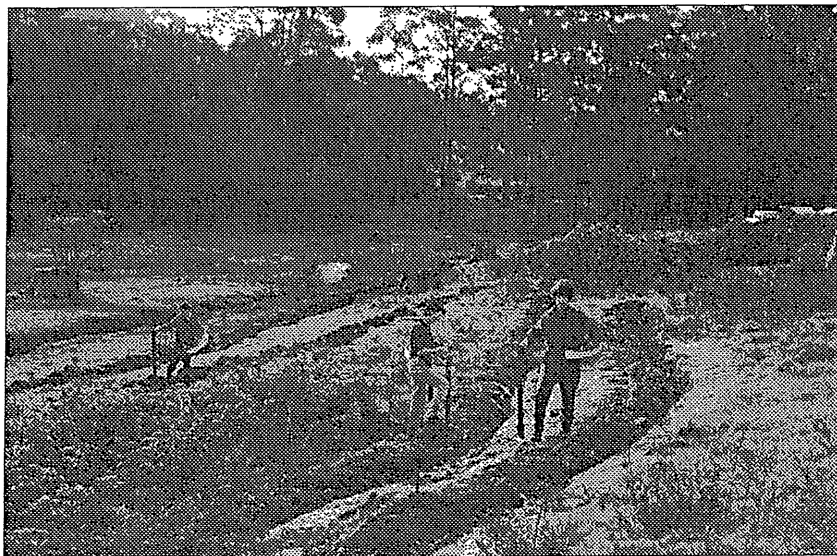
Tree planting adjacent to Little River in July 1996, coordinated by Apace Green Skills, with assistance from the Shire of Denmark and Wilson Inlet Management Authority. This site provides a buffer between Broken Bridge vineyard and the river. A wide variety of local tree and shrub species, grown at the Shire revegetation nursery, was planted at that time.

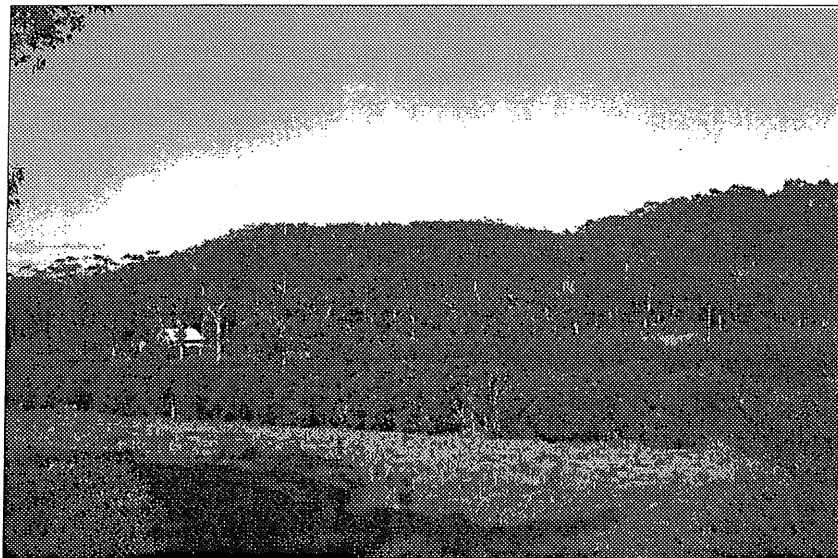
The site, (from a slightly different view), two years later, showing successful establishment and rapid growth rates. Photograph taken in July 1996.

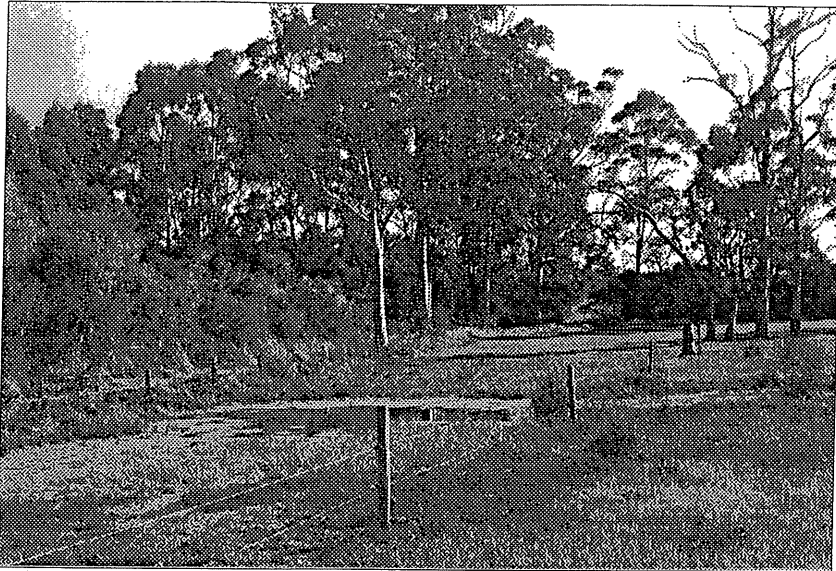
Little river, with its narrow belt of fringing vegetation, and a small tributary, at the point where the river flows into a privately-owned bush block, adjacent to Ocean beach Road. This block performs a valuable bio-filter role.

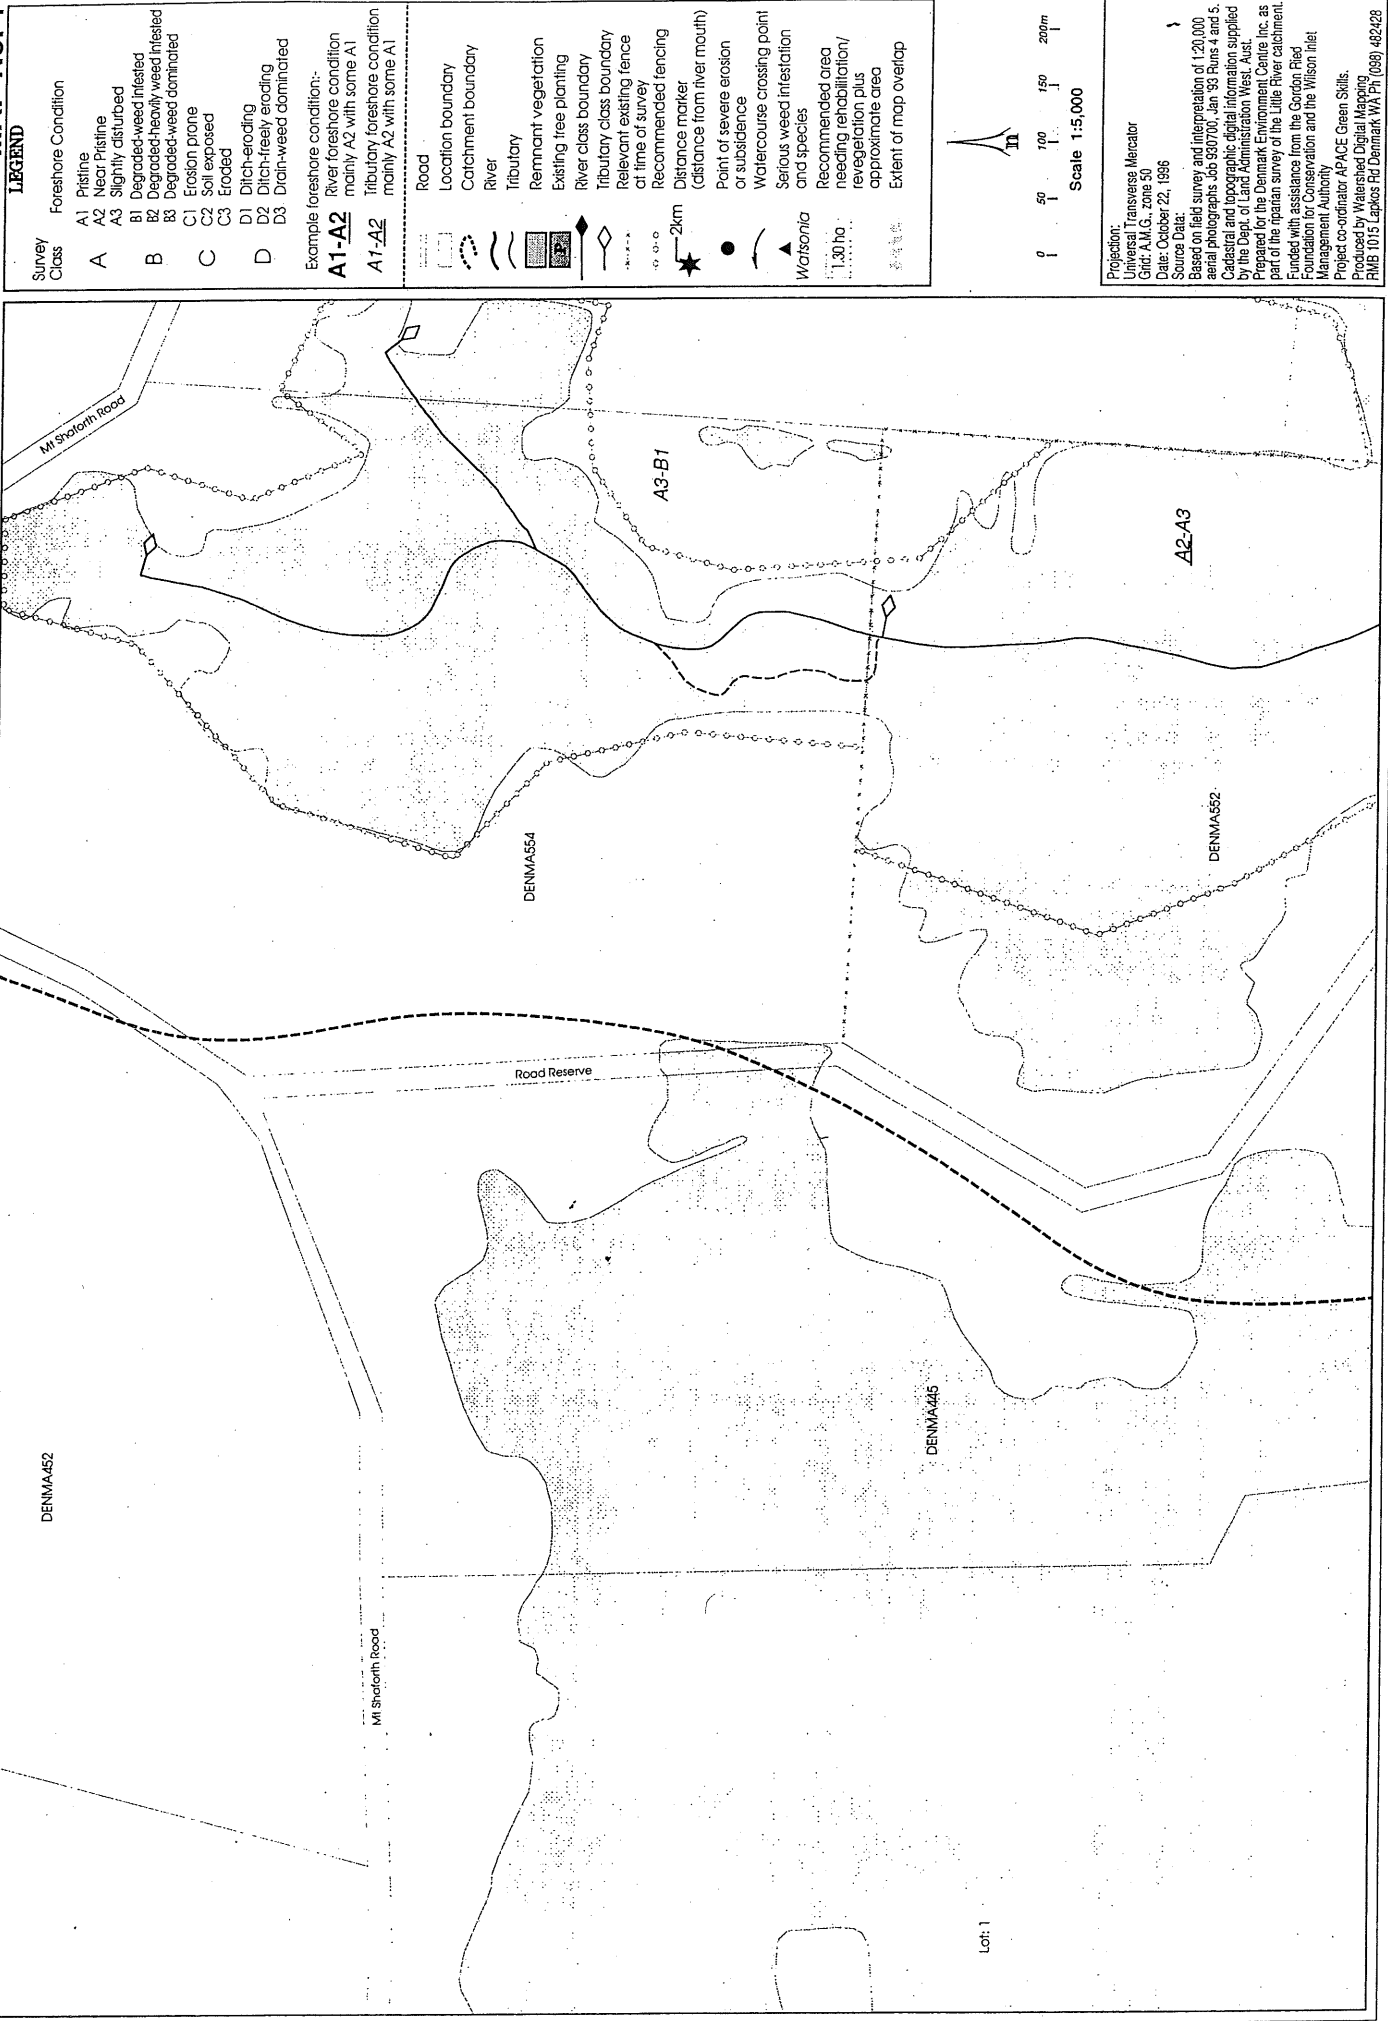
Little River	Tributaries/Tributary
Length of watercourse Fencing In Place	N/A	1,050 Metres
Length of watercourse Fencing Recommended	N/A	2,775 Metres
Number of severe erosion sites	N/A	Nil
Advice on remedial measures required for these sites	Recommendation: N/A	Recommendation: N/A
Approximate area along watercourse requiring revegetation work	Area (Ha.): N/A	Area (Ha.): Nil
Advice on Revegetation Species and Preparation	N/A	N/A
Number of other sites requiring rehabilitation work (ie Serious weed infestations)	N/A	Nil
Advice on Rehabilitation of these sites	Recommendation: N/A	Recommendation: N/A
Other Management Related Information for this map	N/A

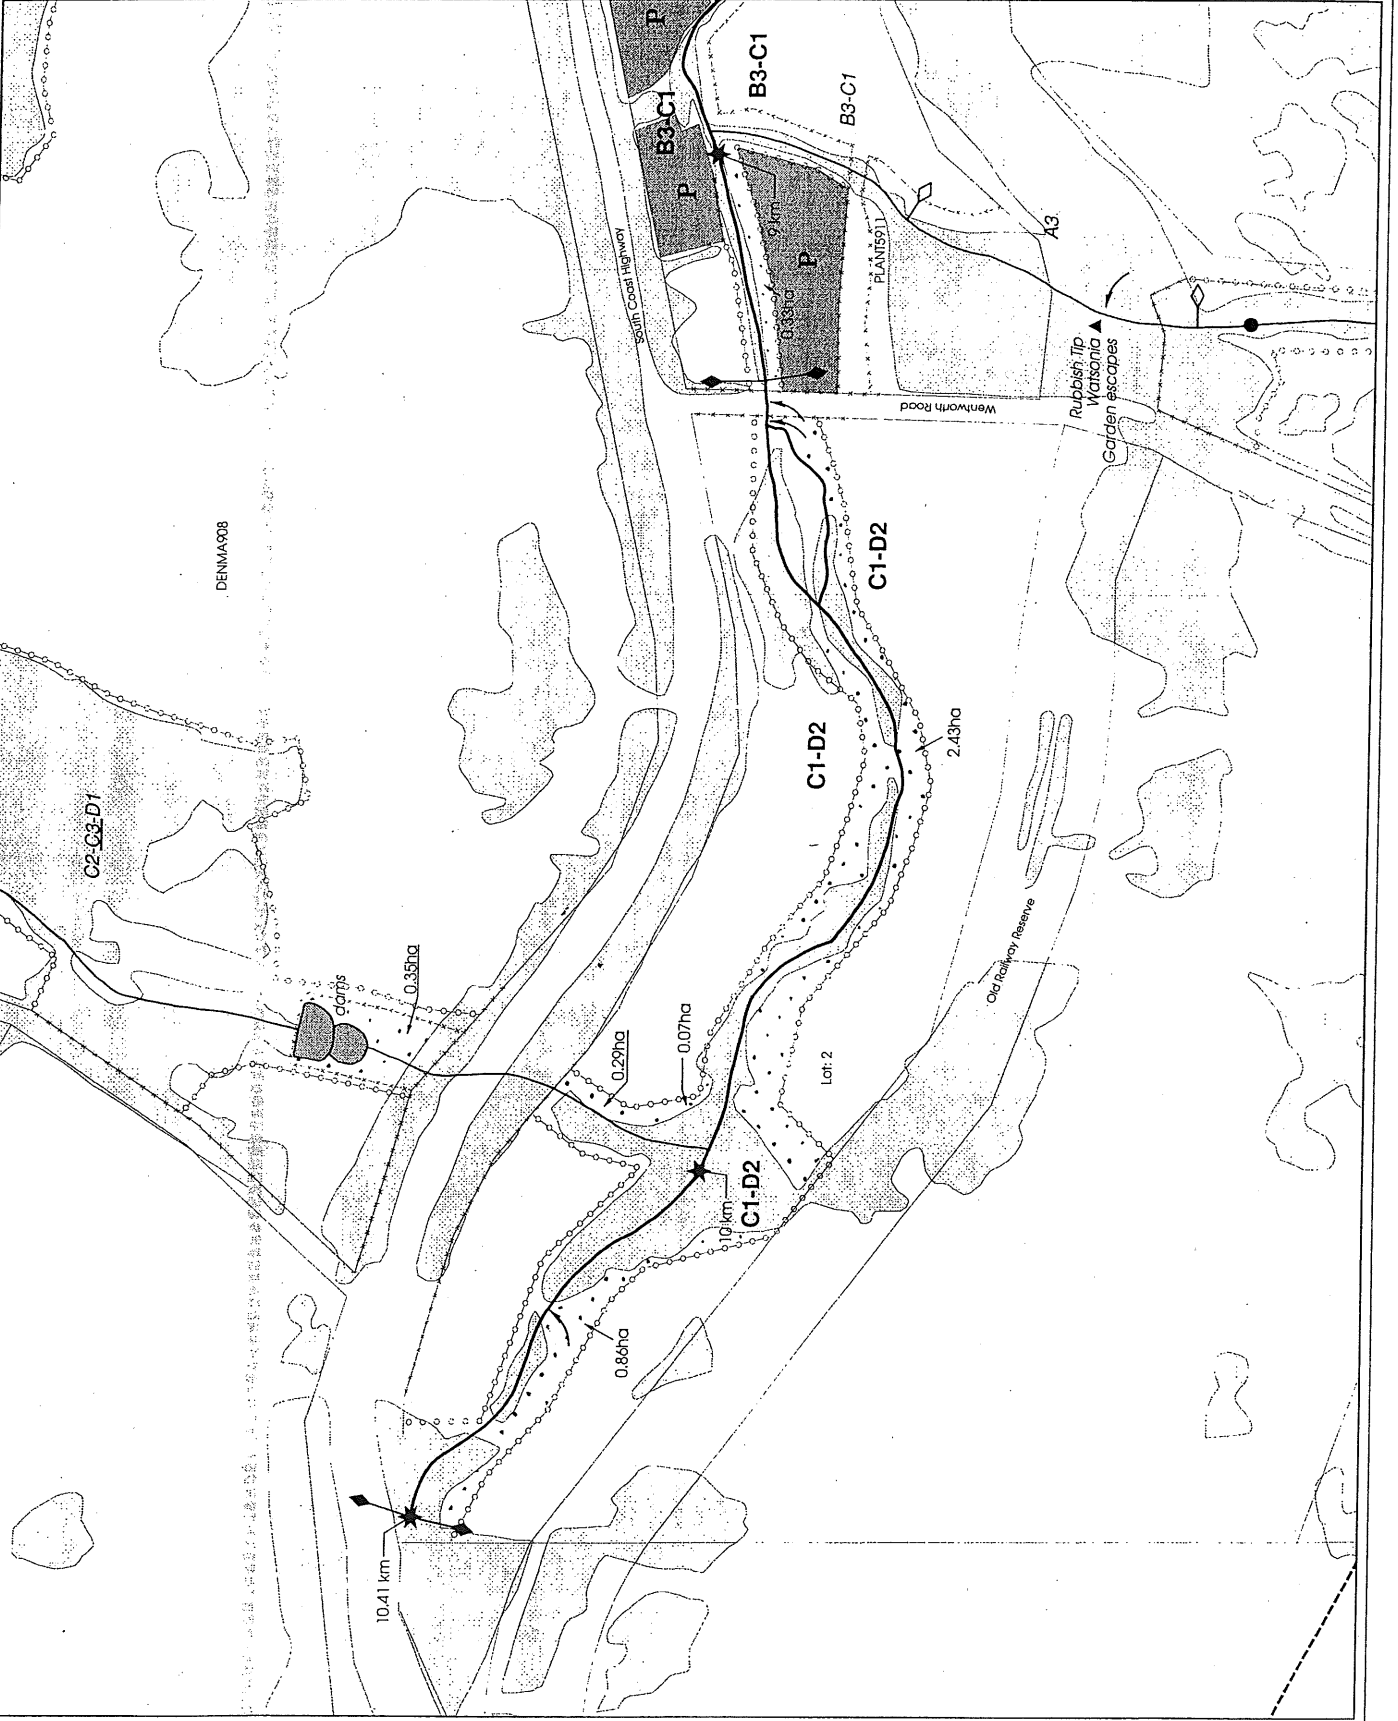
Little River	Tributaries/Tributary
Length of watercourse Fencing In Place	N/A	225 Metres
Length of watercourse Fencing Recommended	N/A	1,475 metres
Number of severe erosion sites	N/A	5
Advice on remedial measures required for these sites	Recommendation: N/A	Recommendation: Exclude stock from frequent use of crossing points. Brush, hand plant, allow natural regeneration.
Approximate area along watercourse requiring revegetation work	Area (Ha.): N/A	Area (Ha.): Nil
Advice on Revegetation Species and Preparation	N/A	N/A
Number of other sites requiring rehabilitation work (ie Serious weed infestations)	N/A	Nil
Advice on Rehabilitation of these sites	Recommendation: N/A	Recommendation: N/A
Other Management Related Information for this map	N/A

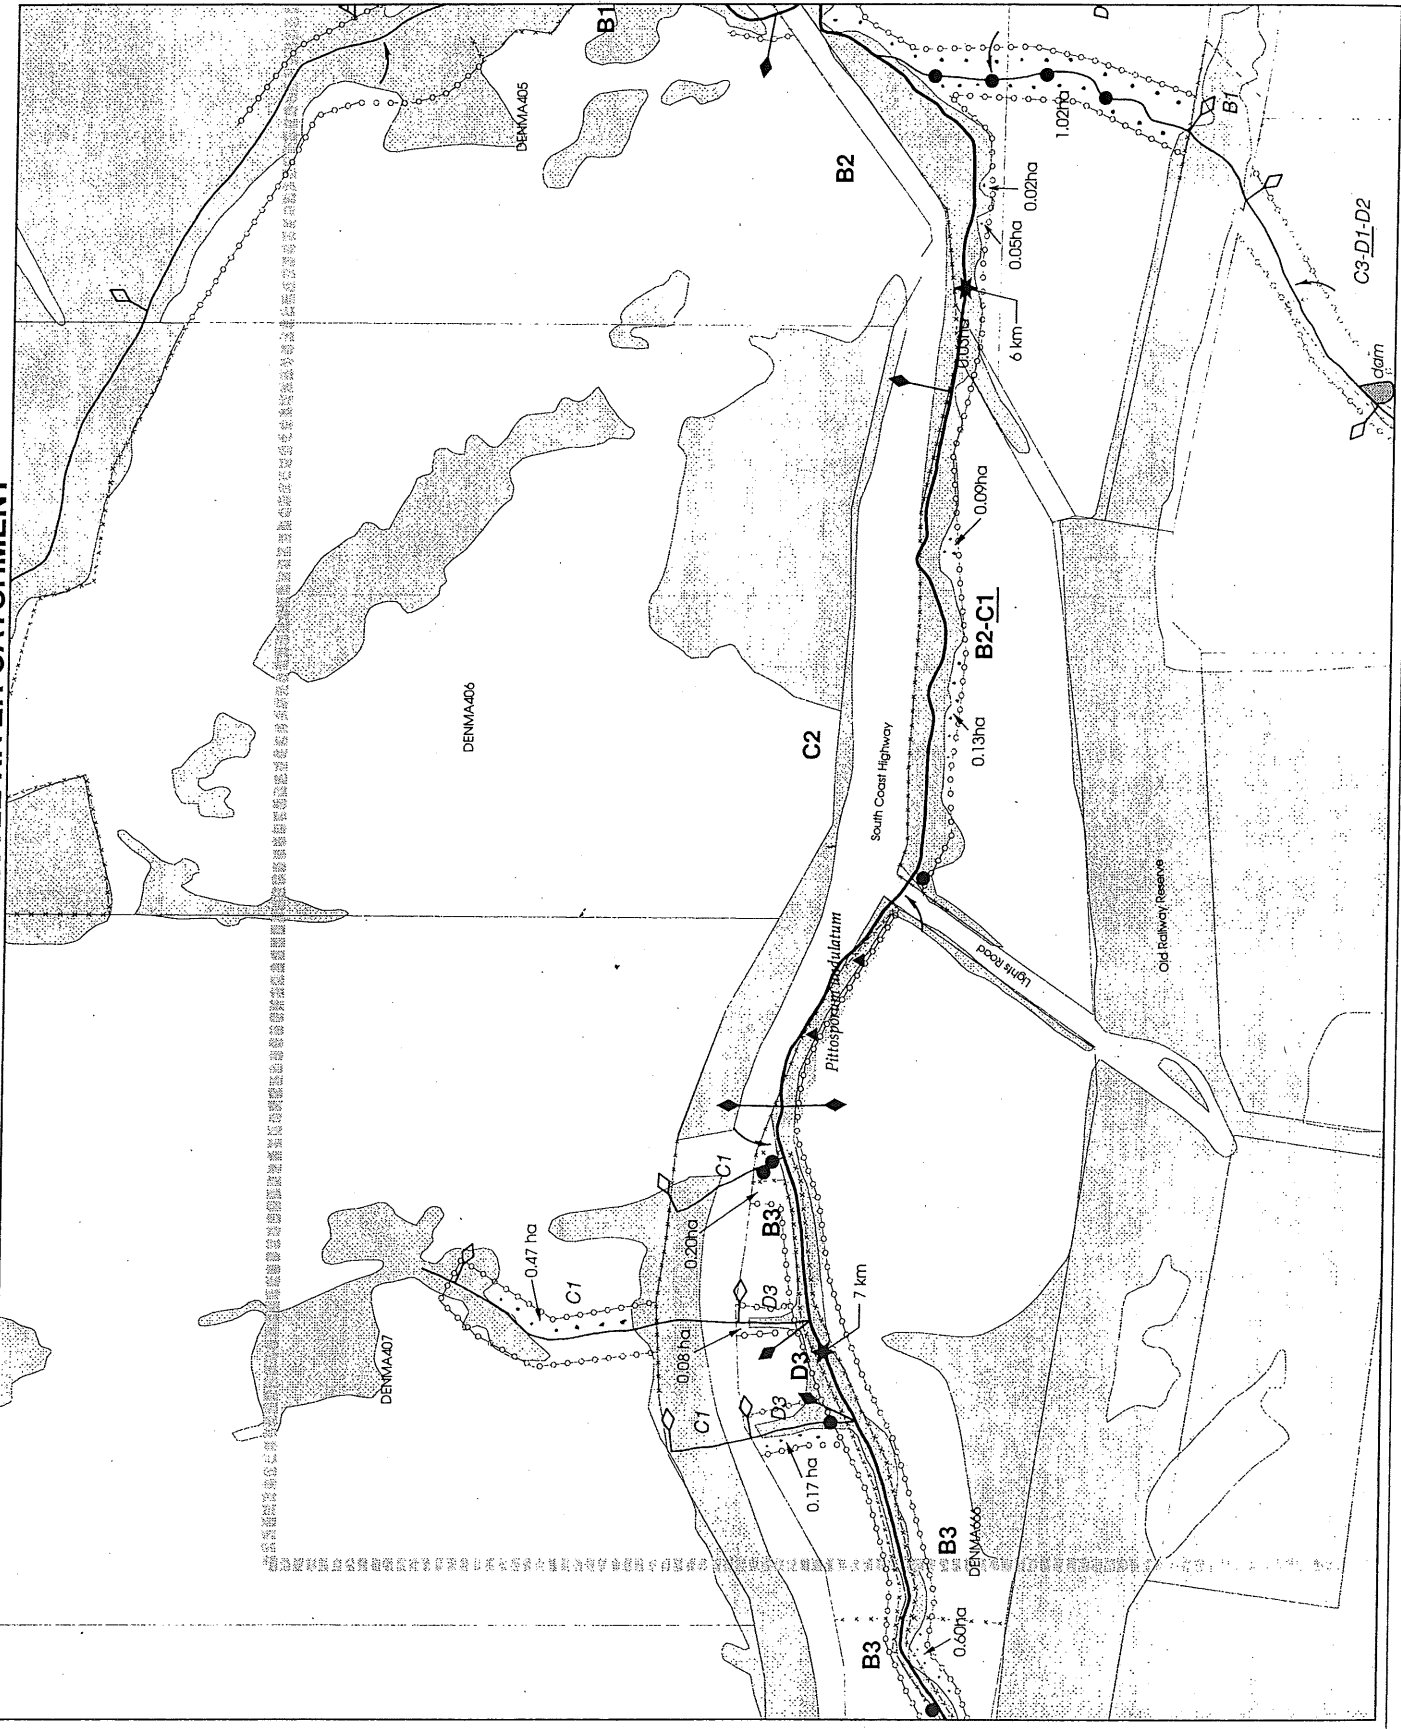
Little River	Tributaries/Tributary
Length of watercourse Fencing In Place	N/A	3,575 Metres
Length of watercourse Fencing Recommended	N/A	2,450 Metres Comment: Includes relocating some existing fence further out from channel.
Number of severe erosion sites	N/A	3
Advice on remedial measures required for these sites	Recommendation: N/A	Recommendation: Exclude stock from frequent use of crossing points. Elsewhere, fence and regenerate.
Approximate area along watercourse requiring revegetation work	Area (Ha.): N/A	Area (Ha.): 3.9
Advice on Revegetation Species and Preparation	N/A	Hand plant <i>Agonis juniperina</i> , <i>E. diversicolor</i> , <i>Eucalyptus calophylla</i> , <i>Eucalyptus patens</i> <i>Eucalyptus marginata</i> (Select further species from Appendix 1)
Number of other sites requiring rehabilitation work (ie Serious weed infestations)	N/A	1
Advice on Rehabilitation of these sites	Recommendation: N/A	Recommendation: Treat blackberry, allow natural regeneration.

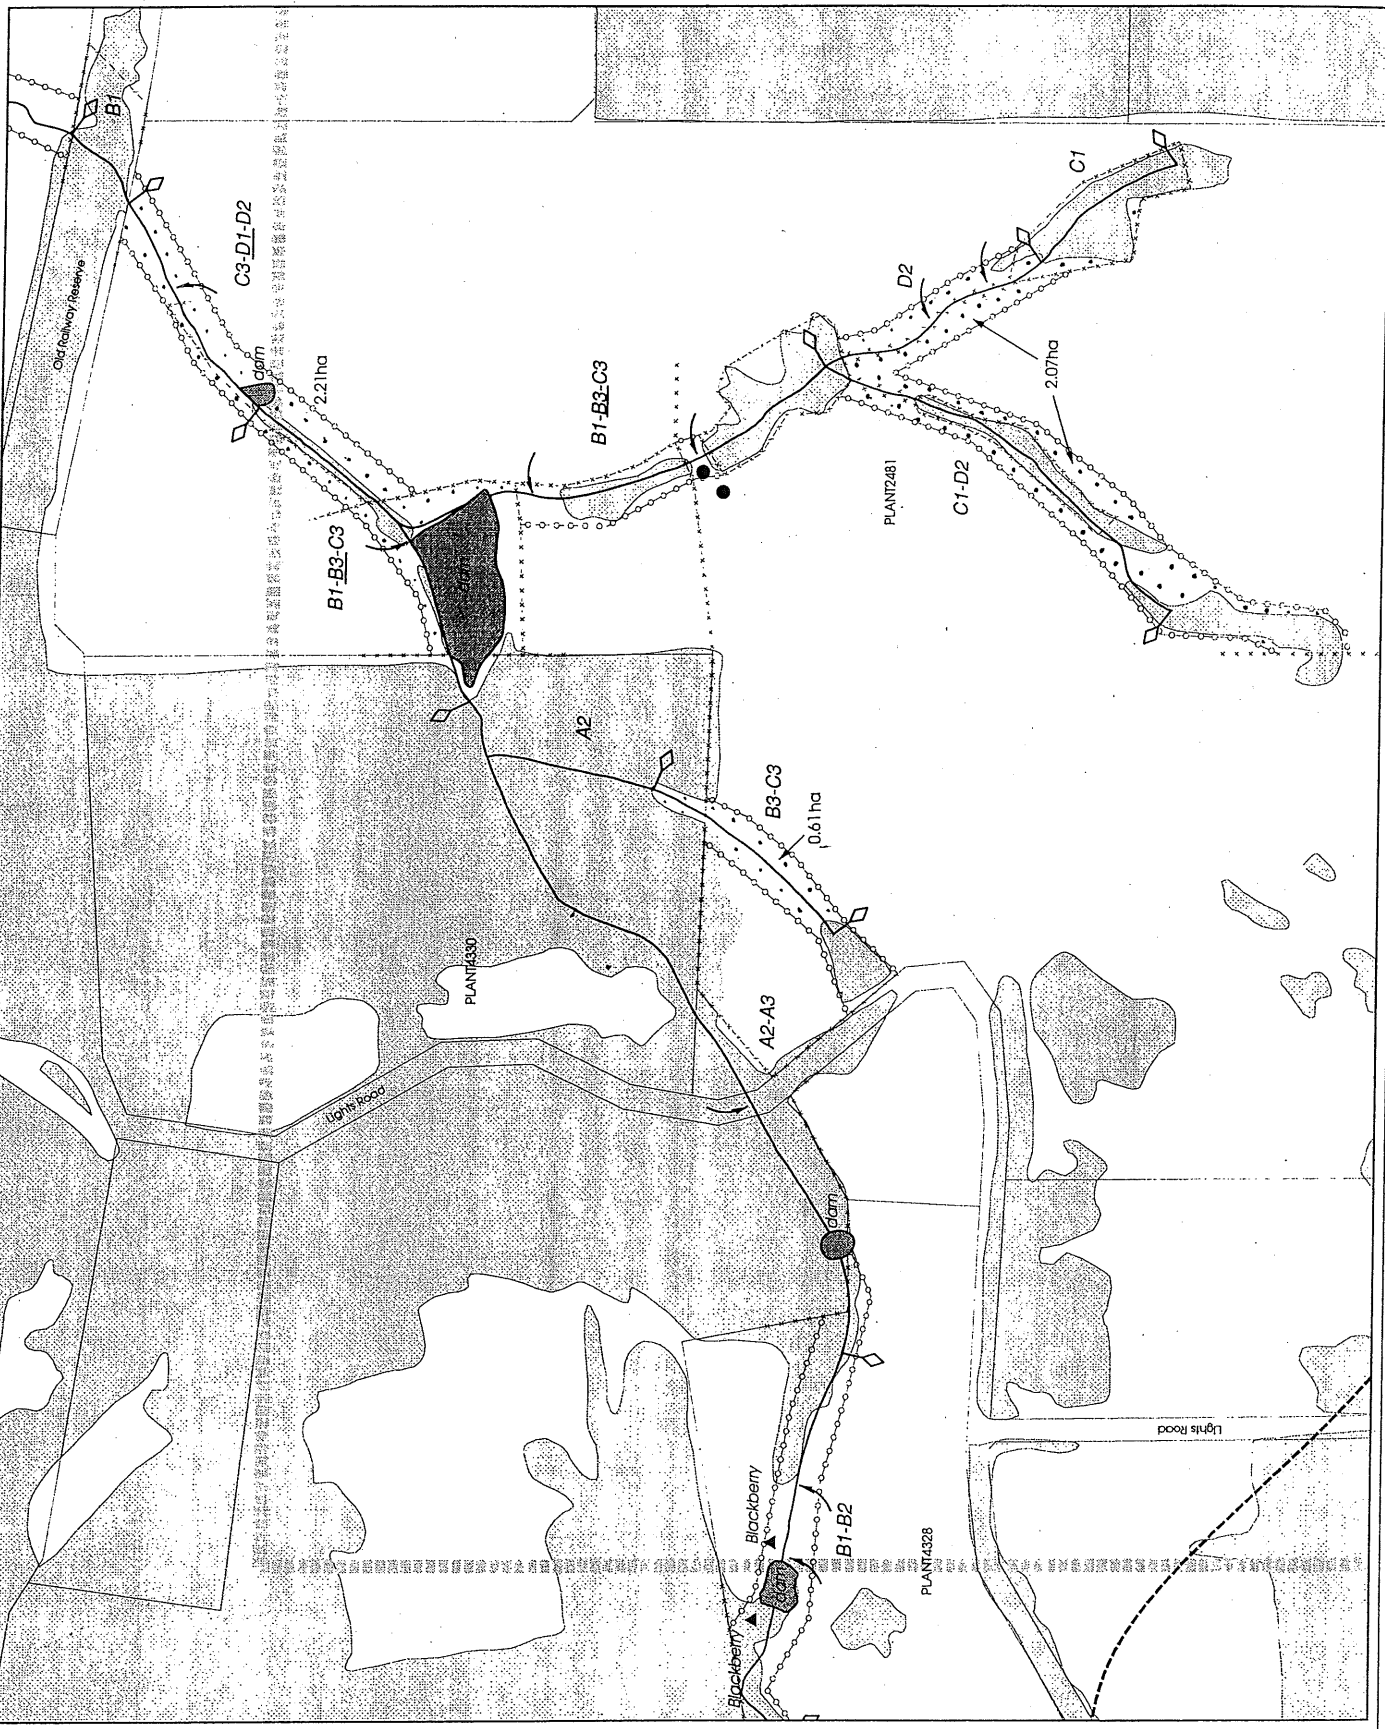
Little River	Tributaries/Tributary
Length of watercourse Fencing In Place	N/A	525 Metres
Length of watercourse Fencing Recommended	N/A	650 Metres
Number of severe erosion sites	N/A	Nil
Advice on remedial measures required for these sites	Recommendation: N/A	Recommendation: N/A
Approximate area along watercourse requiring revegetation work	Area (Ha.): N/A	Area (Ha.): Nil
Advice on Revegetation Species and Preparation	N/A	N/A
Number of other sites requiring rehabilitation work (ie Serious weed infestations)	N/A	2
Advice on Rehabilitation of these sites	Recommendation: N/A	Recommendation: Treat blackberry
Other Management Related Information for this map	N/A

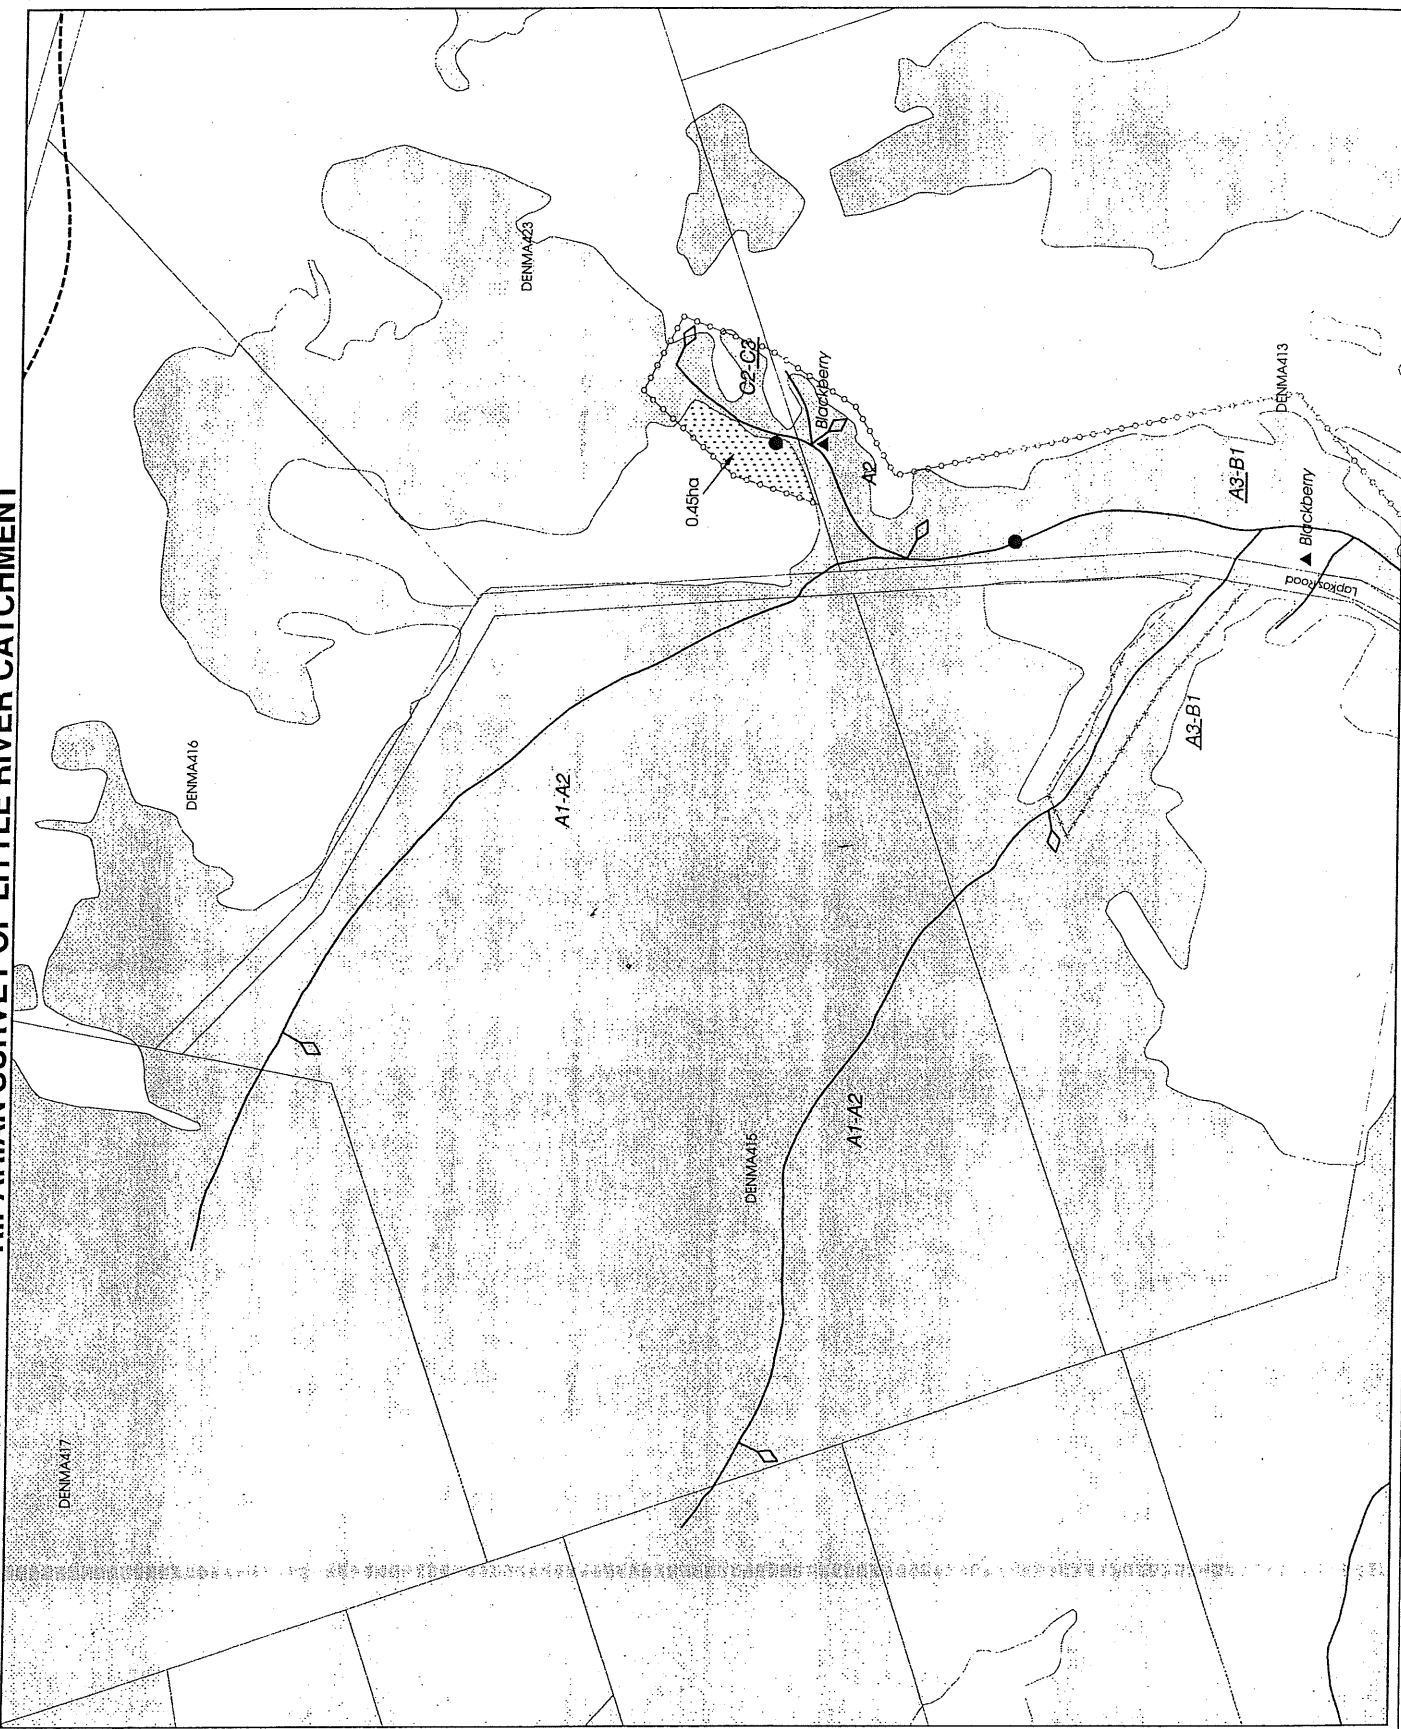
Little River	Tributaries/Tributary
Length of watercourse Fencing In Place	N/A	1,975 Metres
Length of watercourse Fencing Recommended	N/A	2825 Metres Comment: Includes relocating some existing fence.
Number of severe erosion sites	N/A	4
Advice on remedial measures required for these sites	Recommendation: N/A	Recommendation: Exclude stock. Brush, hand plant.
Approximate area along watercourse requiring revegetation work	Area (Ha.): N/A	Area (Ha.): 1.4
Advice on Revegetation Species and Preparation	N/A	Hand plant <i>Agonis juniperina</i> , <i>E. diversicolor</i> , <i>Eucalyptus calophylla</i> , <i>Eucalyptus patens</i> <i>Eucalyptus marginata</i> (Select further species from Appendix 1)
Number of other sites requiring rehabilitation work (ie Serious weed infestations)	N/A	5
Advice on Rehabilitation of these sites	Recommendation: N/A	Recommendation: Treat weeds, allow natural regeneration.
Other Management Related Information for this map	N/A

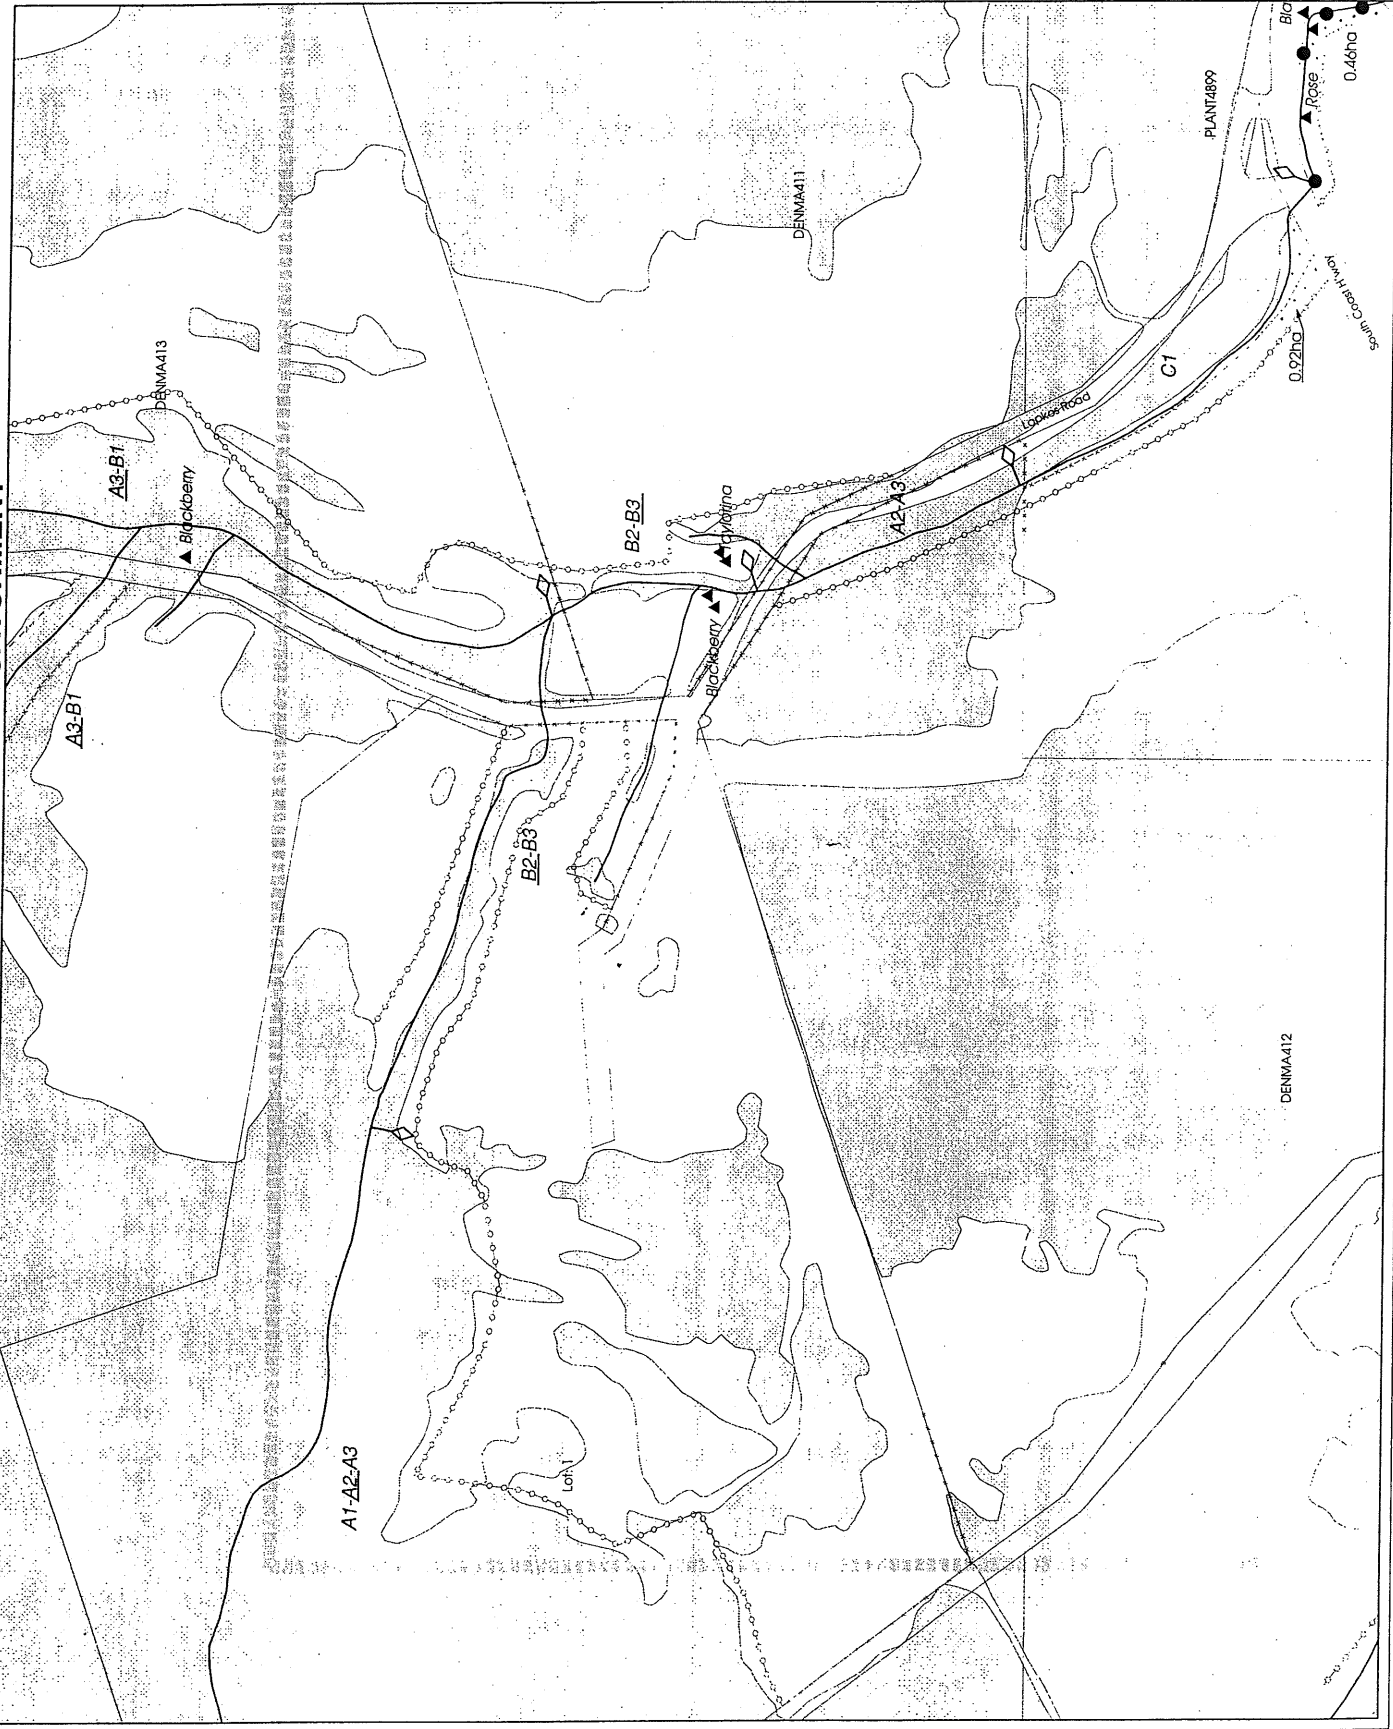
Little River	Tributaries/Tributary
Length of watercourse Fencing In Place	1,725 Metres	750 Metres
Length of watercourse Fencing Recommended	850 Metres Comment: Nil	2,450 Metres
Number of severe erosion sites	Numerous/continuous on Lot 10. 2 others	7
Advice on remedial measures required for these sites	Recommendation: For the Lot 10 section of river may require a soft engineering techniques (construction of pools and riffles) as recommend in the report on Little River Angus MacKenzie (1996) For others exclude stock.	Recommendation: Exclude stock from frequent use of crossing points. Brush, hand plant.
Approximate area along watercourse requiring revegetation work	Area (Ha.): 3.	Area (Ha.): 1.3
Advice on Revegetation Species and Preparation	Hand plant <i>Agonis juniperina</i> , <i>E. diversicolor</i> , <i>Eucalyptus calophylla</i> and species suitable for a wetland area.(Select further species from Appendix 1)	Hand plant <i>Agonis juniperina</i> , <i>E. diversicolor</i> , <i>Eucalyptus calophylla</i> , <i>Eucalyptus patens</i> (Select further species from Appendix 1)

Number of other sites requiring rehabilitation work (ie Serious weed infestations)	Nil	Nil
Advice on Rehabilitation of these sites	Recommendation: N/A	Recommendation: N/A
Other Management Related Information for this map	The severe and continuing erosion on Lot 10 requires urgent attention. Costings to achieve this are contained in MacKenzie,1996)

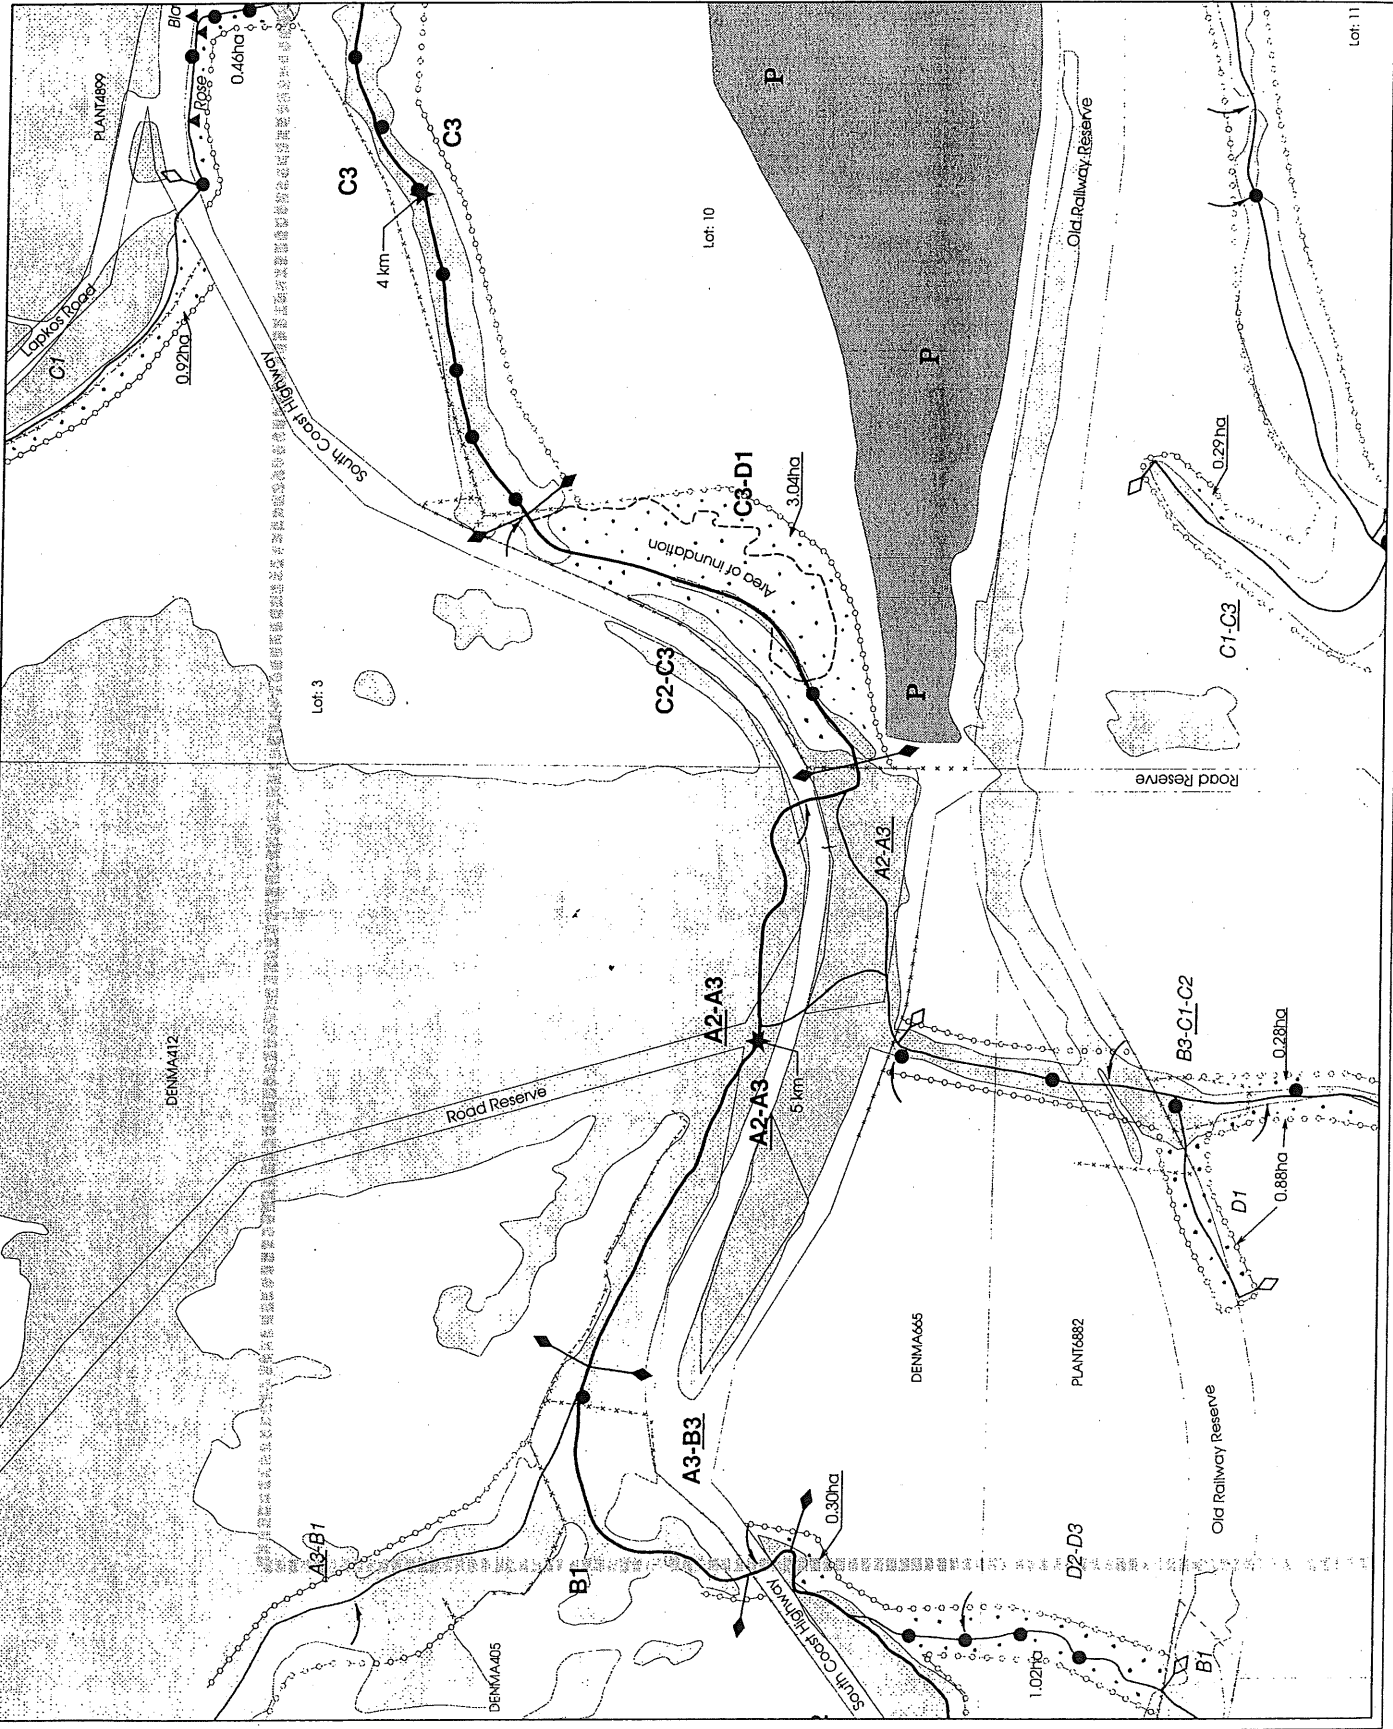
Little River	Tributaries/Tributary
Length of watercourse Fencing In Place	N/A	Nil
Length of watercourse Fencing Recommended	N/A	675 Metres
Number of severe erosion sites	N/A	2
Advice on remedial measures required for these sites	Recommendation: N/A	Recommendation: Exclude stock from frequent use of crossing points. Brush, hand plant.
Approximate area along watercourse requiring revegetation work	Area (Ha.): N/A	Area (Ha.): 2.1
Advice on Revegetation Species and Preparation	N/A	Hand plant <i>Agonis juniperina</i> , <i>Eucalyptus calophylla</i> , <i>Eucalyptus patens</i> <i>Eucalyptus marginata</i> (Select further species from Appendix 1)
Number of other sites requiring rehabilitation work (ie Serious weed infestations)	N/A	Nil
Advice on Rehabilitation of these sites	Recommendation: N/A	Recommendation: N/A
Other Management Related Information for this map	N/A
