Compliance report

A summary of technical building inspections

(Class 1 - residential buildings)

2018/19

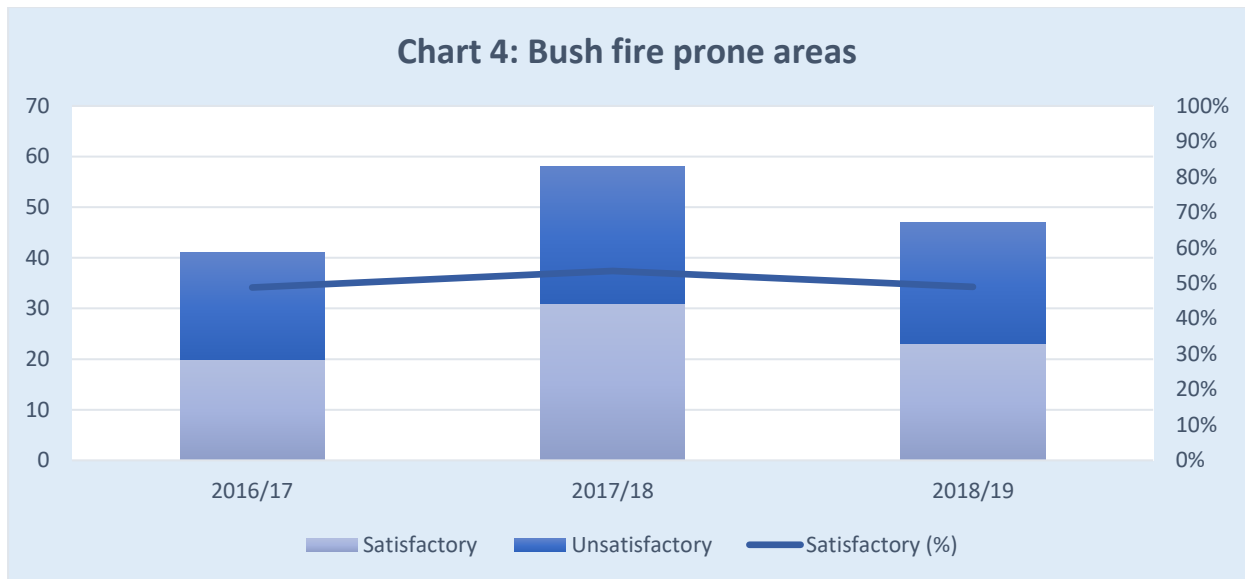
Less than half of the inspection points relating to bush fire area requirements assessed during 2018/19 were deemed satisfactory (see **Chart 4**).

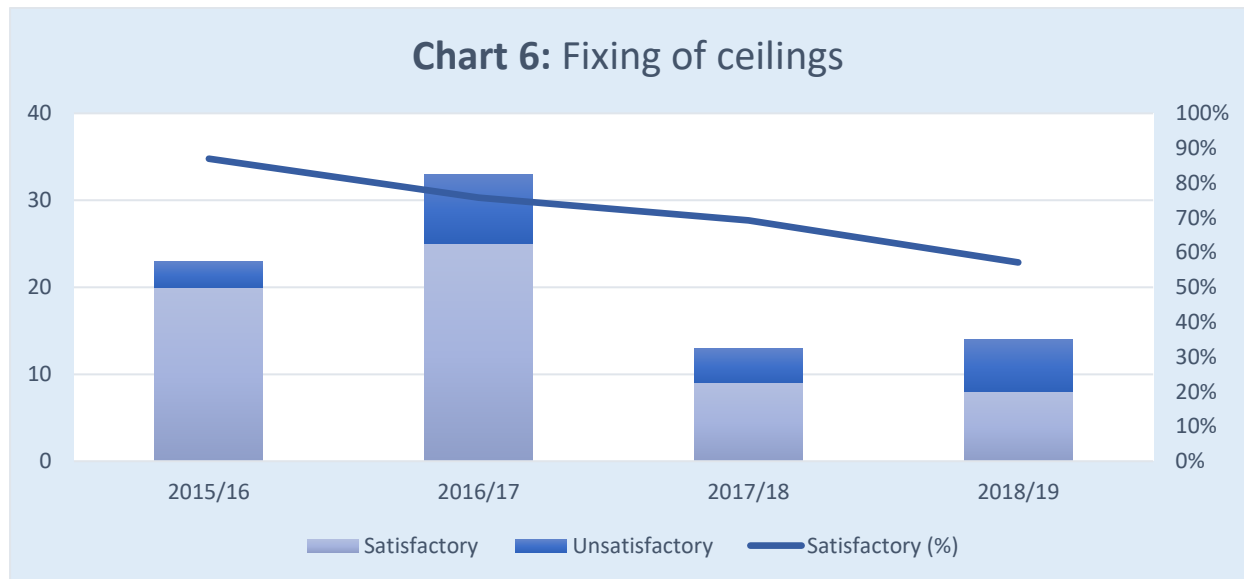
Of concern is the proportion of inspections where the fixing of the ceiling can be assessed which result in an unsatisfactory finding, with the majority of these recorded as being unsatisfactory due to the poor application of adhesives. Six of the 14 properties where the fixing of the ceiling lining could be assessed in 2018/19 were deemed unsatisfactory. In five of these instances, the building inspector recorded that ‘smearing’ of the adhesive daub resulted in the daub being insufficient, while on one occasion it was noted that the spacing of adhesive daubs and screw fixings was not in accordance with AS/NZS 2589 Gypsum linings – Application and finishing.
