Compliance report

**A summary of technical
building inspections (Class 1 -
residential buildings)**

2019/20

June 2021

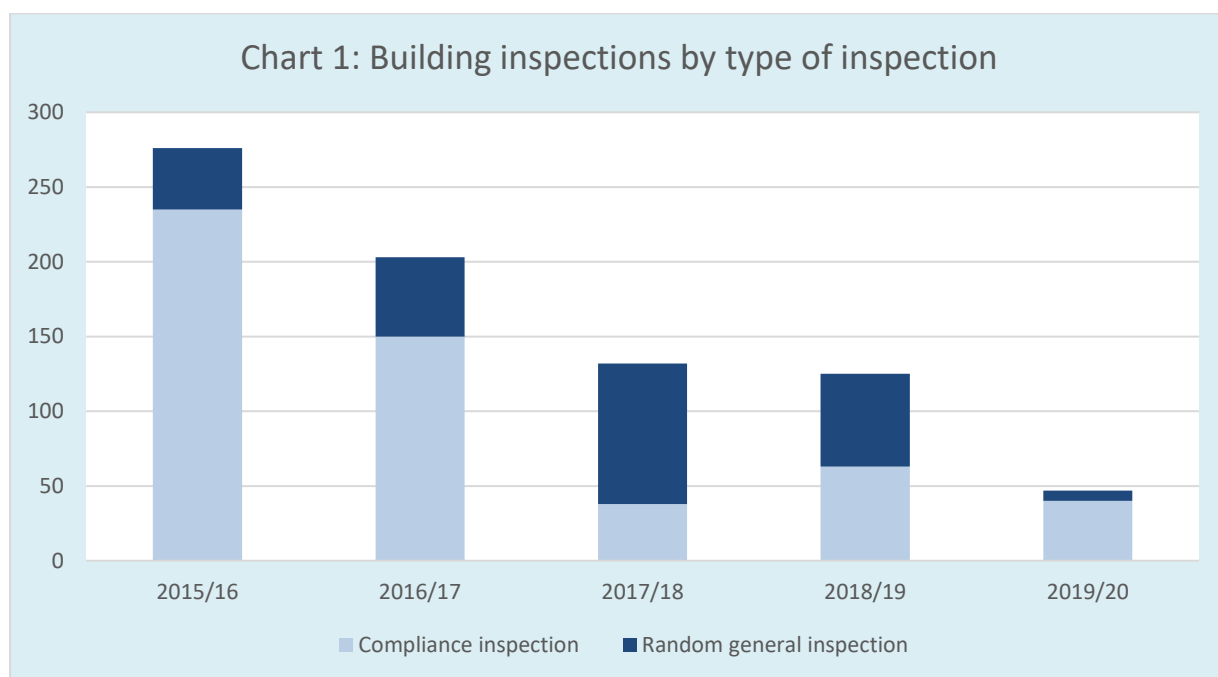
In 2019/20, Building and Energy undertook 47 technical inspections of building work stemming from its Compliance and random General Inspections activities (see **Chart 1**).³ This number has reduced from 125 inspections in 2018/19 due to the prioritisation of inspections into other classes of buildings and undertaking targeted General Inspections into specific areas of construction which are reported on separately.⁴

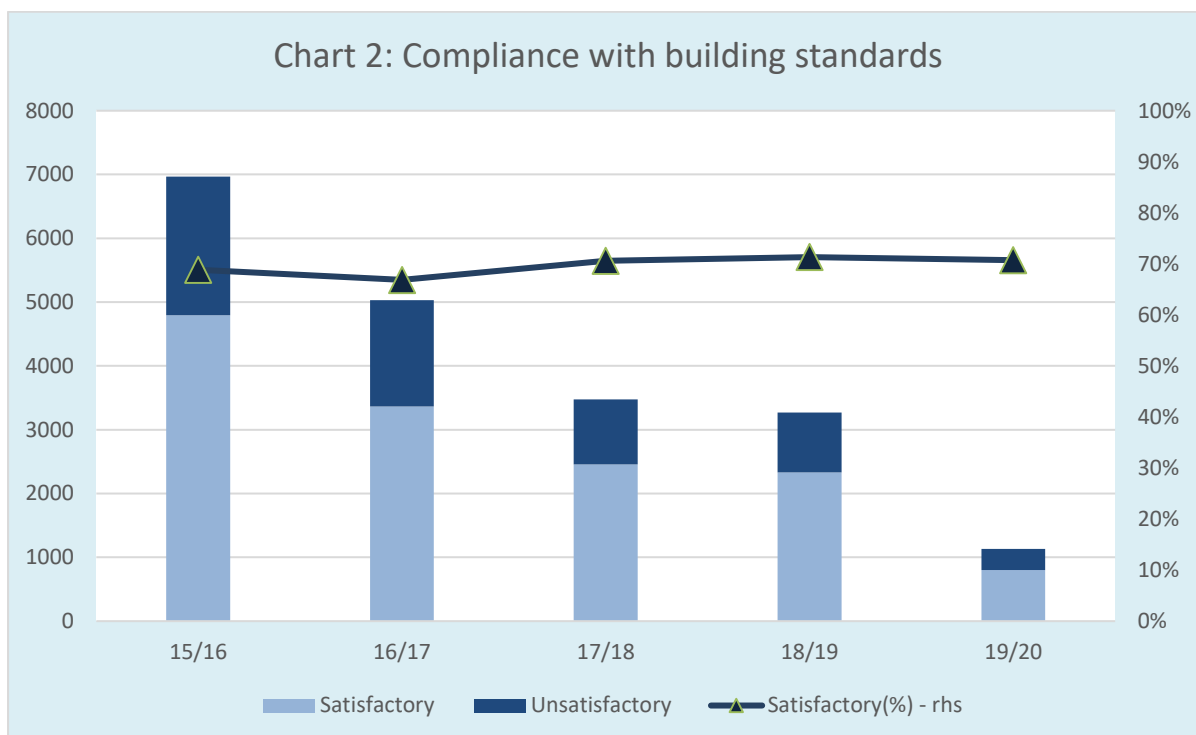
During the 47 technical inspections performed in 2019/20 a total of 1,131 inspection points were assessed by Building and Energy. Of these, 800 (71%) were deemed to be satisfactory (see **Chart 2**). This is consistent with the historical satisfactory rate which has been 71 per cent for the past three financial years.

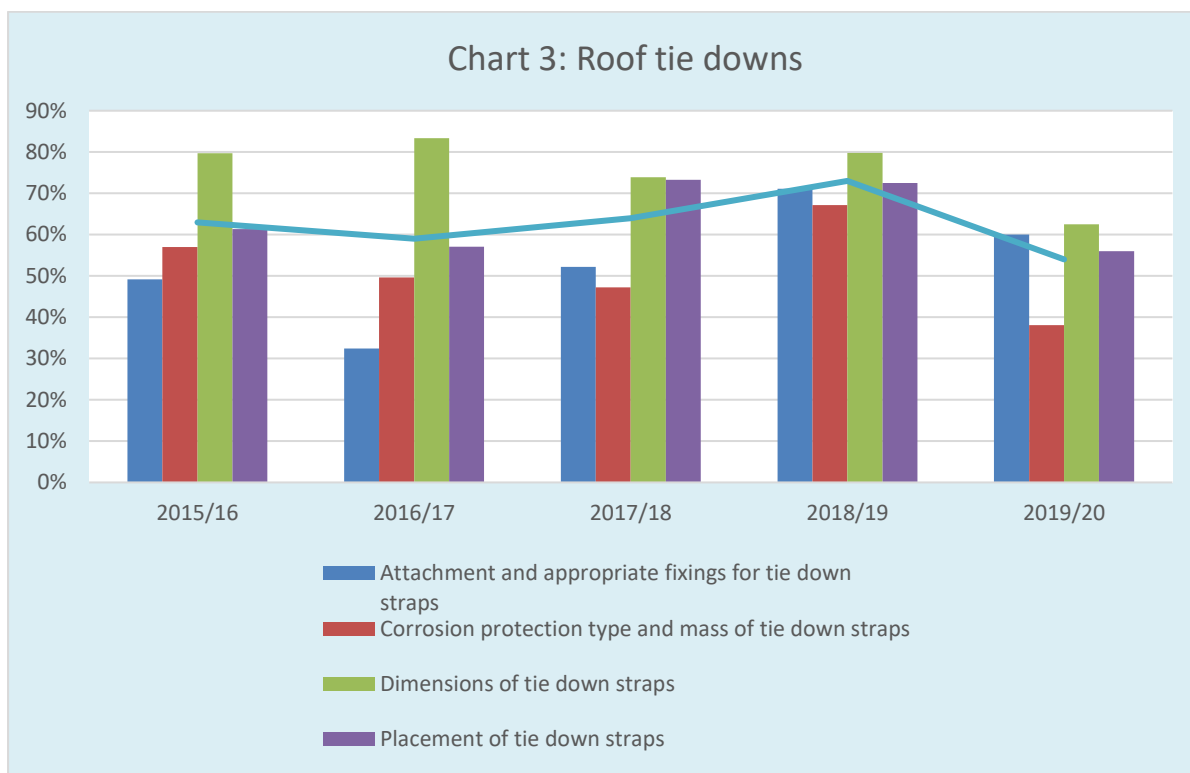
Since the release of general inspection report one Building and Energy has observed an increase in the number of tie down fixings in roof construction; however, while this indicates a greater effort towards compliance, the manner of tie-down is still being incorrectly applied in some instances.

- attachment and appropriate fixings for tie down straps (60 per cent down from 71 per cent);
- corrosion protection type and mass of tie down straps (38 per cent down from 67 per cent);
- dimensions of tie down straps (63 per cent down from 80 per cent); and
- placement of tie down straps (56 per cent down from 73 per cent).

One of the areas of concern addressed in the general inspection report was the use of roof tie downs. While Building and Energy observed an increase in compliance in this area since the release of the general inspection report, there was a decline in compliance during 2019/20.

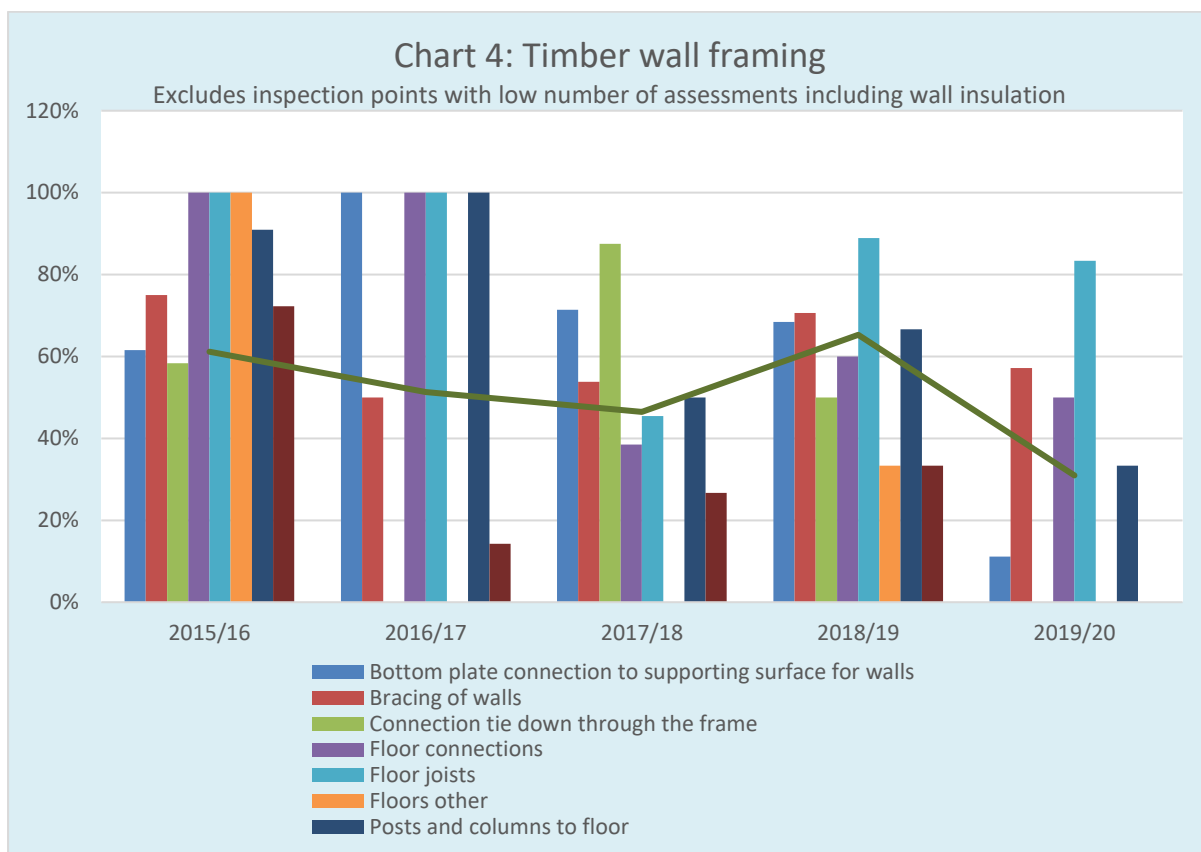
Ensuring appropriate connections through the timber wall frame are an important part in ensuring structural integrity of a building. As such, it is concerning to Building and Energy that the proportion of timber wall framing inspection points fell to 31 per cent in 2019/20, down from 65 per cent in 2018/19 (see Chart 4).

This included only one of nine assessments of a bottom plate connection to supporting surface for walls as being satisfactory and zero of nine assessments of the connection tie down through the frame as being satisfactory.

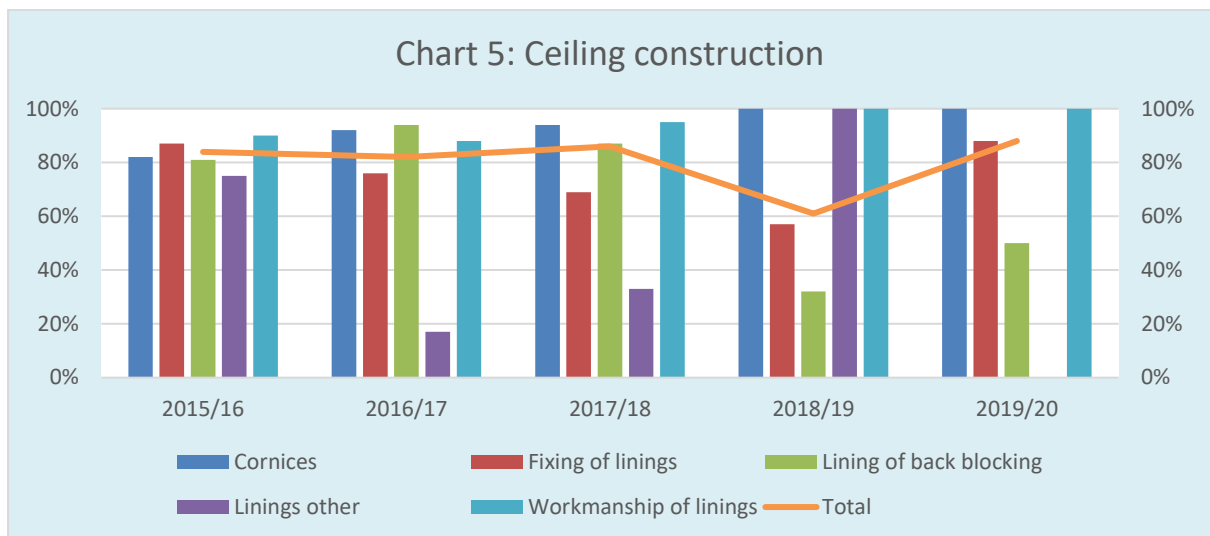
The narrow ‘window of opportunity’ for inspecting ceiling work resulted in 24 inspection points related to ceilings assessed in 2019/20 with (88%) considered satisfactory (see chart 5).

Inspection point	Satisfactory	Unsatisfactory	Satisfactory (%)
Ceilings - Total	21	3	88%
Cornices	6	0	100%
Fixing of linings	7	1	88%
Lining of back blocking	2	2	50%
Linings other	0	0	N/A
Workmanship of linings	6	0	100%
Drainage work - Total	0	0	N/A
Drainage system - water diverted away	0	0	N/A
Drainage systems - other	0	0	N/A
Energy efficiency - Total	1	3	25%
Building sealing for conditioned space	0	0	N/A
Building sealing other	0	0	N/A
Ceiling insulation	0	1	0%
Insulation other	0	1	0%
Roof foil insulation installed correctly	1	0	100%
Wall insulation	0	1	0%
Excavation work - Total	6	4	60%
Excavation of other	0	2	0%
Excavation of unprotected embankment	3	1	75%
Retaining adequate	3	1	75%
External render and plaster - Total	15	1	94%
External acrylic other	0	0	N/A
External render other	6	0	100%
Ground level finish	5	0	100%
Ground level finish of external acrylic	0	0	N/A
Workmanship of external acrylic	4	1	80%
Fire separation - Total	35	2	95%
