# FINAL REPORT

General Inspection Report Two: A general  
inspection into Yuanda-supplied products in the  
Western Australian building industry

# BUILDING COMMISSION GENERAL INSPECTION REPORT TWO (GIR2)

A general inspection into the  
use of Yuanda products in  
Western Australian buildings

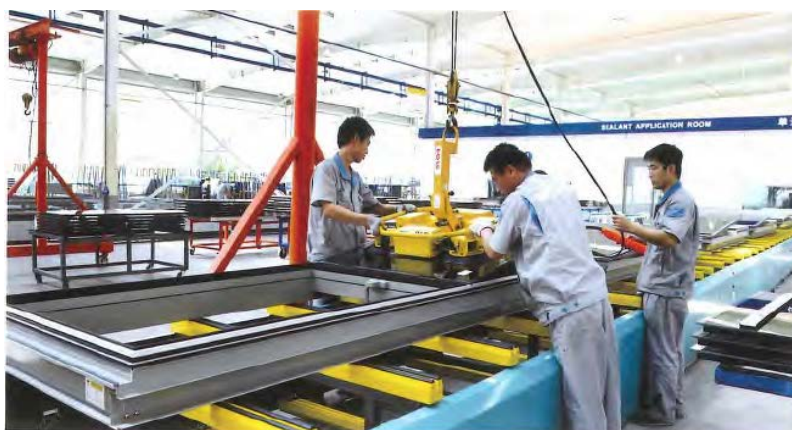
**Figure 1:** Yuanda China product assembly (typical)

Where Yuanda (Aus) procures products from sources other than Yuanda China there is a separate procurement policy. The Yuanda (Aus) procurement process focuses on budget and accuracy of quotation. The process also requires details from the product supplier including testing and commissioning.
